# Archaeological Evaluation of the Ruin beside Water's Clough, Castleshaw, Saddleworth

Report written by Norman Redhead  
for the Friends of Castleshaw Roman Forts

January 2018

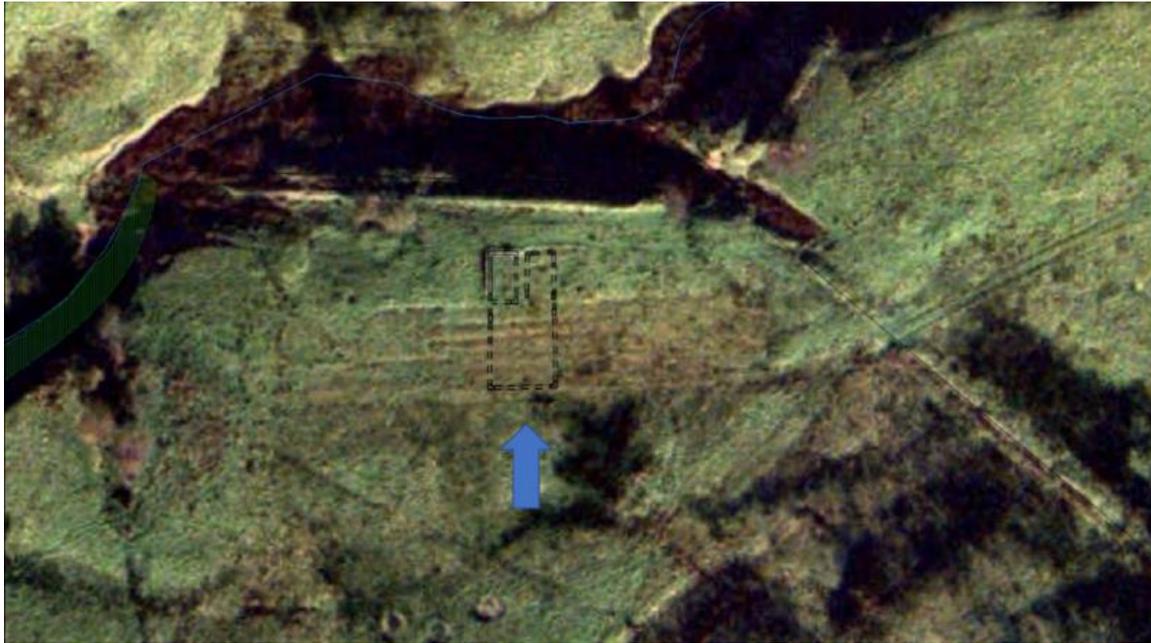
The aerial photograph above, dating to the late 1990s, shows the line of walls revealed during the 2016 investigations. These depict a structure measuring 20 by 10 metres aligned on a north to south axis. On either side of the structure can be seen a rectangular area with lines representing potential walls and gullies. The Google Earth picture below shows the same site but looking from just north of the ruin. The key indicates the main features: A = remains of ruined walls beside the bank of Waters Clough with a pronounced earth bank bounding the edge of the slope down to the clough, B = rectangular platform of possible western range, C = rectangular platform of possible eastern range, D = central range incorporating the ruined walls and showing parallel lines, with the southern edge of the central range defined by a vegetation change, E = the line of the Roman road which appears to be partly cut into by the eastern range building platform (C).

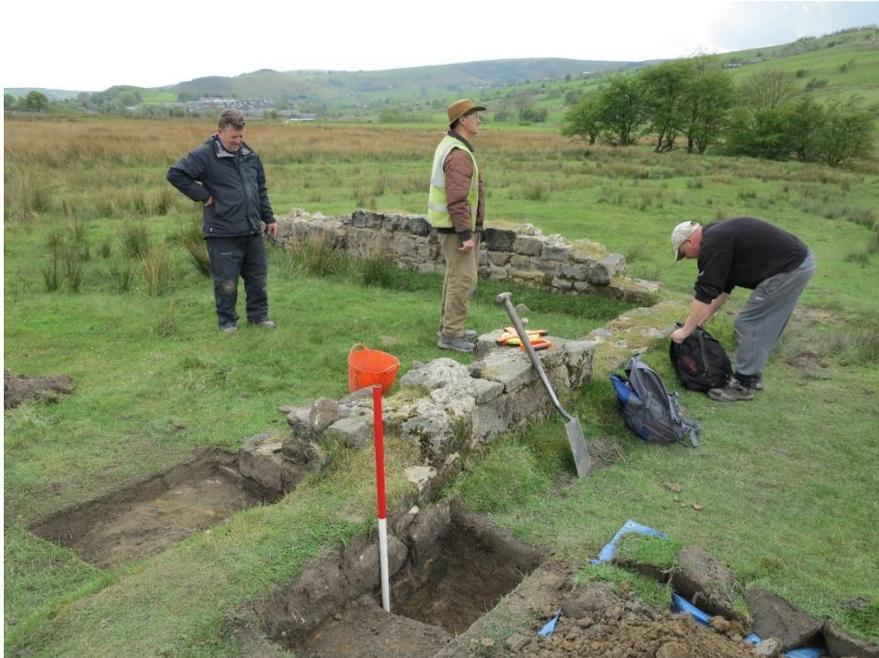
Cliff, Steve and Mike excavate a section against the northernmost ruined wall

Test pits were excavated either side of the northern wall of the ruin to examine the depth of the wall foundation and evidence for a floor surface. The external test pit revealed two courses of stone representing a wall depth at this point of 40 cm. A deposit of mid-grey silty clay loam with frequent pieces of mid orange-yellow mortar was encountered level with the base of the first course of stonework, at a depth of 30 cm beneath the turf line. This deposit was c 15 cm deep against the wall and tapered away from it, being the construction phase material. It was evident that the foundation trench was cut very neatly and very close to the foundation stonework. The interior test pit was located next to an internal return wall. This found natural clay at a shallow depth of around 10 cm, with no evidence for a floor. The internal wall butted up against the external but was of similar construction. The natural clay is an excellent material for building on. The foundations were robust and well-constructed, which is consistent with the high quality of walling seen elsewhere in the structure.

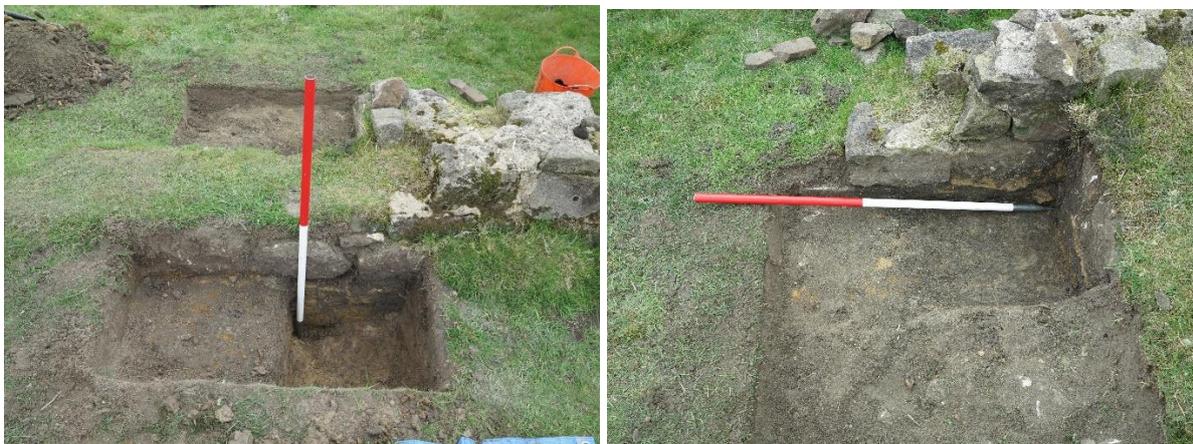
External wall test pit (left, looking south) and internal test pit (right, looking west).

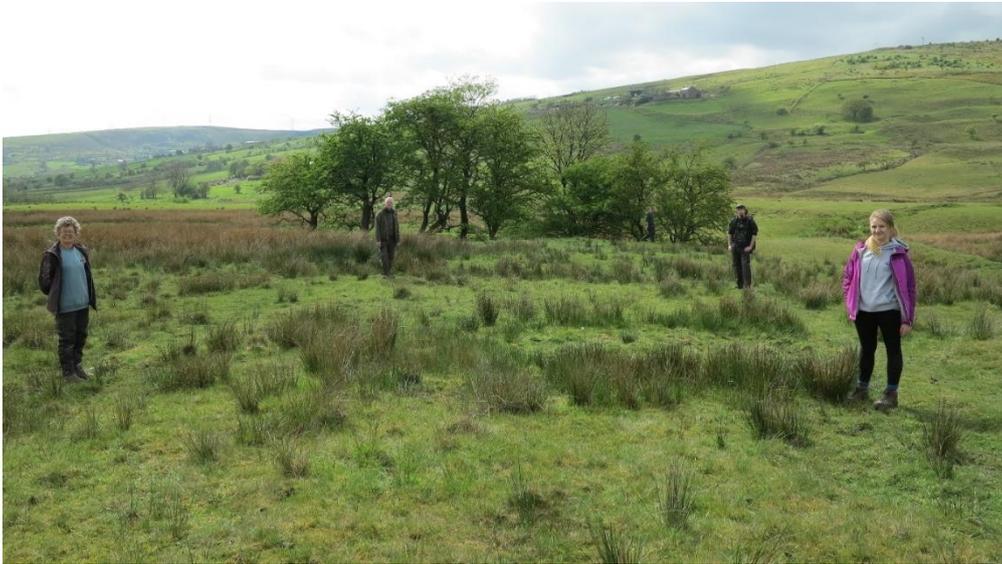
At the end of the day, the digging team took the opportunity to explore the land immediately to the west of the ruined walls. It was very apparent that other potential walls existed in this area, along with the lines of what appeared to be linear depressions. The aerial photographs indicate a rectangular platform and this was evident on the ground as a flat area defined by low linear mounds interpreted as grassed-over wall foundations. Clearly there is more to the site than the central structure of 20 metres by 10 metres defined in our test pitting last year.

Left to right: Sue, Mark, Rob and Eleanor stand on the possible wall lines for a structure west of the ruin.

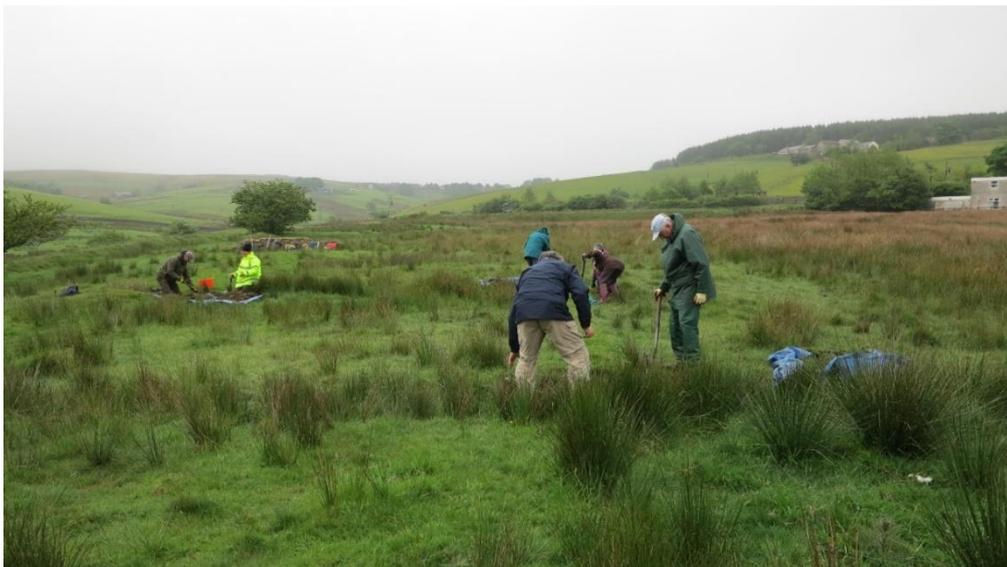
Commencement of test pitting on the site of the west range, looking east. The central range's upstanding walls are in the background beyond the figure in yellow.

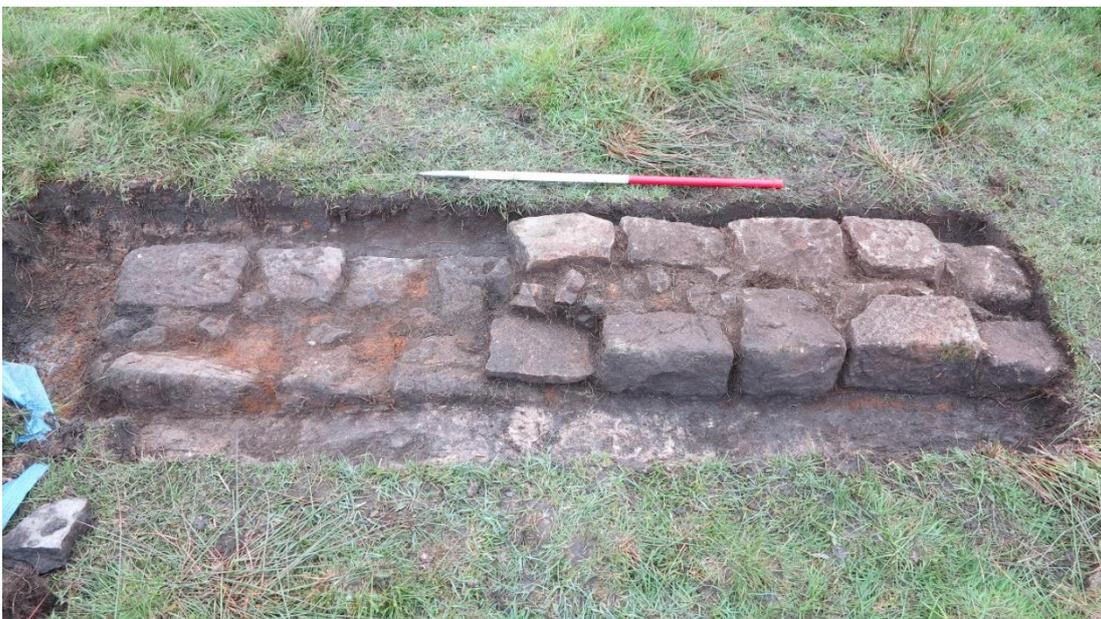
A 3 metre long trench (A) was opened up across one of the most prominent grassed-over wall bases along the western wall line of the putative structure, around 20 metres from the western wall of the central range. This was found to have wall remains stepping down from two courses in height to just a robber trench on the east side where all stonework had been removed. The surviving wall section was consistent with that found in the central structure in the 2016 evaluation. It was 50 cm wide comprising roughly dressed facing stones with a narrow rubble core, set in a dark orange-yellow mortar.

Well-preserved section of southern wall (A), looking south, showing wall construction with the dark orange-yellow mortar visible.

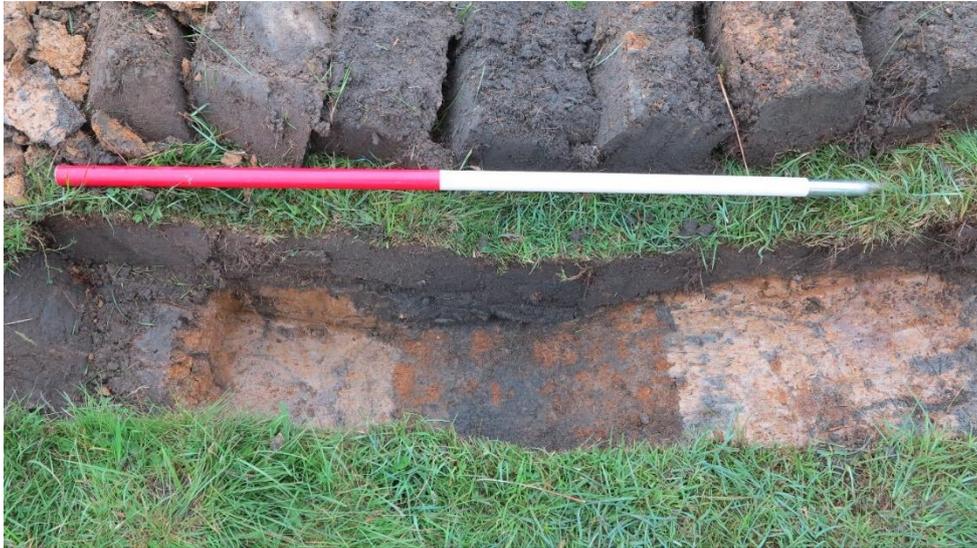
A narrow test pit was excavated 10 metres east of the well-preserved section of wall foundation. Here only the vestiges of the wall foundation trench survived, with all the stone work having been robbed out.

Robbed-out section of southern wall line (B), with only the mortar surviving within the foundation trench cut into natural yellow clay. Looking east. Scale = 1 metre.

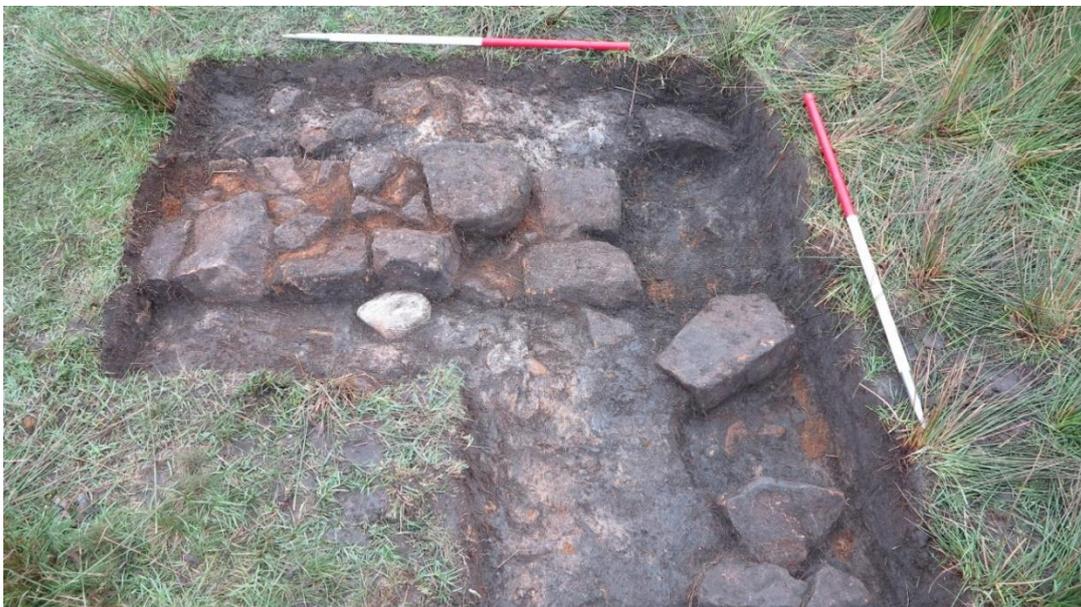
The south-west corner of the western range was found at 31.8 metres from the central range's western wall. Evidence for the corner was found in a trench that exposed well-preserved foundations of the southern wall, similar to that shown above, joining a robber trench representing the return wall for the western gable. As seen elsewhere, there was no evidence for floor surfaces on the interior with natural light white-yellow clay being exposed at very shallow levels beneath the turf line.

South-west corner of western range (C), with southern wall base evident at the top, and the robbed-out western wall on right with a few disturbed stones left in the trench. Looking south.

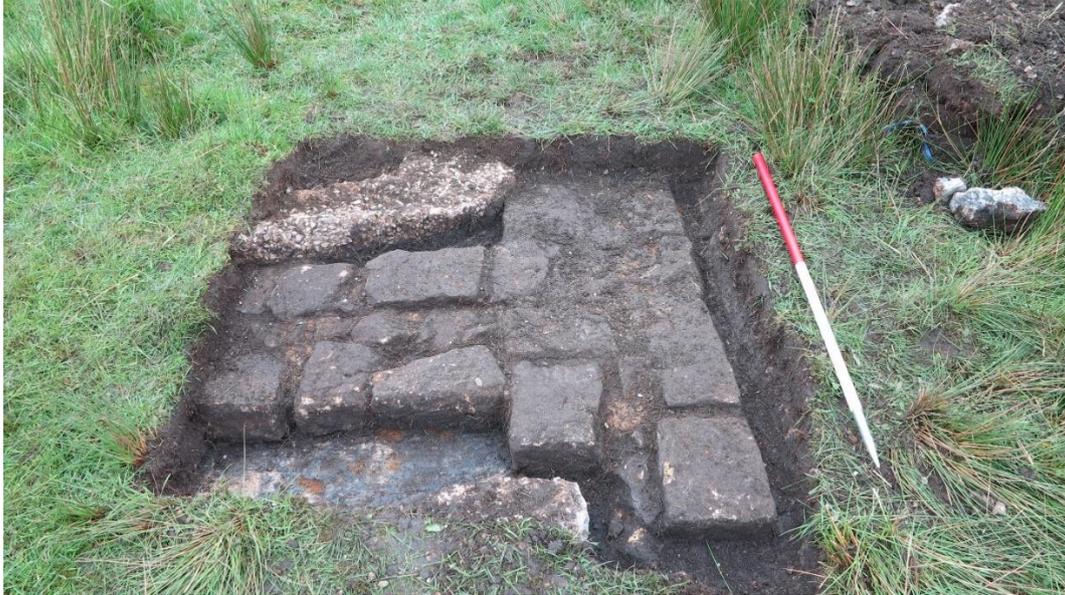
The north-west corner of the trench was also investigated. This was better preserved with both the western gable wall and northern return wall having coursed stonework forming a level surface. Again, the construction was consistent with that seen elsewhere in terms of

the wall being 50 cm wide and bonded with dark orange-yellow mortar. The western gable wall extended beyond the junction with the northern wall. This suggests either a corner buttress or the continuation of the wall northwards beyond the western range. Excavation of this area was limited by time constraints and the presence of apparent 20<sup>th</sup> century activity in the form of spreads of concrete. It is not clear why the concrete is at this location. It did not overly the earlier stone building foundation. Beyond this north-west corner of the west range the land drops away to a ford across the stream (Waters Clough) and a possible trackway is apparent. This is an area that would repay further investigation.

The north-west corner foundation of the western range (D), looking south, showing an offset (bottom of photo) for a possible corner buttress. 20<sup>th</sup> century concrete straddles the early walls

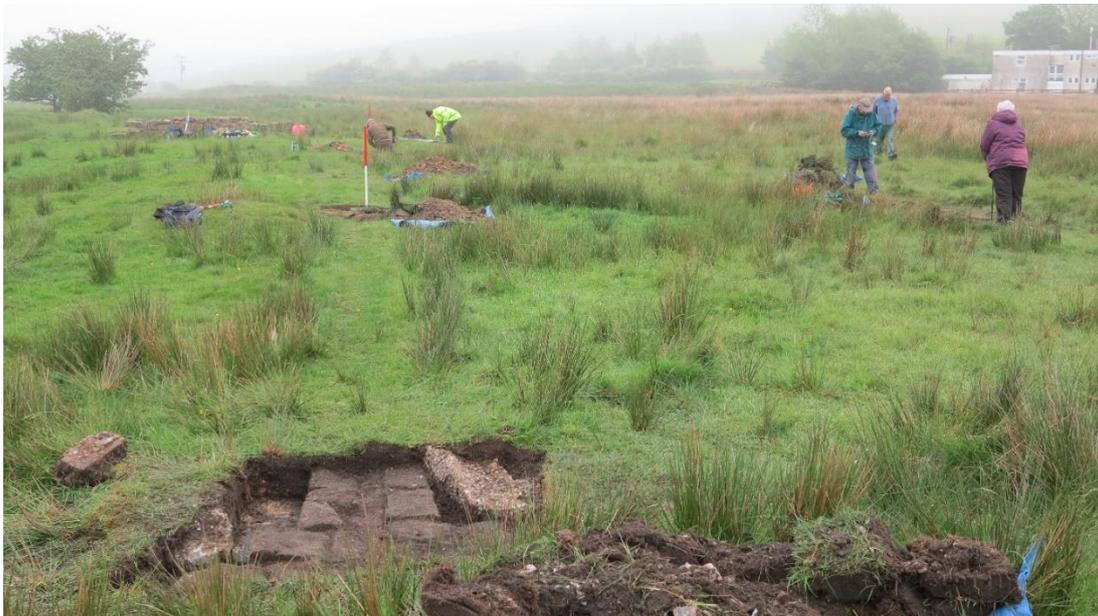
Looking east from the north-west corner of the west range. The photographic poles show the line of the north wall running nearly 32 metres to the central range. The figures on the right are working on the southern wall of the west range.

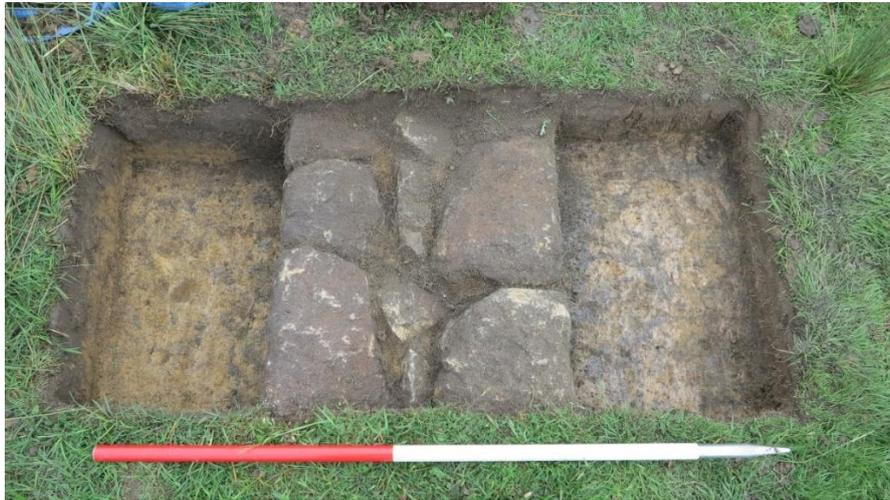
A test pit was excavated half way along the line of the northern wall at (E), around 19 metres from the north-west corner. Here the wall foundation was well-preserved, with natural yellow clay on either side – as can be seen in the photograph below (looking west).

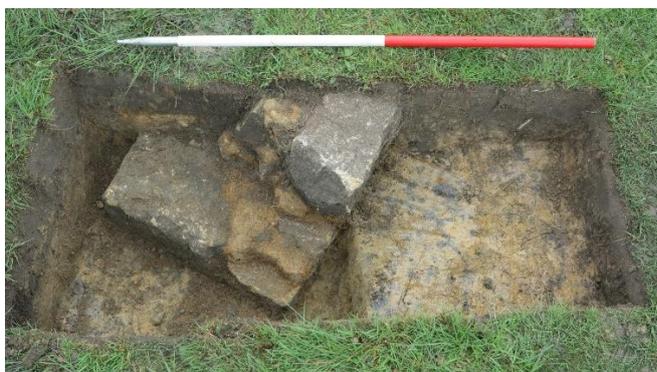
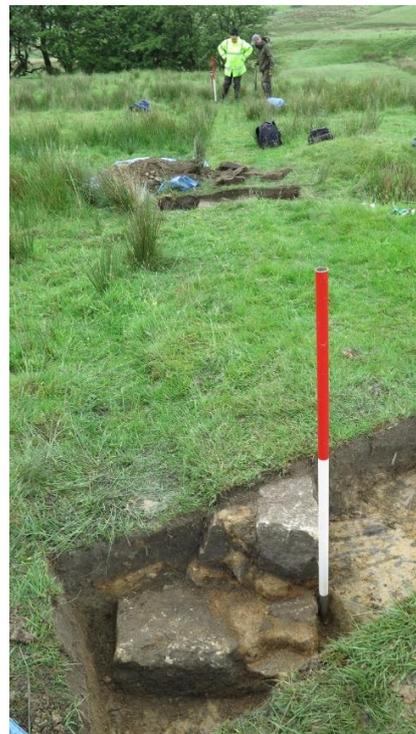
Between this test pit and the central range, a further exploratory test pit was excavated diagonally across the line of the wall (F). This revealed a two-course deep section of wall foundation in the western part of the test pit but with the wall having been removed/robbed out in the eastern part.

Test pit across north wall of the western range showing stepped survival of footings (F) with, on the right, the figures standing on the far north-west corner of the building. Looking west.

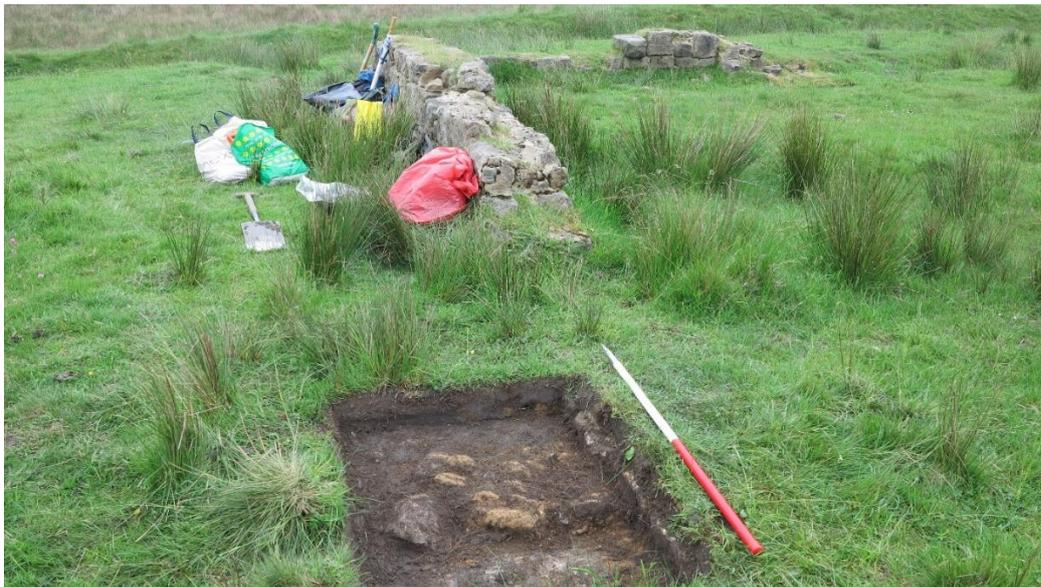
Finally, a small area was opened up against the western wall of the central range to examine where the northern wall should join it (G). As can be seen below, there was evidence for the wall here but only in the form of pieces of mortar showing where stone footings had been

located. The wall remnants appeared to abut the footings of the eastern wall of the central range (visible in the photograph below under the 1 metre photo scale, looking north).

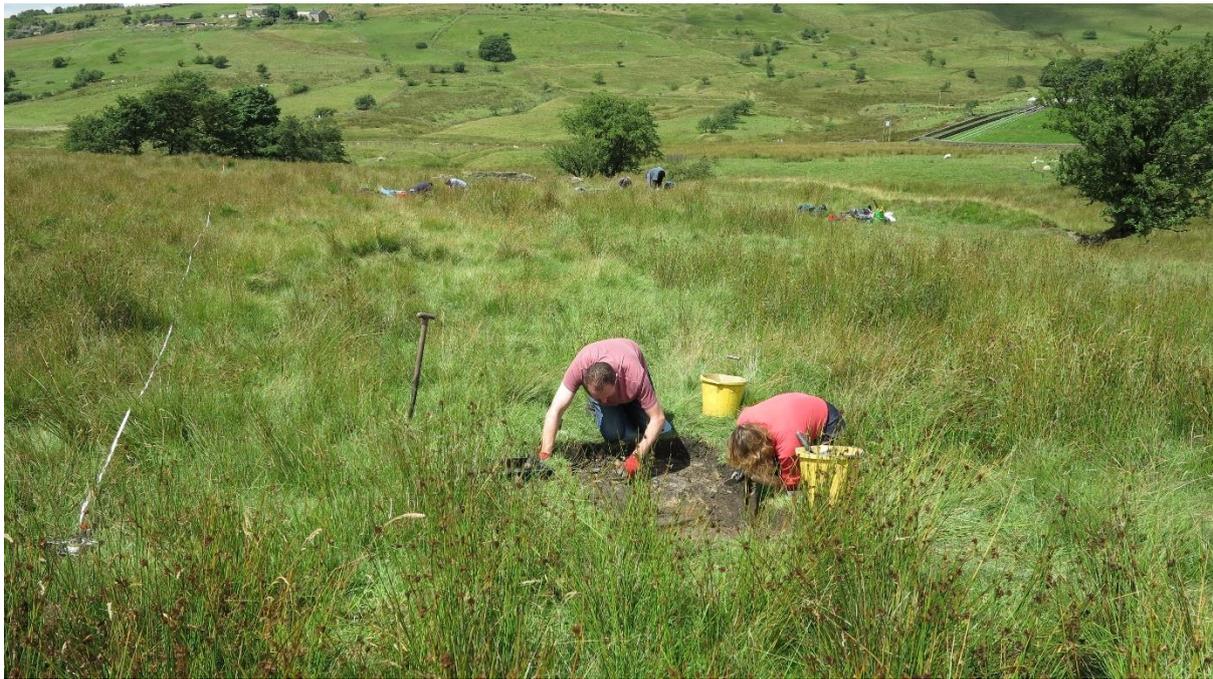
Nick and Gill excavate a test pit across the eastern range gable wall, with the measuring tape on the left showing the full length of the building. The figures in the background are at the central range, with Waters Clough to the right. The overgrown nature of the site made excavation and recording more challenging. Looking west.

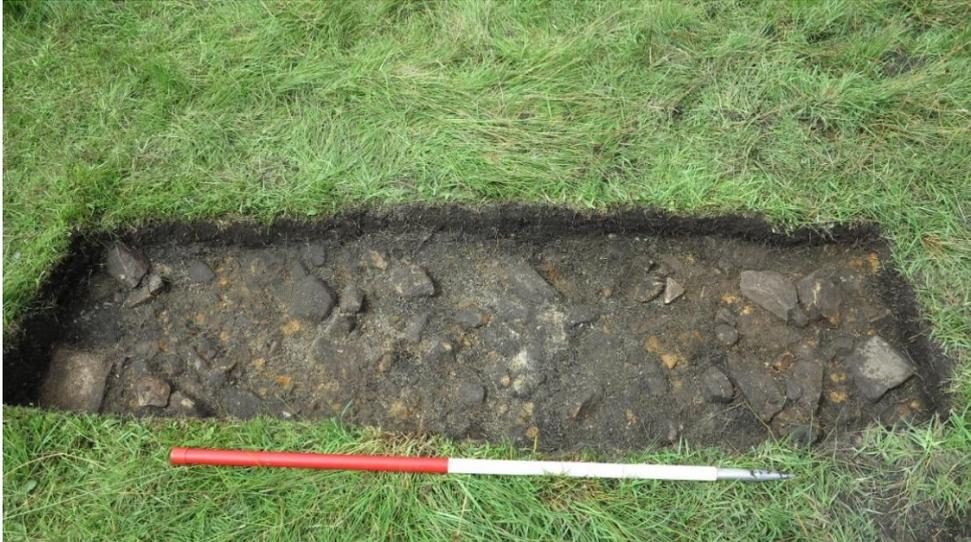
A 2 metre by 1 metre trench (H) was excavated close to the Roman road to determine its character and how it relates to the eastern range of the building. The excavation revealed a solid surface of gritstone, with a mix of medium, angular flat-laid stones and smaller metalling. No finds came from this surface and it was assumed to be part of the Roman road, being similar to examples excavated at the Roman fort site.

Stone surface (H) interpreted as part of the Roman road. Looking west.

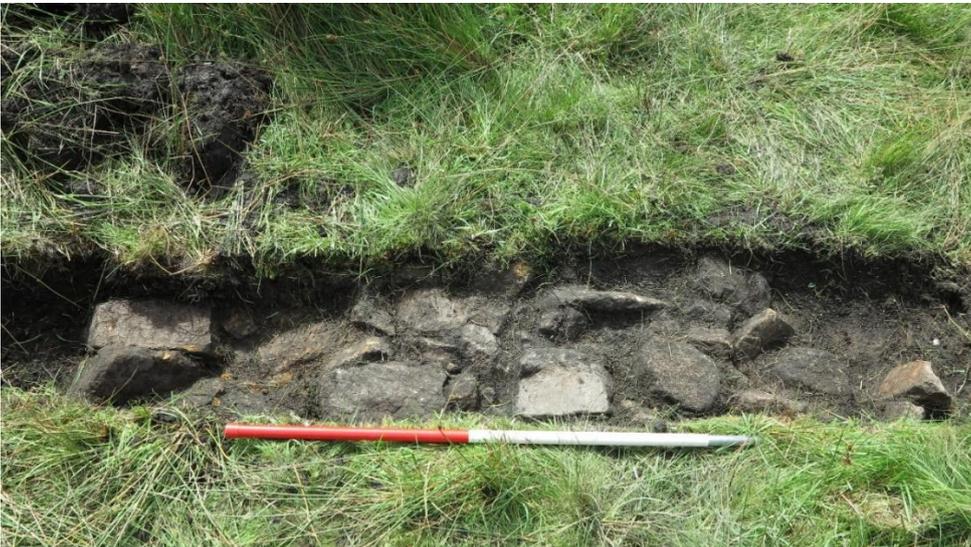
A further trench was excavated just south of, and adjacent to, the southern wall of the central range (I). This trench was only 0.5m wide and 2 metres long. It revealed a rough stone surface made of angular medium to large gritstones, with a kerb apparent on the southern side of the trench forming an edge with soft, rushy vegetation. From within the fill of a linear depression in the stone surface came two sherds of Pennine Gritty Ware. These are the first datable, stratified finds from the site of the building. They can be dated to the later medieval period, ie the 12<sup>th</sup> to 15<sup>th</sup> centuries.

Slot excavated across rough stone surface (I) adjacent to the central range southern wall. The kerb can be seen on the left and from the depression just to the right of this came the medieval pottery sherds. Looking west.

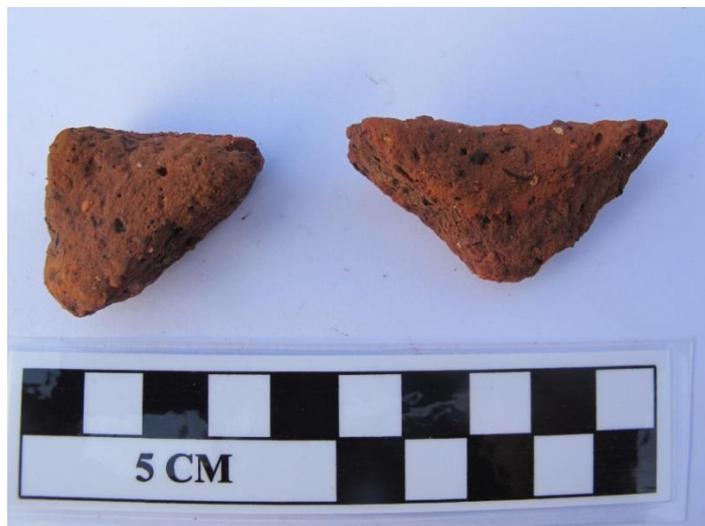
The two body sherds of Pennine Gritty Ware

Given the large scale and quality of construction, landscape management evidence, the historical framework and medieval pottery finds, the building foundations are interpreted as belonging to the medieval grange of Friarmere. The name first appears in 1455 but was previously known as 'Hilbrighthope' (Buckley 2009, 45-6). This was held by the Cistercian Roche Abbey (near Rotherham) from the late 12<sup>th</sup> century to the Dissolution of 1538. Medieval granges were outlying estate farms established to provide food and other materials for the use of the mother abbey and for wider distribution. Granges were essential for the self-sufficiency of the Cistercian order. Intensive farming was undertaken by labourers under the supervision of lay brothers. In the Castleshaw valley lies the small hamlet of Grange which may have been the original residence of the lay brothers; it lies around 0.75 km to the west of excavated building.

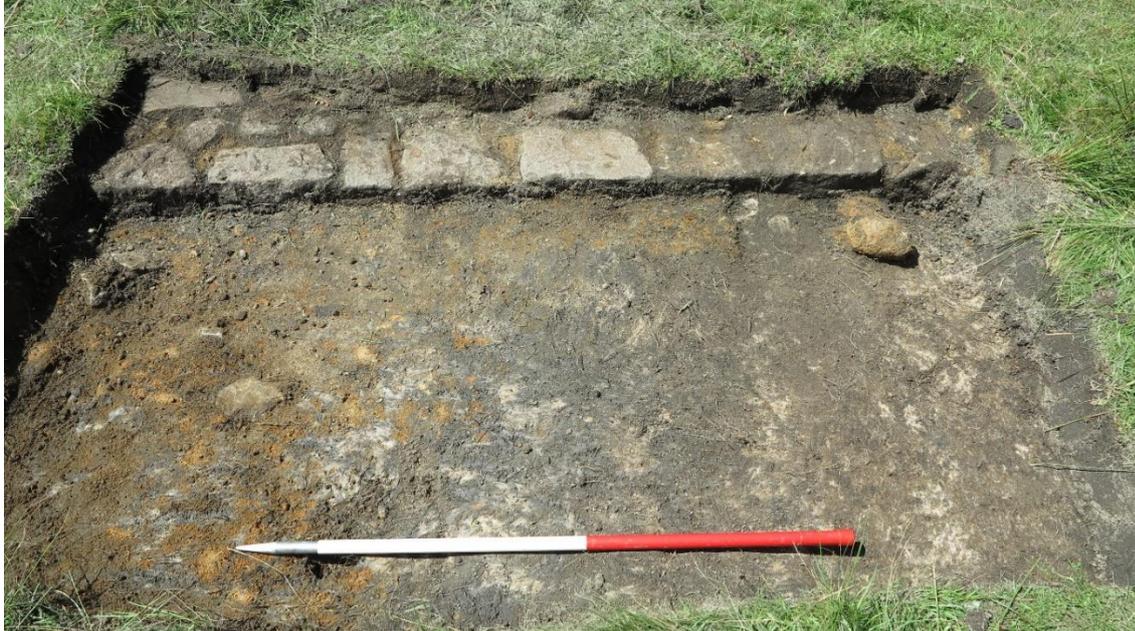
Trench (J) was excavated to look for the northern wall of the east range where it connects to the eastern wall of the central range. No evidence for the wall footing was found, although a spread of dark orange-yellow mortar was evident. However, based on later trenching of the eastern gable wall of the eastern range, it is possible that (J) is positioned too far south. Further exploratory work a little further north of (J) is desirable.

The eastern wall edge of the central range is well defined in trench (J), with a spread of dark orange-yellow mortar visible on the left side of the photograph. Looking west.

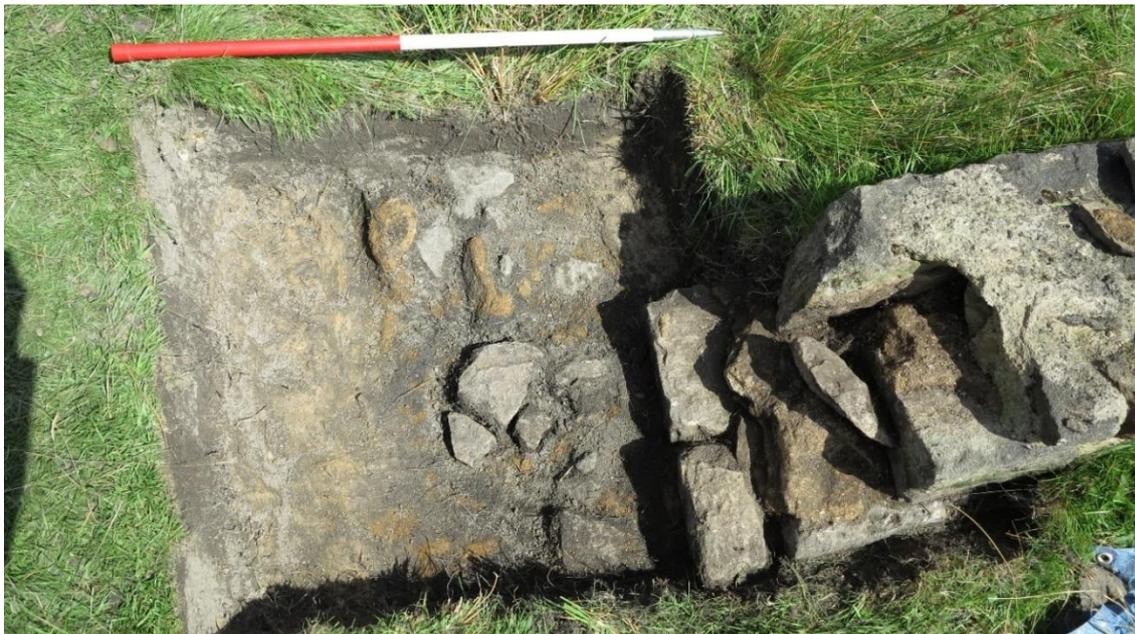
Aerial photograph analysis suggested that the extant, ruined wall at the north-east corner of the central range is not actually the corner of the building. A small trench (K) was opened up to clarify this. It found the remains of a wall base running eastwards from the corner, demonstrating that the central range is more complex and extensive than previously thought. The extent of this northern wall should be defined in future investigations.

The trench at (K), looking east. Footings of the northern wall can be seen as mortar and rubble in a grey silt fill.

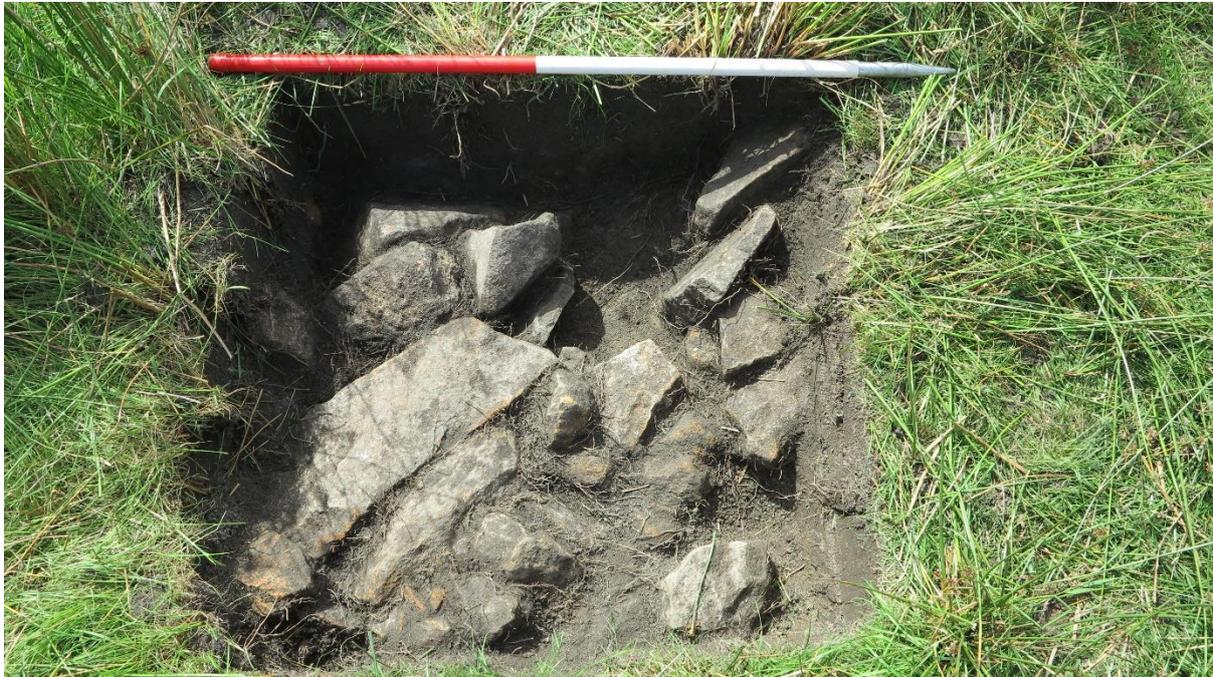
The main purpose of the investigations on 16<sup>th</sup> July was to locate and define the east wall of the eastern range, with 4 test pits being excavated. A 1 metre square test pit was dug across the suspected site of the north-east corner of the eastern range (M). This immediately came on to a dense spread of gritstones. These were on edge but closely packed together, as though a section of wall had been pushed over. There was not time to define the edge of the stones or their relationship to the possible building corner.

Stone spread at suggested north-east corner of eastern range (M), looking west.

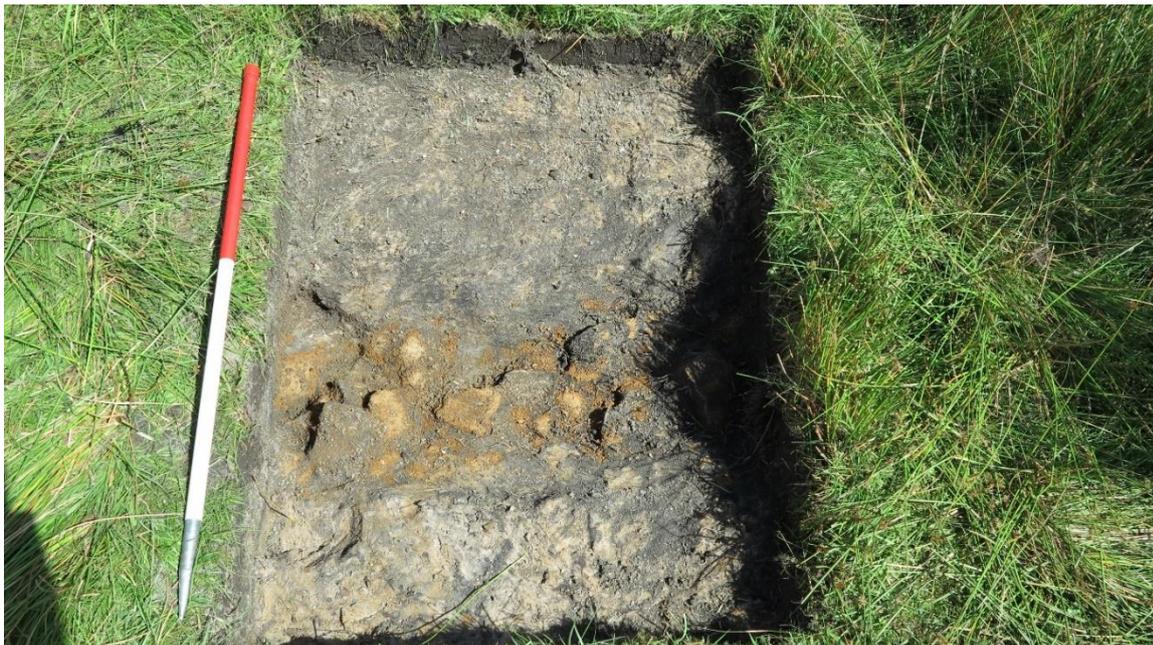
It was not possible to distinguish a wall foundation so another test pit (N) was excavated 2 metres to the south. This successfully located the site of the east wall, although at this point it had clearly been extensively robbed out with just a few stones and mainly mortar surviving in situ.

Remains of east wall footing exposed in (N), looking east.

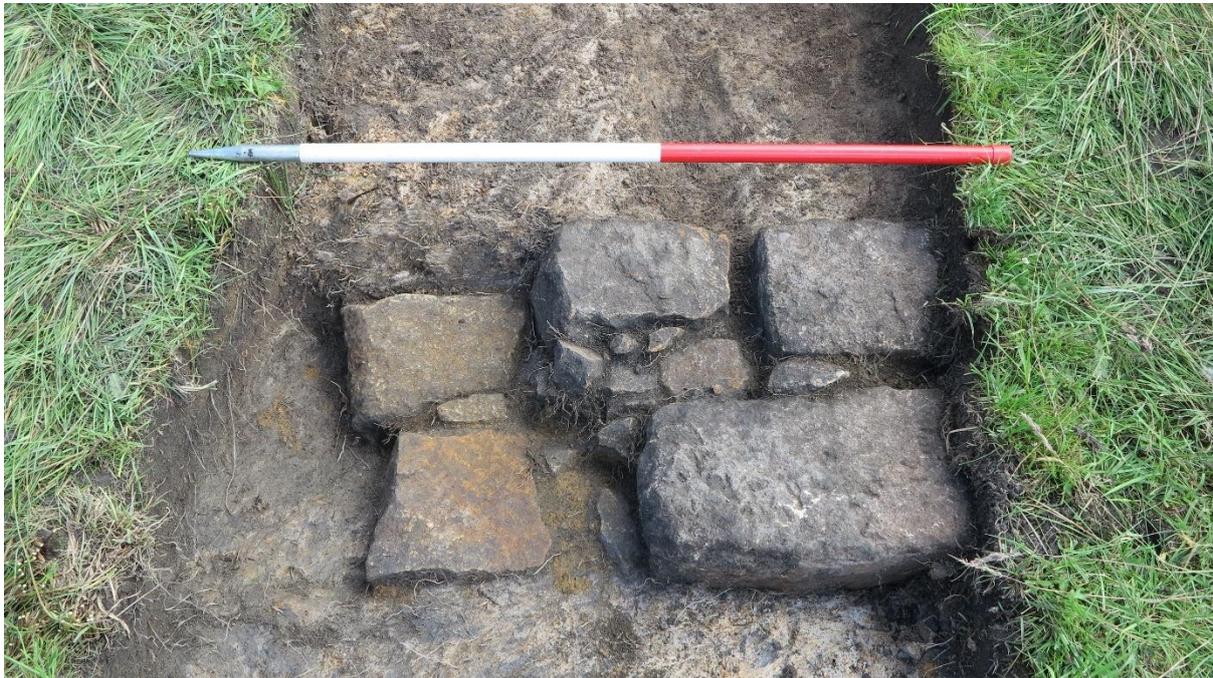
At 4 metres south of (N) a much better-preserved wall base was found in the test pit at (O). This was partly 2 courses of stonework and partly 1 course in height, and totally consistent with surviving walls revealed elsewhere being 0.5 metres wide and with a thin rubble core and dark orange-yellow mortar.

Stepped survival of east wall footings in (O), looking west.

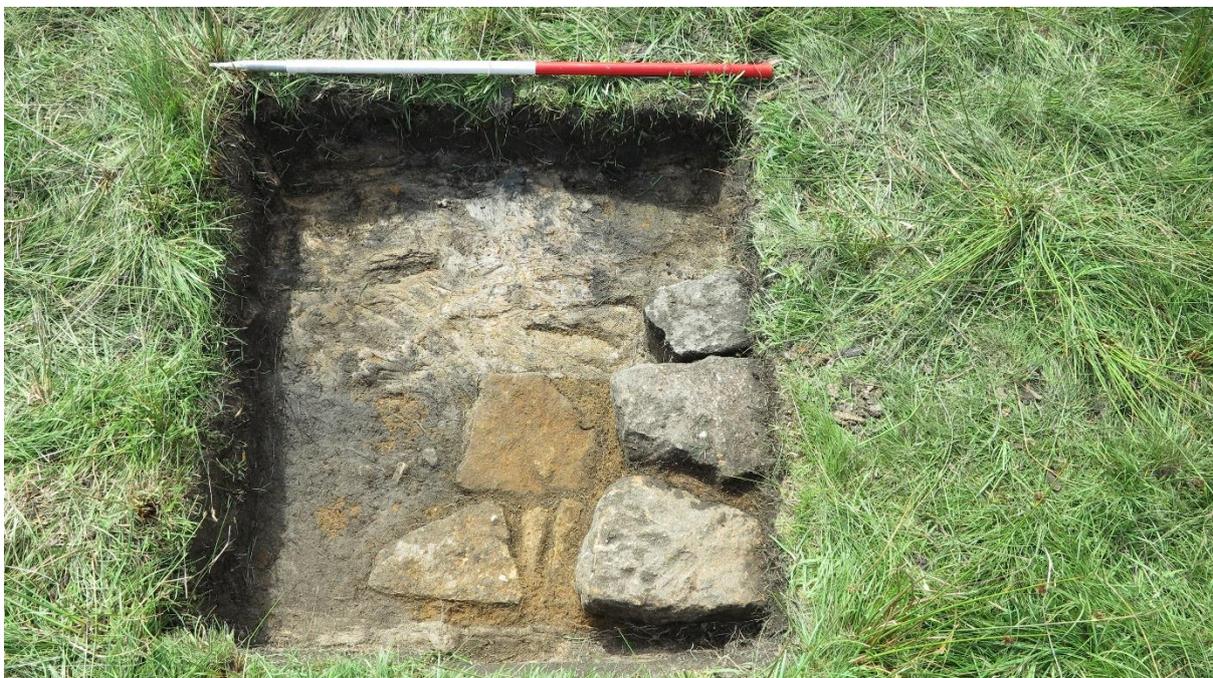
The established east wall line was chased 2.5 metres further south of (O) where a test pit at (P) found more remains.

Test pit at (P), looking west and showing the stone footings partial survival with the robbed-out foundation trench on the left side of the test pit filled with grey silt and some patches of dark orange-yellow mortar.

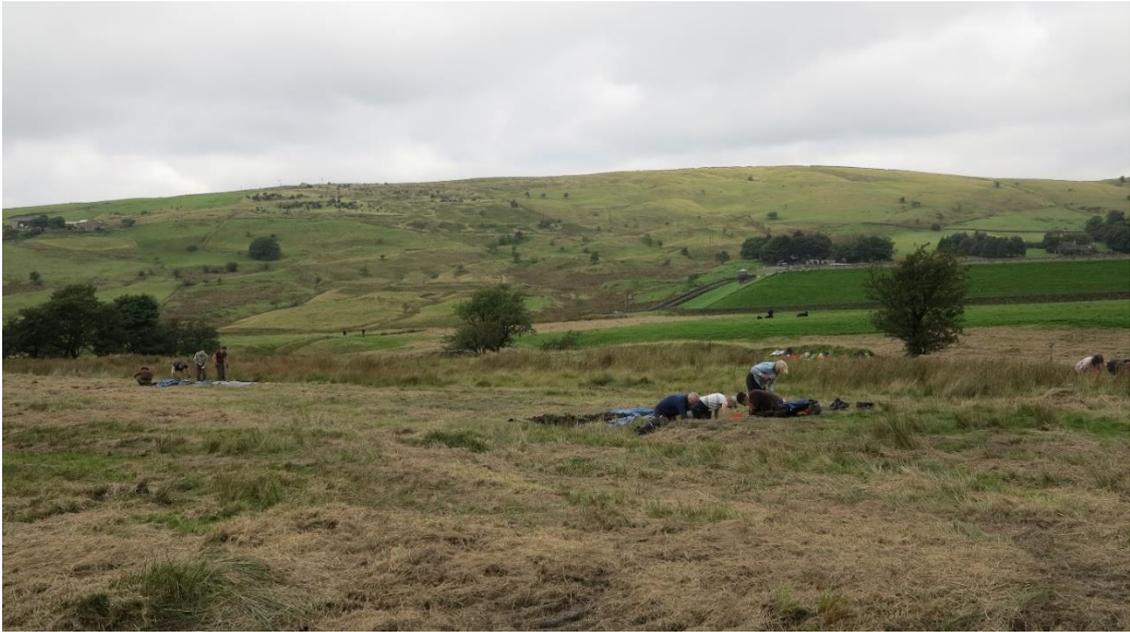
The picture above shows excavation in progress on 28<sup>th</sup> August, with figures working on the eastern-most wall of the complex on the right and the stony area adjacent to the central range on the left. Trenches I and M were revisited and enlarged, whilst 3 new test pits were dug. Most of the long grass and rushes had been cut since the previous investigation making conditions easier for digging and surveying.

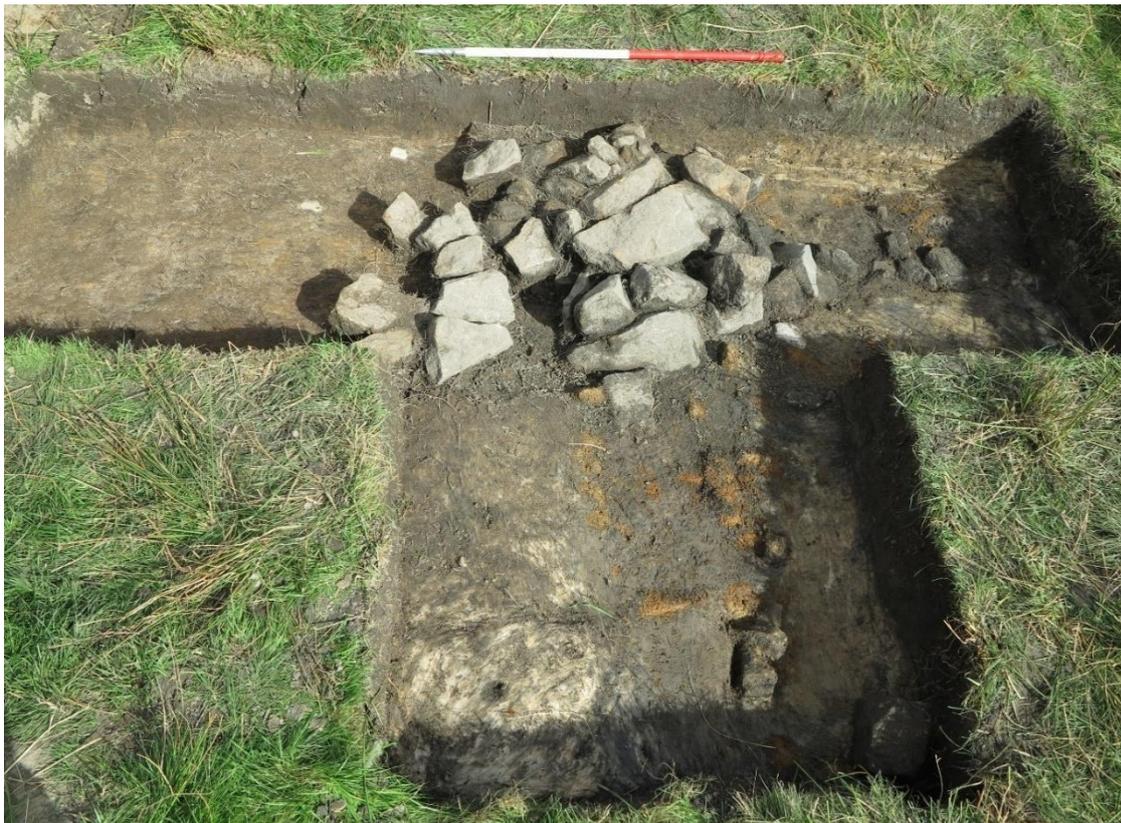
At (M) the former test pit was extended to create a 'T' shaped trench to identify the character of the north-east corner of the eastern range. This had been obscured by what appeared to be wall tumble. This material was cleaned and defined and shown to be tumble or deposited stone. There was no evidence for mortar binding the stone work so it did not appear to be collapsed stone wall. One interpretation is that the stones were collected into a pile ready for carting away for use elsewhere, but were never collected. The context for this theory is discussed in more detail in the conclusion.

By opening-up areas adjacent to the pile of stones it was possible to confirm that the stones covered the corner of the building as two wall lines could be discerned running under the stones. The wall foundations for the east and north walls had been extensively robbed, with only a few stones and patches of mortar visible with the grey fill of the wall cuts.

Trenches at (M), looking east and showing wall foundation trenches and stone pile overlying the north-east corner of the east range

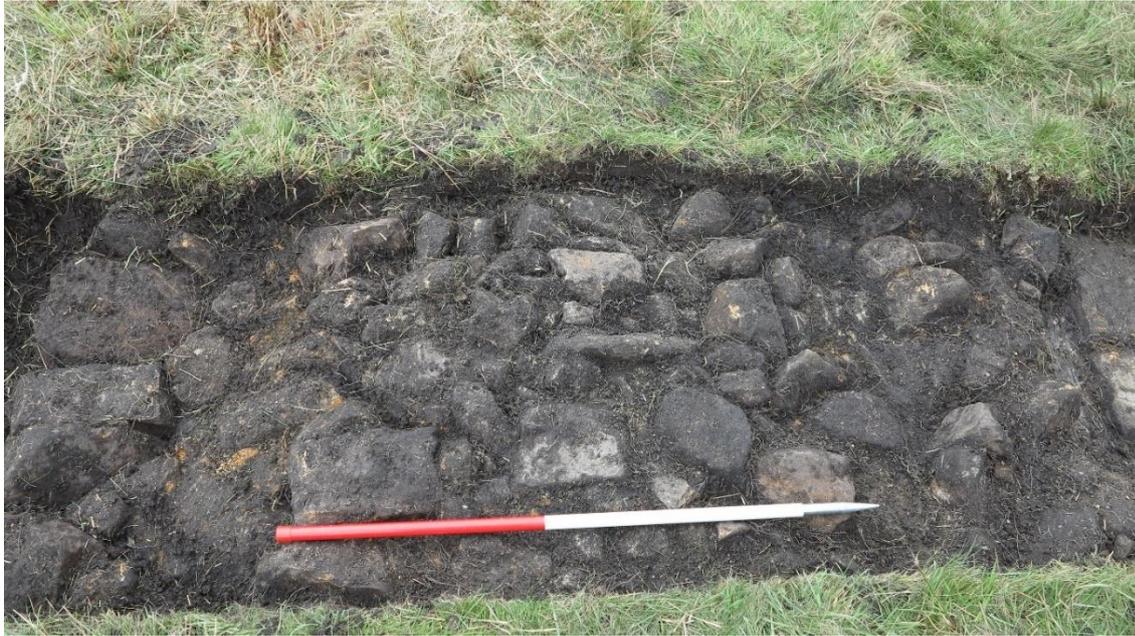
The narrow trench excavated at (I) in the previous evaluation was revisited on the 28<sup>th</sup> August and widened to 1 metre and lengthened to 4.5 metres. The northern half of the trench was finally widened by another 0.5 metres to better define the south-east corner of the central range. This conformed to other excavated walls, being well made and 0.5 metres wide, although the southern return wall was a little narrower at this point. There was no evidence for a floor on the inside corner of the building.

The rough stone surface identified previously was found to run from the kerb to the south right up to the southern wall of the central range. The gritstones making up the surface were mainly medium to large in size, roughly laid, and formed a gentle camber in the middle, with linear depressions on either side running east to west. These are interpreted as cart wheel ruts within a trackway running alongside the building. The base of the ruts was 15 cm lower than the highest point of the centre of the track. The distance between the ruts was around 1.3 metres wide.

Stone surface revealed in the extended trench at (I), looking west. The kerb is on the left with the southern wall of the central range just visible on the right.

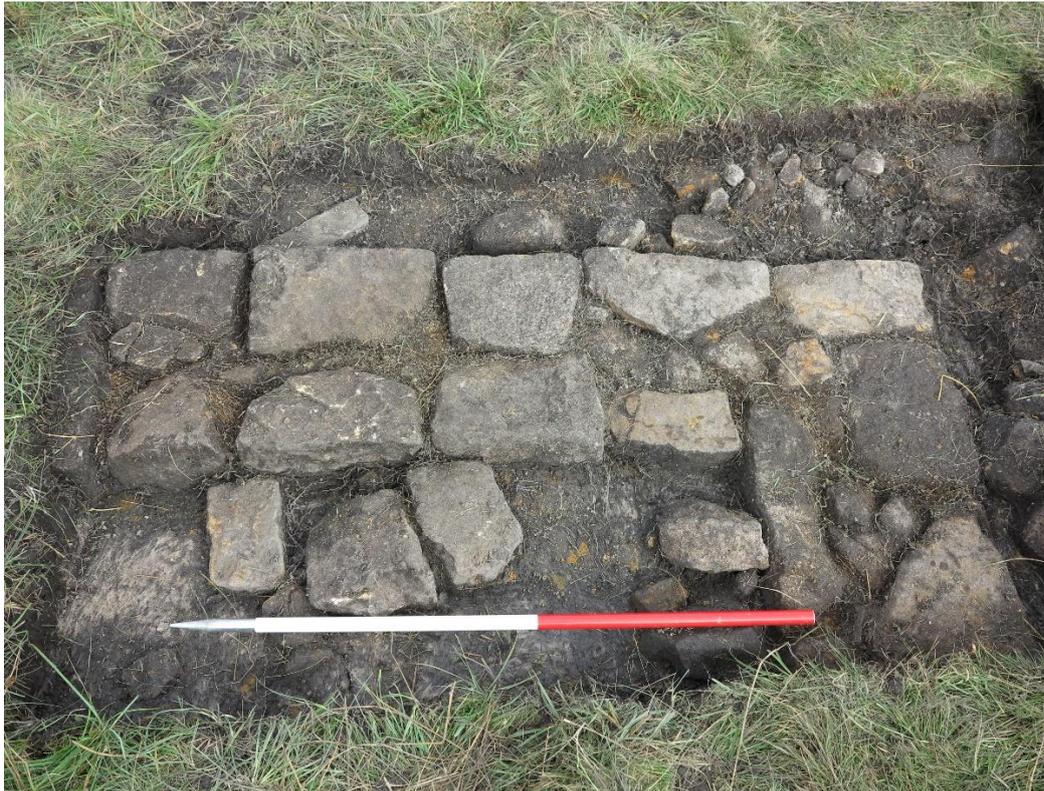
View of wall foundations at (I), looking east.
