# Archaeological Evaluation of the Ruin beside Water's Clough, Castleshaw, Saddleworth

Report written by Norman Redhead  
for the Friends of Castleshaw Roman Forts

January 2018

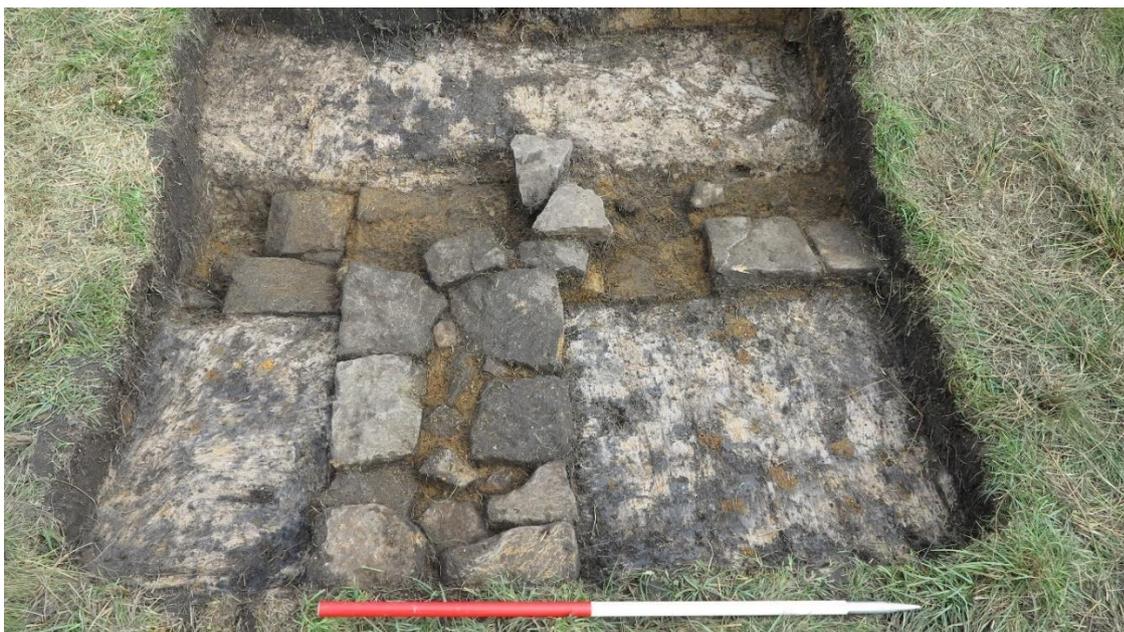
The south-eastern corner of the eastern range had still not been found, so a further section of wall just south of (P) was opened-up. This trench, at (Q) was about 1.5 metres long and successfully exposed a return wall. This was in the same style as the eastern gable wall to which it joined and, as elsewhere, its foundation trench was cut into natural white clay. However, the eastern wall did not form a right angle but continued further south meaning that the newly discovered return wall must be an internal division. It is apparent that the eastern range is more complex than the western and is not just a mirror image.

The internal wall in the foreground can be seen running up to the eastern gable wall at area (Q). Looking east.

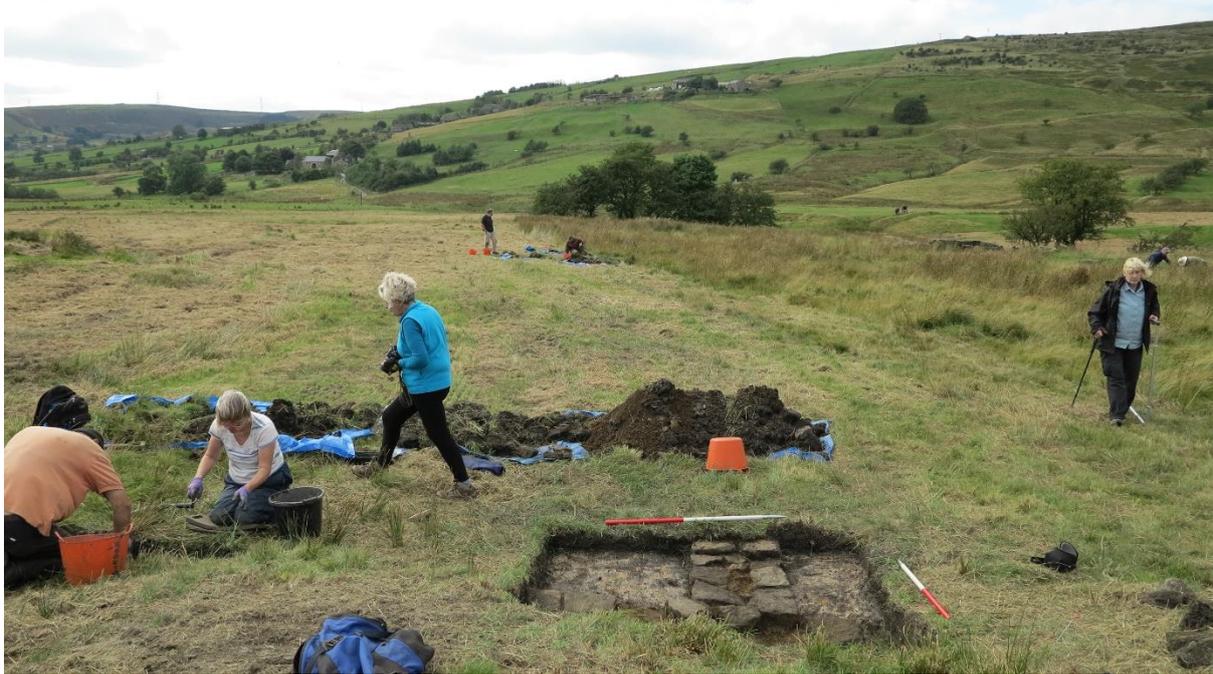
The location of the wall foundations at (Q) can be seen in their landscape context in this photo. The figures in the middle distance are at (I) beside the central range. Work has commenced at (R) on the left.

Towards the end of the day, (R) was excavated 2 metres to the south of (Q) in order to locate the corner of the eastern range. Although the trench was narrow, it proved to be very useful. Not only did it reveal the south-east corner of the eastern range but it also found what is probably the continuation of the trackway found in (I). The corner was evident as a robbed-out foundation trench with only occasional gritstones surviving and mainly filled with dark orange-yellow mortar. To the south of this was a rough stone spread similar to that encountered in (I), with a possible kerb stone on the north side close up against the building corner. The southern edge of the stone spread was not excavated due to time constraints.

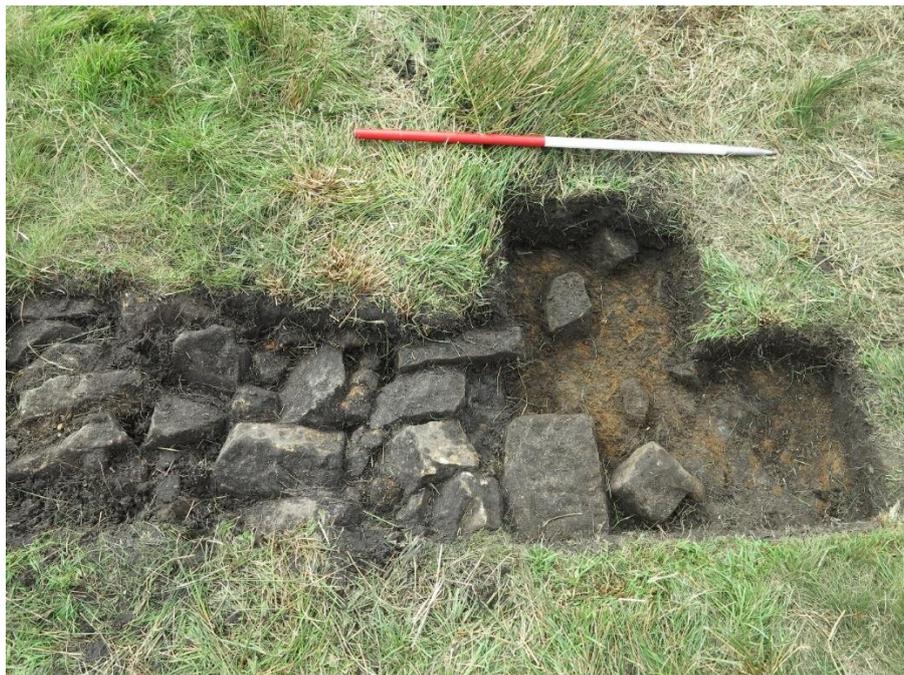
Stone spread and robbed-out building corner at (R). Looking west.

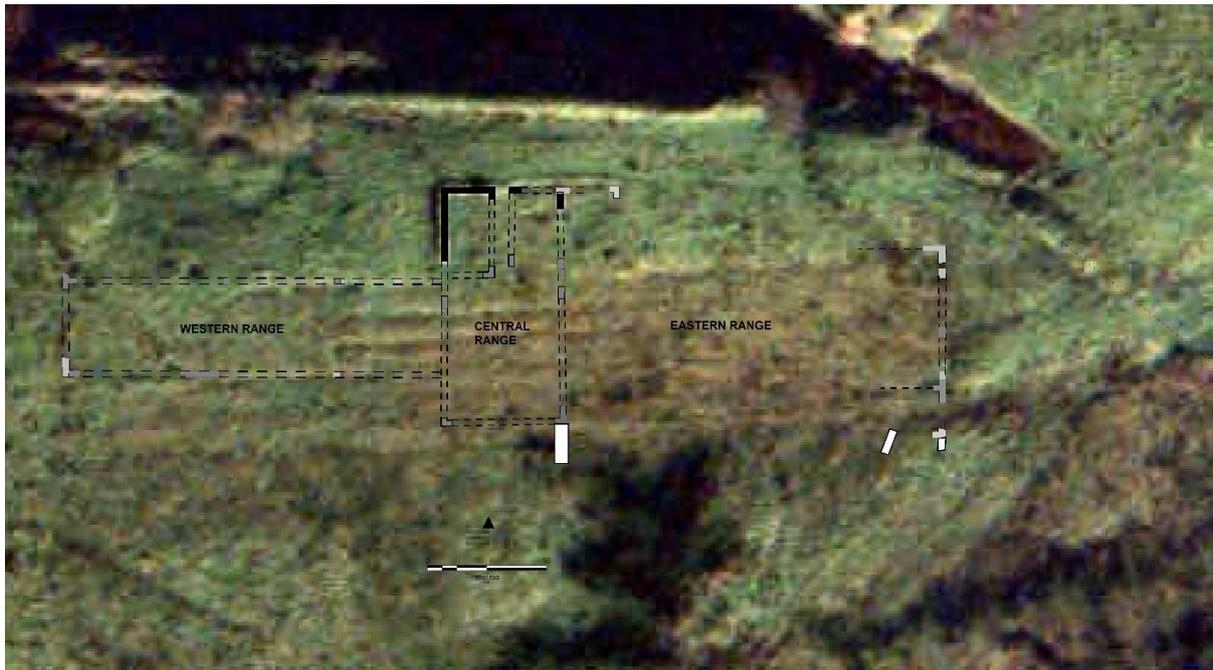
The plan is overlaid on to the late 1997 Cities Revealed aerial photograph below. Several linear depressions can be seen running west to east parallel with already proven wall lines – it is possible that these represent internal wall divisions or drains. There is still considerable work to do in confirming the configuration of the eastern range walls and internal arrangements in the central and western ranges. But the work of 2017 has allowed for the first time an appreciation of the massive scale of this building and will inform where further

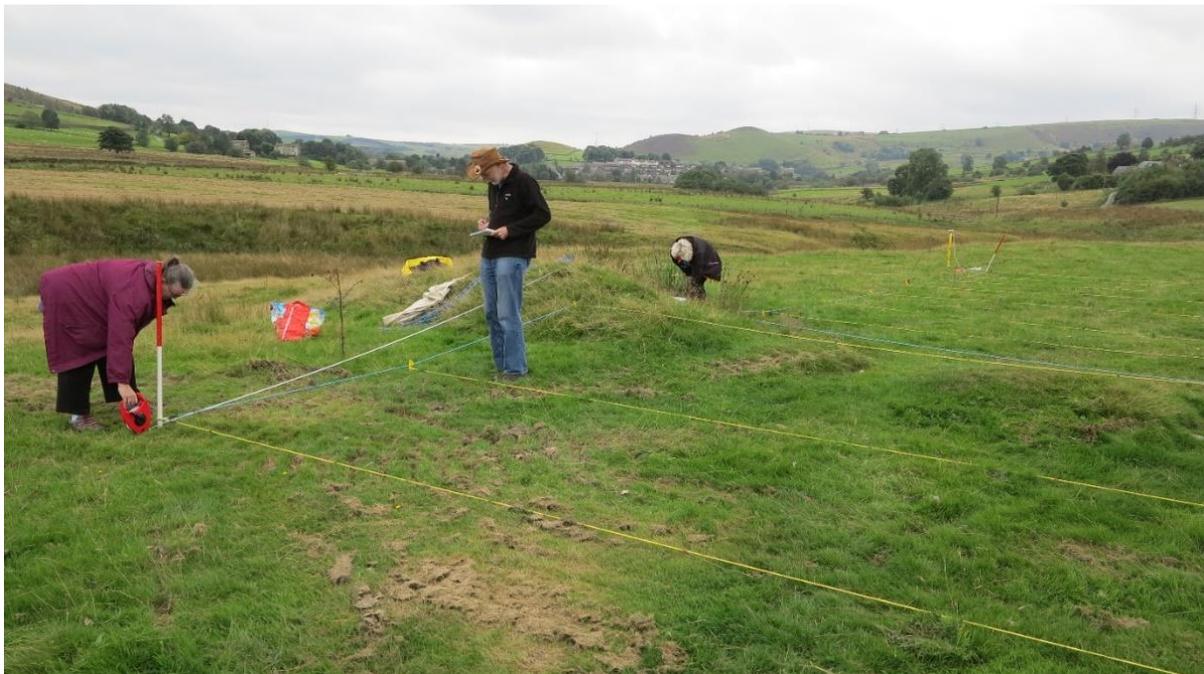
Sue, Phil and Jane carry out a resistivity survey of a field to the west of the 'ruin' site, on the opposite side of Water's Clough. This sort of work, extended across the valley floor fields, could identify other buried features/buildings relating to the medieval grange.

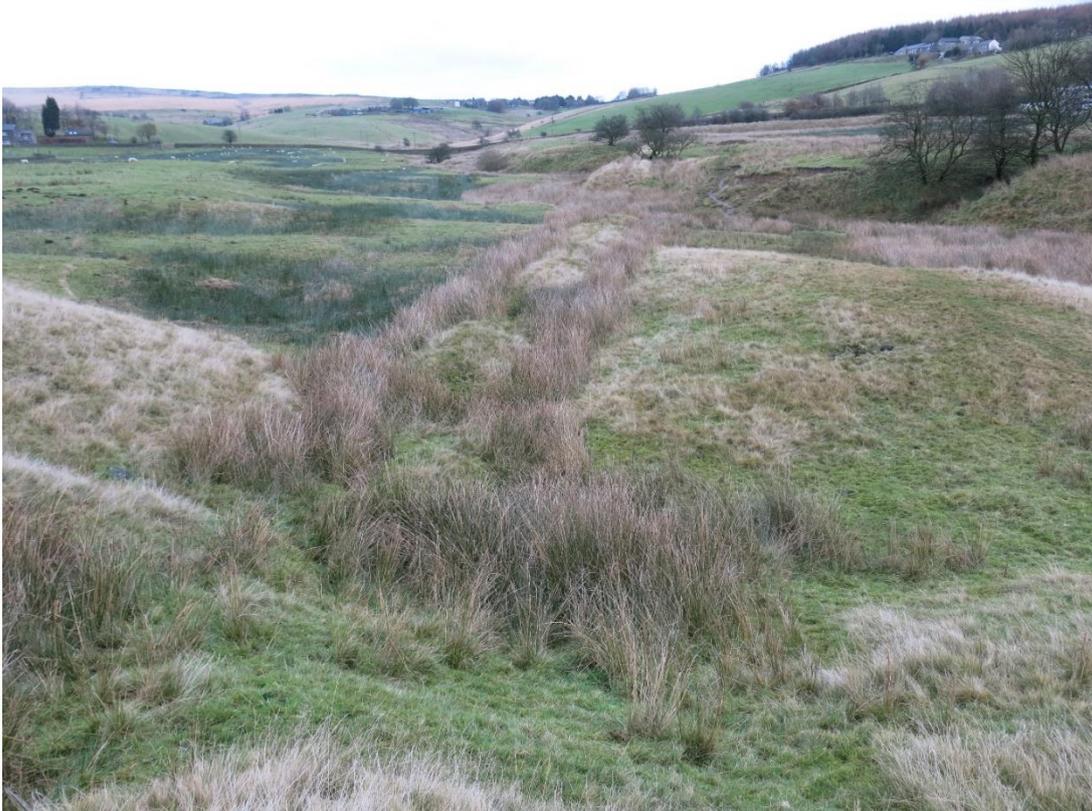
The photo below shows one of the impressive earth bank field boundaries running towards the building site which is just to the right of the hawthorn trees in the middle of the picture. It is important to now map and record these field boundaries to gain a better understanding of the medieval field system associated with the grange.
