Archaeological Excavation of the possible monastic grange building at Water's Clough, Castleshaw, Saddleworth

2019

Report written by Norman Redhead
for the Friends of Castleshaw Roman Forts

June 2020

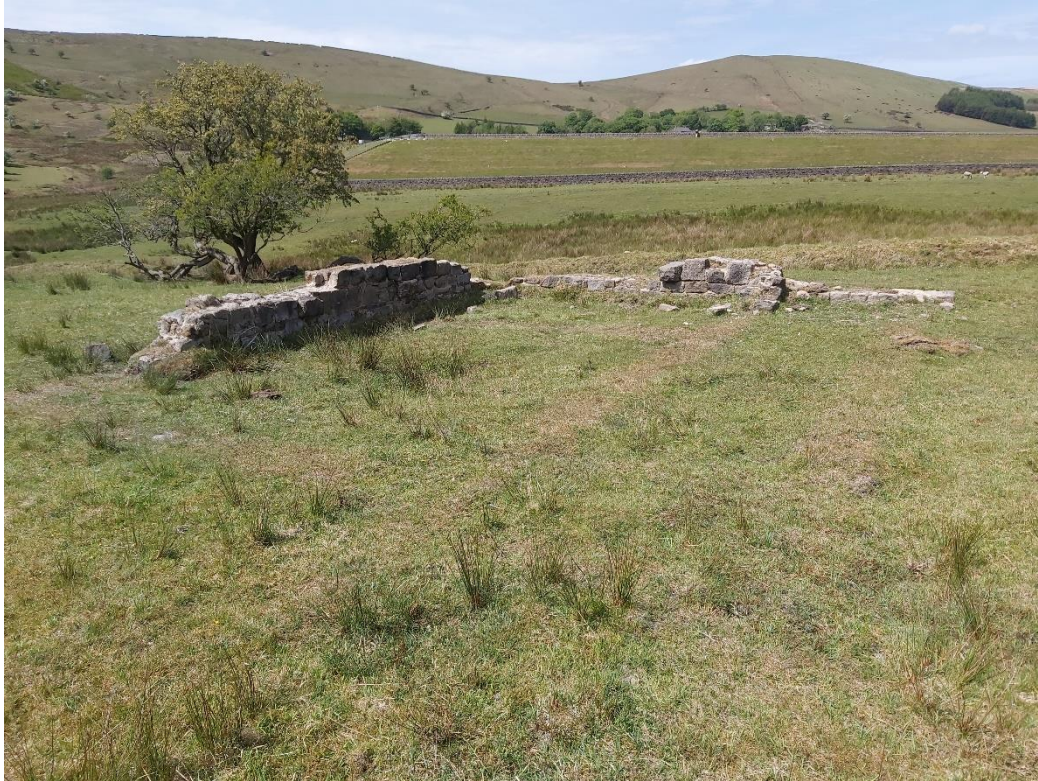
The ruin beside Waters Clough – parch marks during a dry spell indicate wall lines within the central range

Previous investigations from 2016 to 2018 demonstrated that a set of low ruined walls beside Waters Clough form part of a massive building. It comprises a long narrow central range 20 metres long by 10 metres wide, flanked by a west and east range, each being 31.8 metres in length and 8.4 metres wide. The total building length is an astonishing 73.6 metres (including the central range). Each corner has a projecting small chamber. The main plan form has been established and includes a series of internal rooms and a central corridor, with adjacent symmetrical wings.

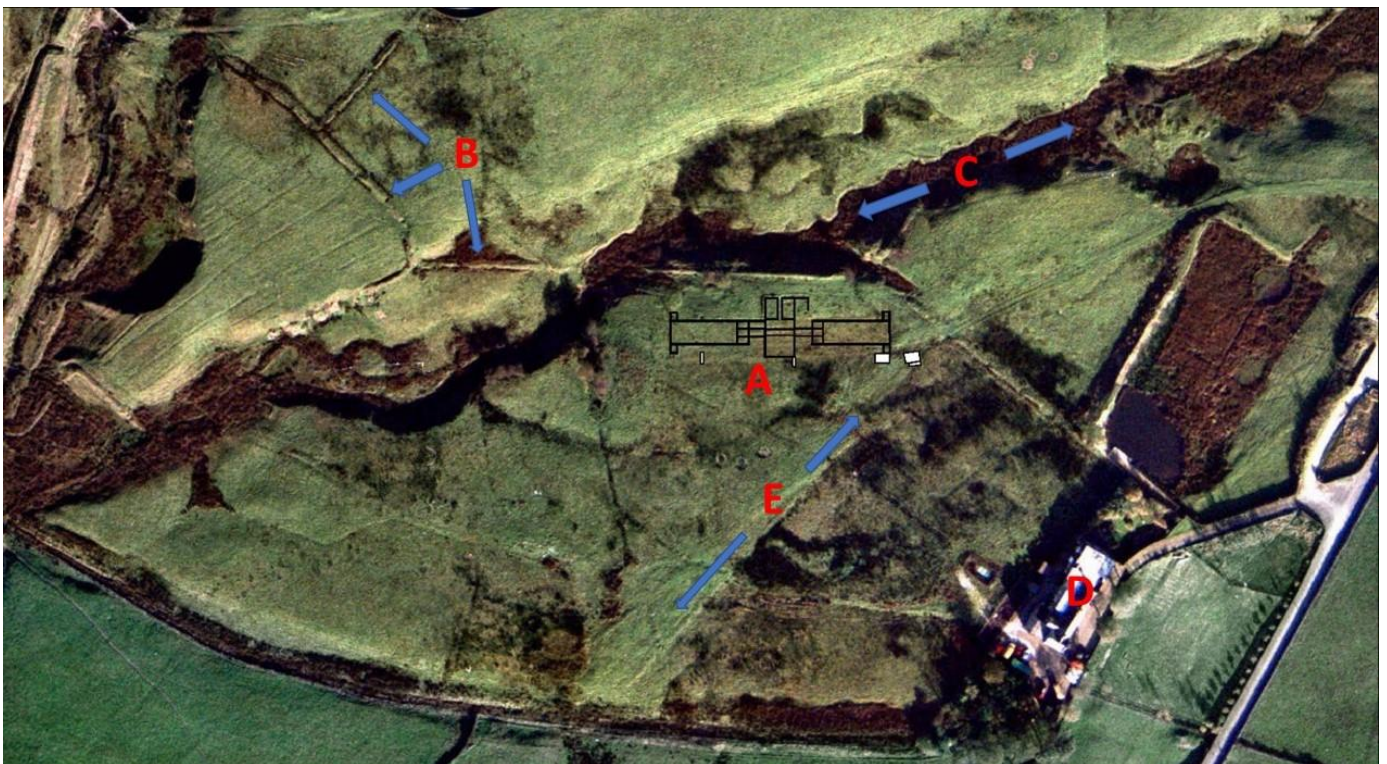
Aerial photo showing the 2018 interpretive plan of the Water's Clough excavated building in its landscape context.
A = outline of grange walls in black, B = medieval field boundary banks, C = Waters Clough, D = Castleshaw Centre,
E = line of Roman road

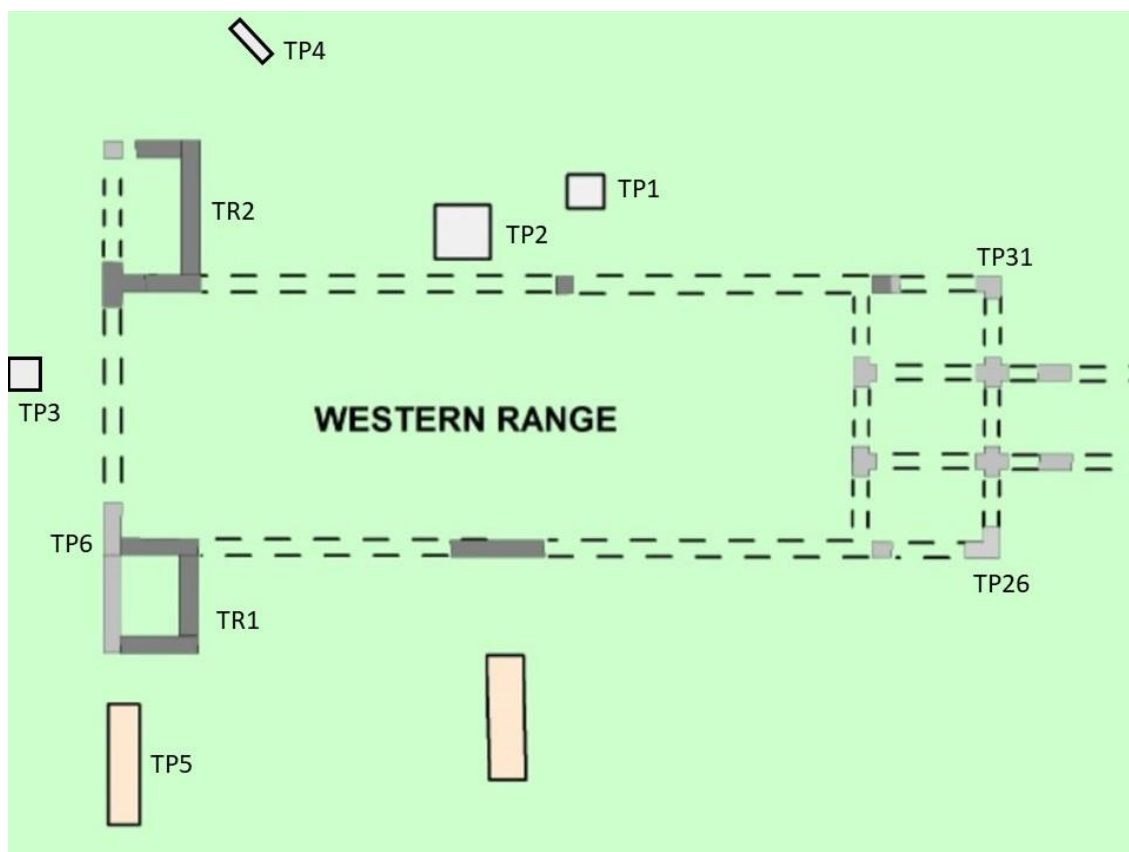
Plan of western range showing excavation trenches and test pits for 2019 season (unlabelled trenches are previous year's investigations). Dark grey = wall foundations stones, light grey = 'robbed-out' foundation trenches, white = external test pits, buff = stone trackway

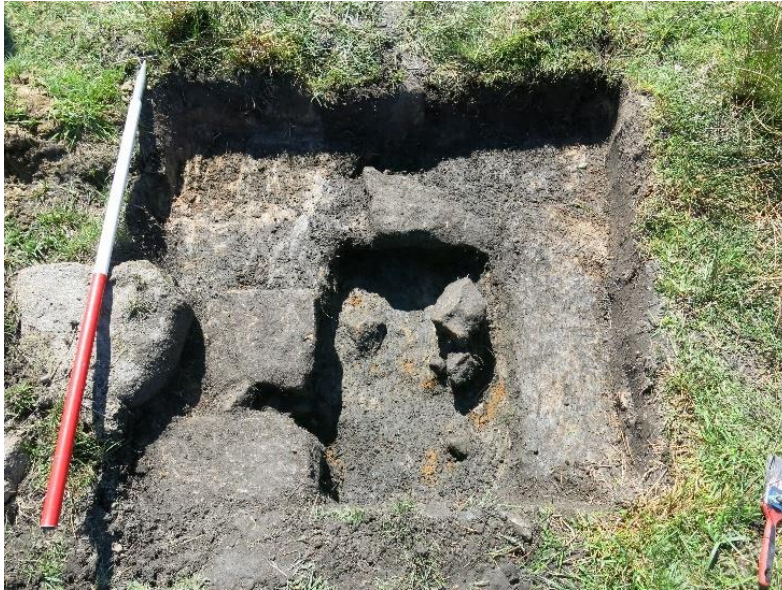
TP6 showing remnant of wall on left (partly under photo scale) and 'robbed out' wall trench in middle

It soon became apparent in TP6 that although the wall stones had been removed the cut of the foundation trench clearly continued beyond the corner of the building. The trench was almost devoid of stones and filled with a dark grey silt with frequent lumps of orange mortar.

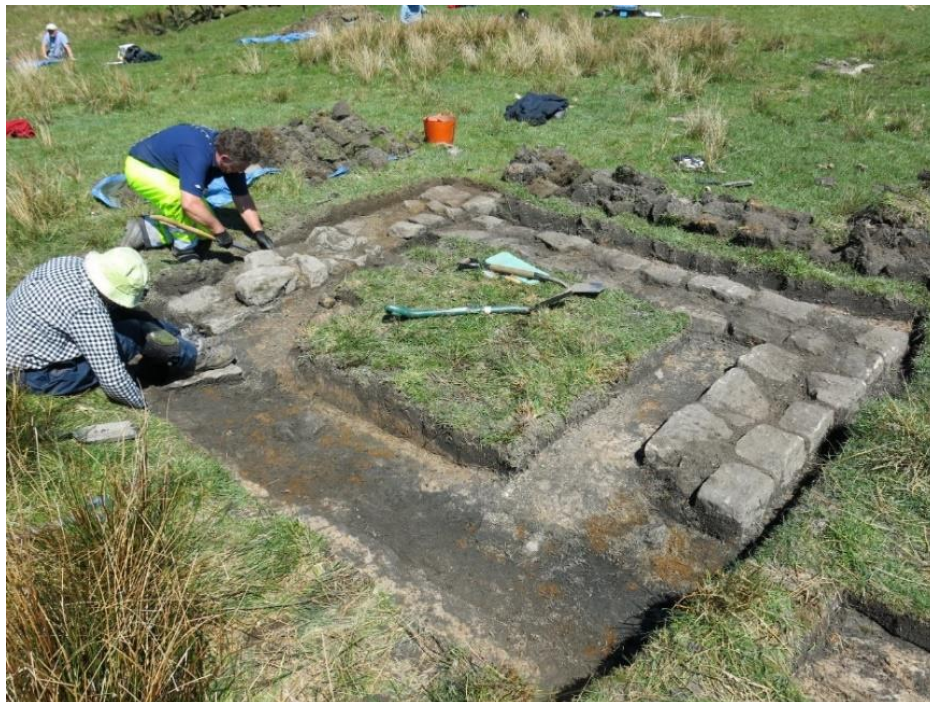
Closing stages of excavating the walls forming the projecting chamber in the south west corner of the west range.
Looking north east with the south wall of the range being cleaned

It was then decided to open a much larger area, Trench 1, to expose all the wall foundations forming what was anticipated to be a replica of the chamber discovered at the opposite, south east corner of the grange building last year. The wall foundations were well-preserved on the east and south sides but the western side walling had been completely removed during demolition to leave a silt-filled construction trench showing its location. The north side of the chamber was attached to the intact main south wall foundation of the central range. As seen everywhere else, where walls survive, the stones are well laid and bounded by an orange mortar. The walls were c 50 cm wide and formed a room interior measuring 2.4 by 1.7 metres, which matches the south east projecting chamber. The room interior was not fully excavated but enough was exposed to show that no floor survived, with a creamy white natural clay being revealed.

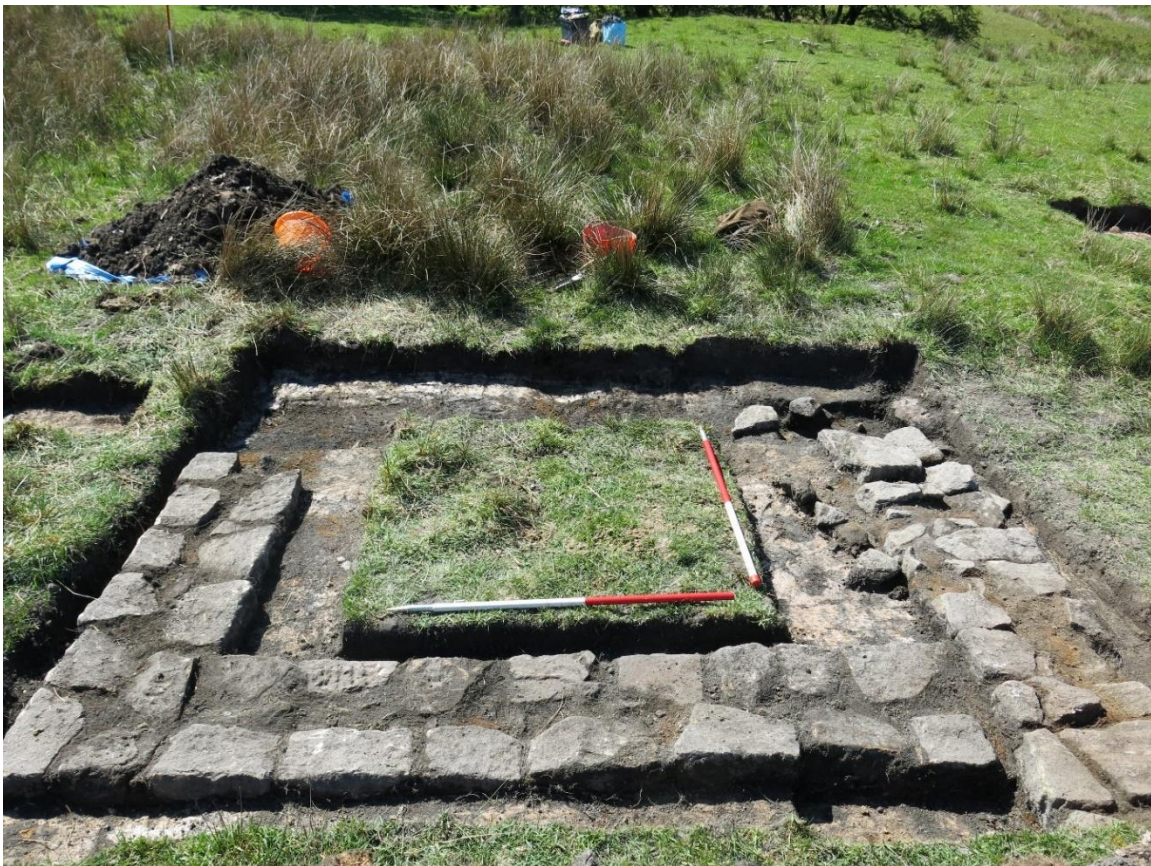
Looking west at the wall foundations of the projecting chamber, with the main, south wall of the western range on the right of the photo

Where the wall survived it could be seen that the eastern wall of the chamber was butted on to the western range's south wall, suggesting that the chamber had been added to the existing range. However, only the lower course of stones survives so it is possible that the wall was tied in at a higher level. The removal of all stones from the western wall means that evidence of jointing has been lost. The wall top for the projecting chamber varied from 223.46 to 223.61 metres above Ordnance Datum (m aOD) whilst the robbed out trench silt top level was 223.28 m aOD in the south west corner.

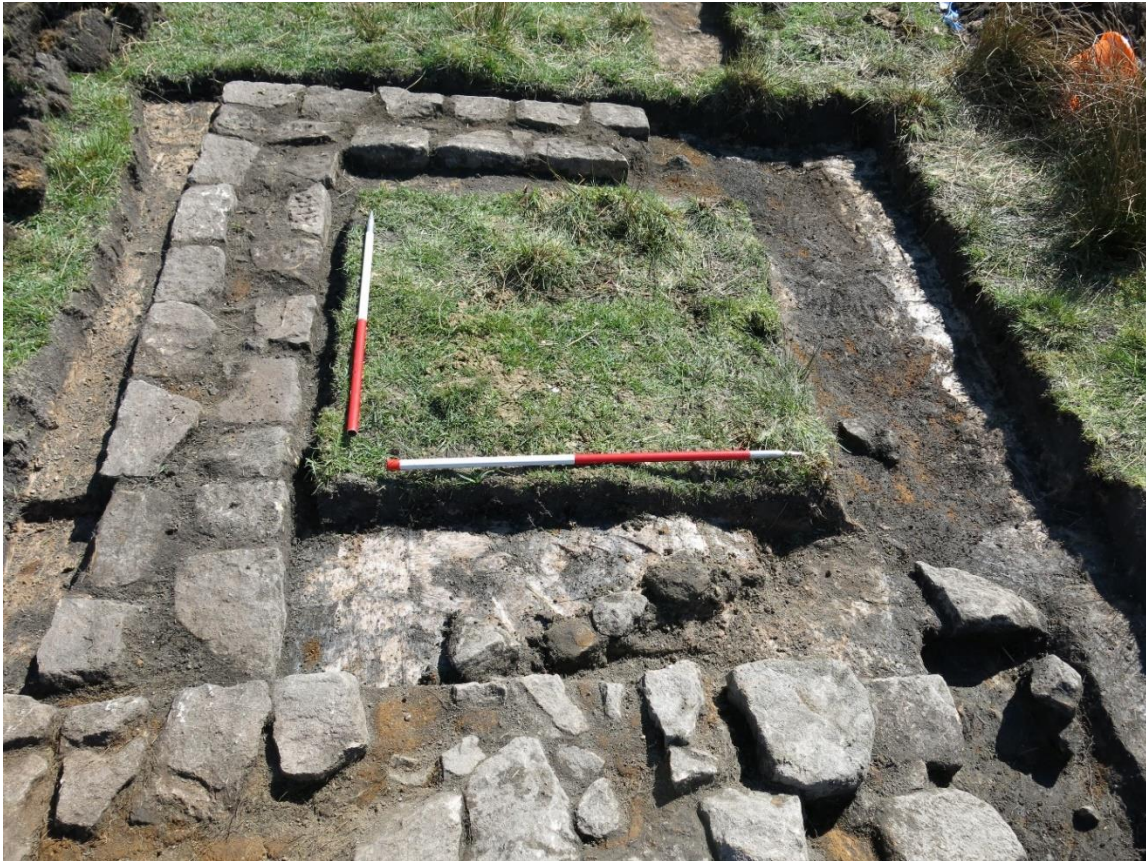
Looking south with the main wall in the foreground, from which the chamber projects with the robbed-out foundation trench on the right

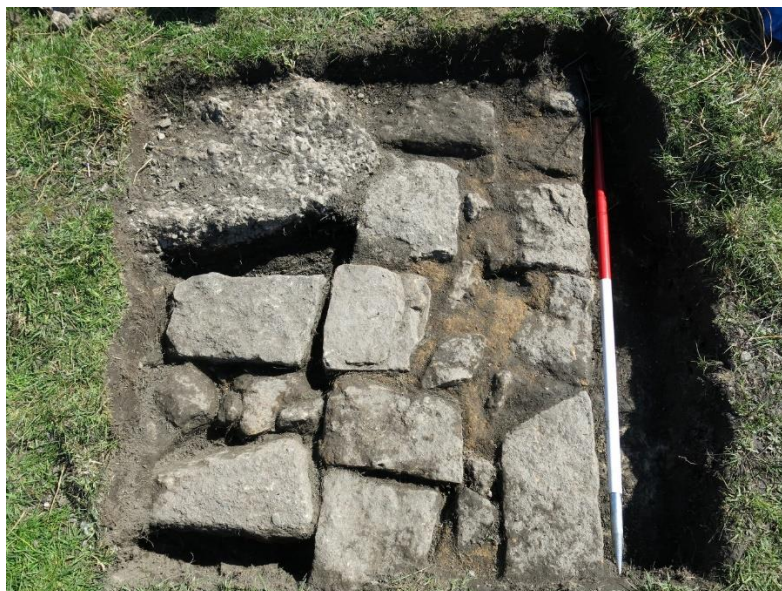
North west corner of the western range looking south, with the western gable wall (right), the butt joint visible with the northern wall of the range (left), and the concrete showing top left against the inside corner of the building

As with the south west chamber, the western wall had mostly been robbed of its stones except for a small section adjoining the corner of the main building. Interestingly, there was a butt joint which showed that the western gable wall of the main building ran on seamlessly to form the west wall of the projecting chamber, with the main wall of the western range being butted up against this wall. A spread of concrete was revealed against the inside corner of the main building. The full extent of the concrete was not revealed and it is uncertain when this originated or what its function was. It could be associated with 20th century pipe trenches that have been cut diagonally through the grange site and it is worth noting that other 20th century material is evident to the west of the building so this area could also have been used to dump waste.

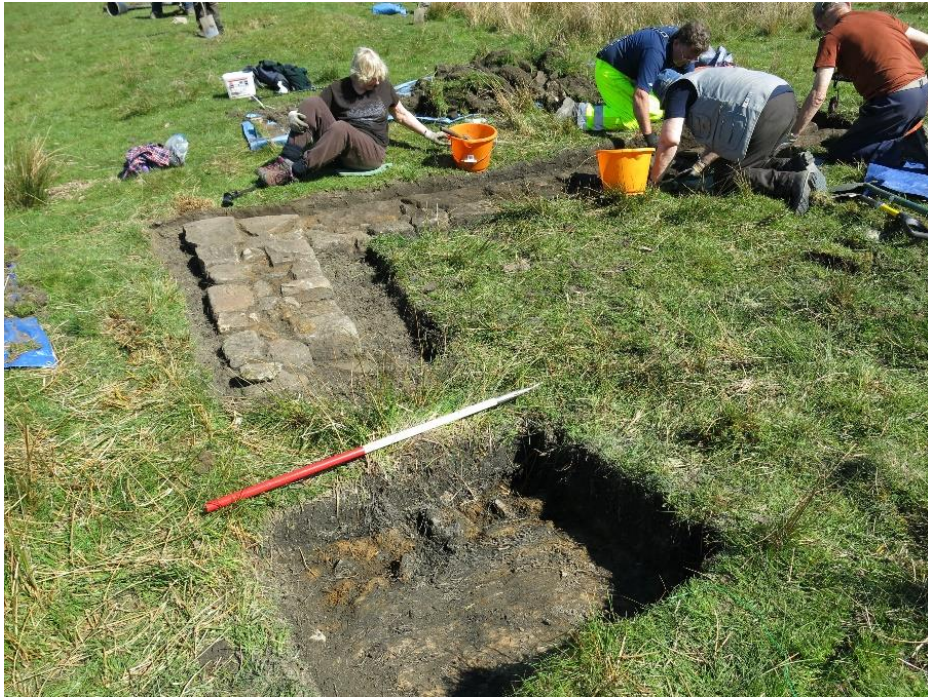
Looking east across the northern end of the projecting chamber, with the robbed out western wall foundation visible in the test pit in the foreground as a linear spread of lumps of orange mortar (in front of the photo scale)

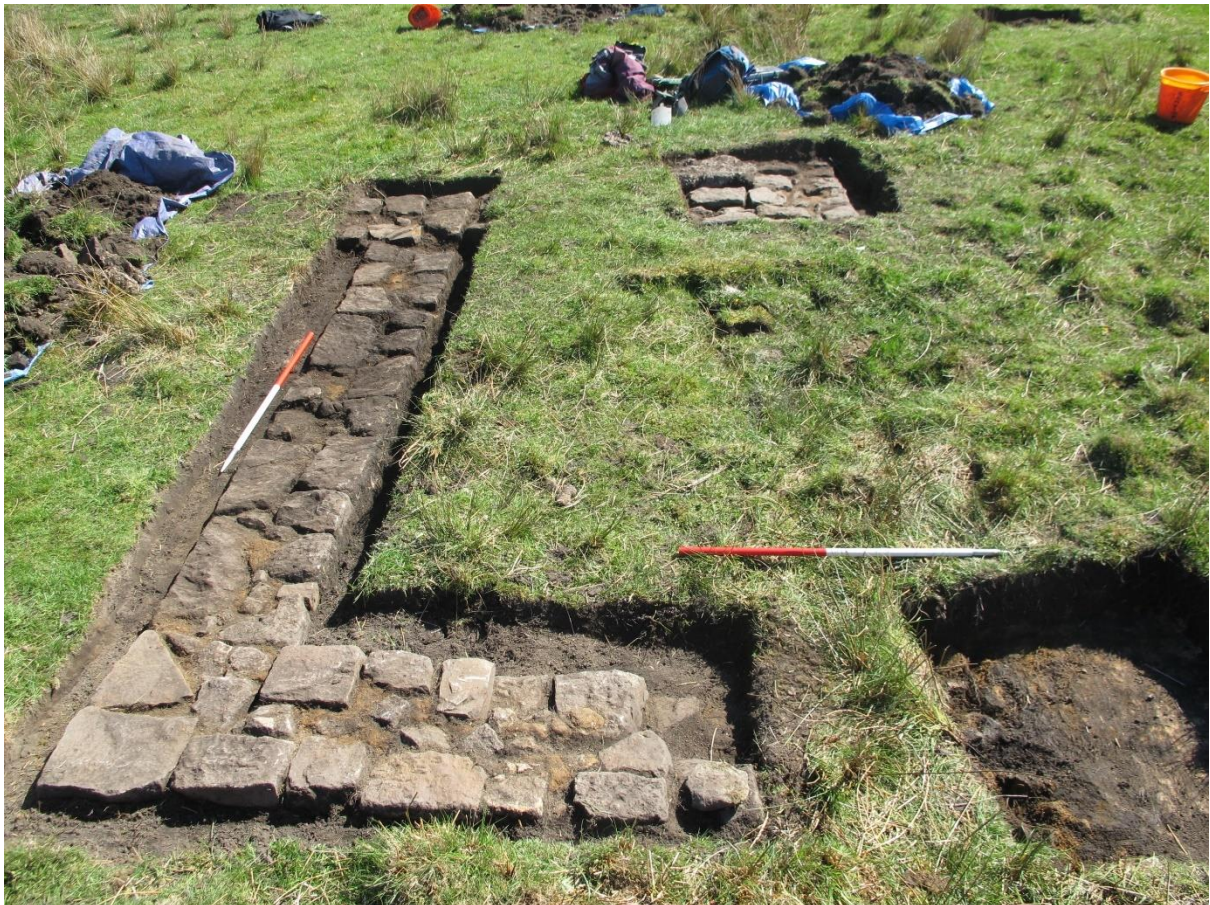
The north west projecting chamber looking south

The east and north wall foundations of the projecting chamber were well-preserved, except for where the north wall joined with the robbed out west wall foundation trench. The corner was not fully excavated but part of the west wall line was exposed to show that most of the stones had been removed to leave some smaller stones and lumps of orange mortar in the bottom of the foundation trench. The walls meeting at the north east corner of the projecting chamber were keyed in, and the eastern wall also appeared to key in with the main, north, wall of western range. There appeared to be a break in the main north wall of the western range and, along with the butt joint against the corner of the building; this suggests that the projecting chamber could have originally been open to the main building. However, such an interpretation should be treated with caution as only the lowest level of the foundation wall survives and the wall may have been keyed in above this level. There were just a few sherds of 19th/20th century glazed pottery from this area. The wall tops/surfaces of the opposite, south west and north east, corners had identical levels of 223.32 m aOD.

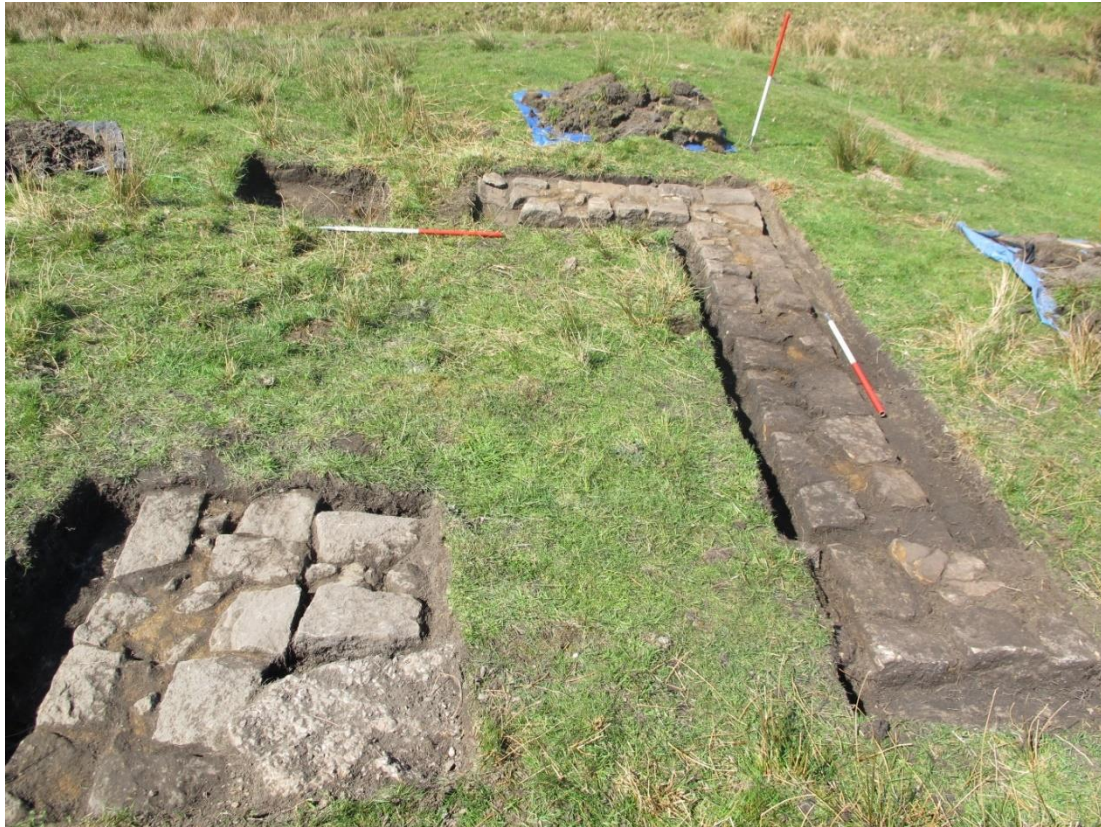
The projecting chamber looking north, showing the butt joints between the western gable wall on the left and the western range north wall/projecting chamber east wall on the right

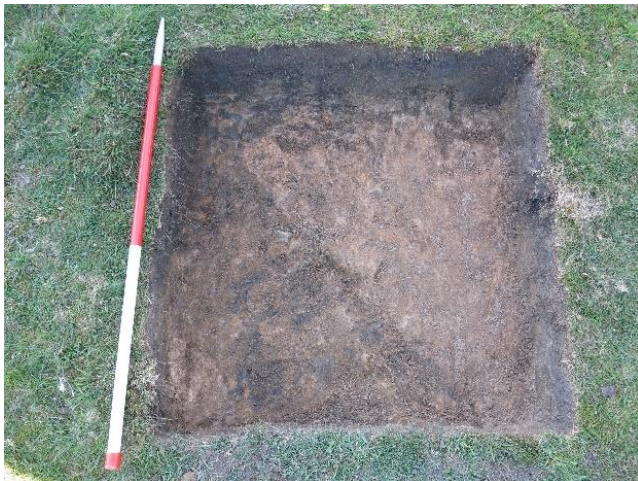
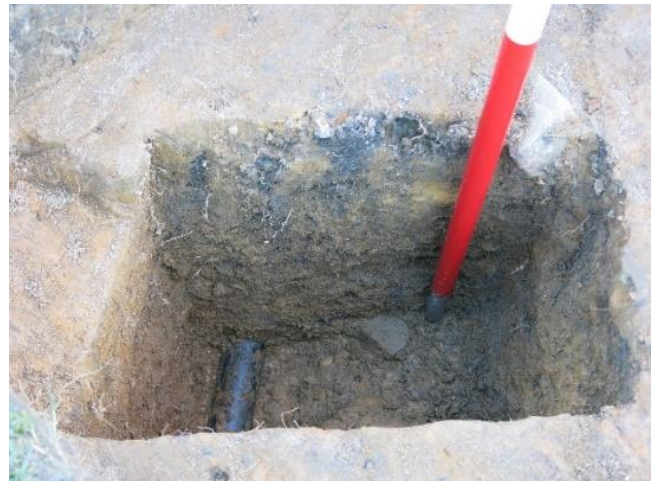
TP 1 looking north with the cut of the pipe trench clearly visible (left) and a section dug through the trench to reveal the plastic pipe (right)

The geophysical survey had picked up a linear anomaly running north from the north wall of the western range. TP1 was located 2.5 metres to the north of the wall to examine this anomaly to see if it might part of the grange structure, but it quickly became apparent that it was a modern pipe trench.

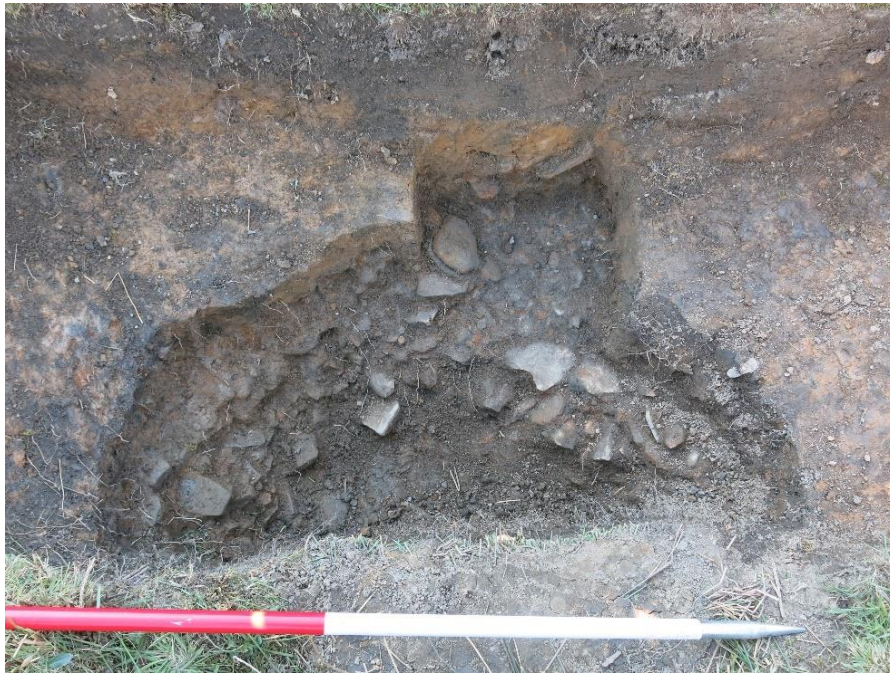
TP2 in early stages of excavation, showing the pit cut through a stone deposit (looking west)

When more fully excavated it was found that there was nothing buried in the pit. The reason for its excavation remains obscure. The stone deposit comprised small to medium gritstones in a matrix of mid-grey silty clay with frequent small patches of orange or yellow clay. The stones were generally flat and densely packed horizontally and in places where small stones were packed together resembled road metalling. The deposit appeared to run through the centre of the trench west to east but, as the sealing mixed layer was only partly excavated, it is not clear if the stones run across the full width of the trench. The stone deposit could represent an early track perhaps contemporary with the grange building, or natural. Further investigation is recommended to better define the extent, character and function of this stone layer.

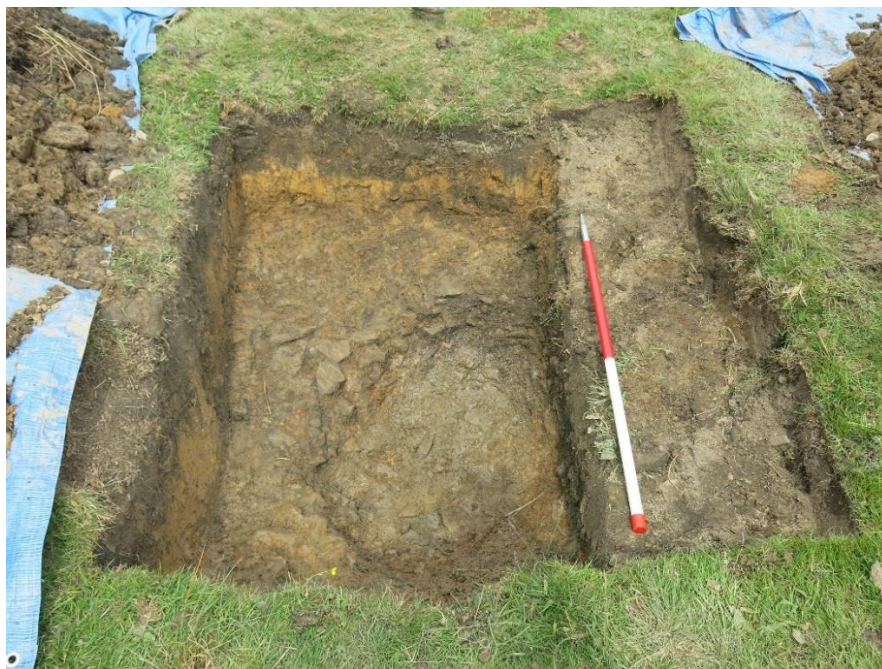
TP2 showing most of the pit excavated, looking north, with the stone deposit clearly visible

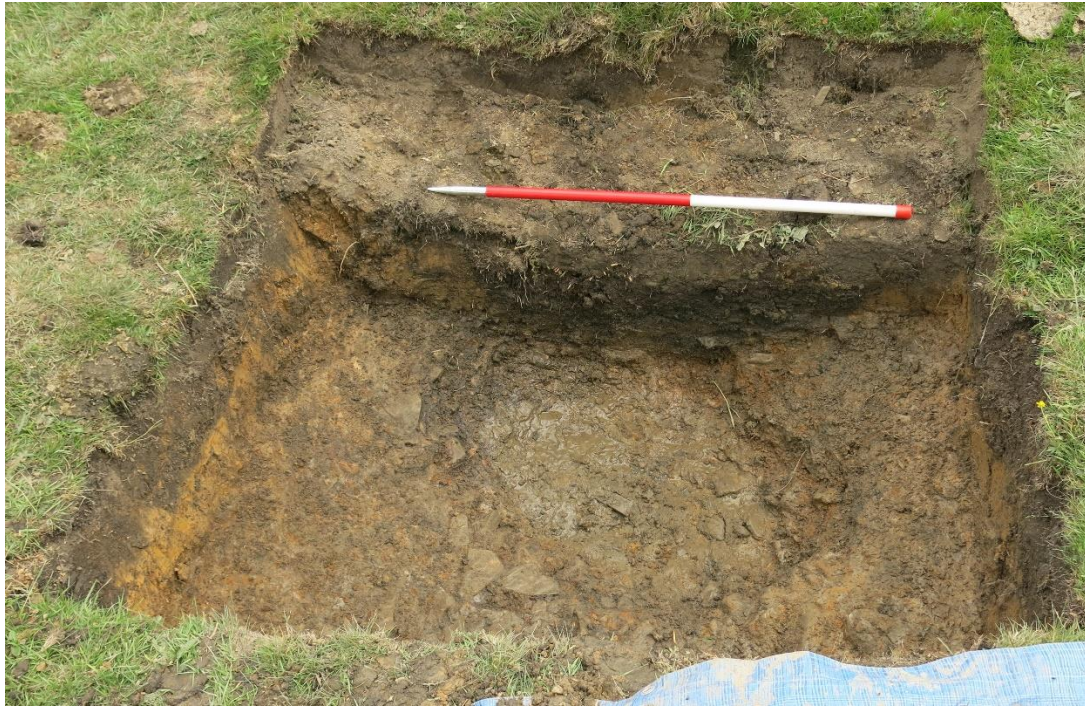
TP2 looking east at the section showing the humic soil fill

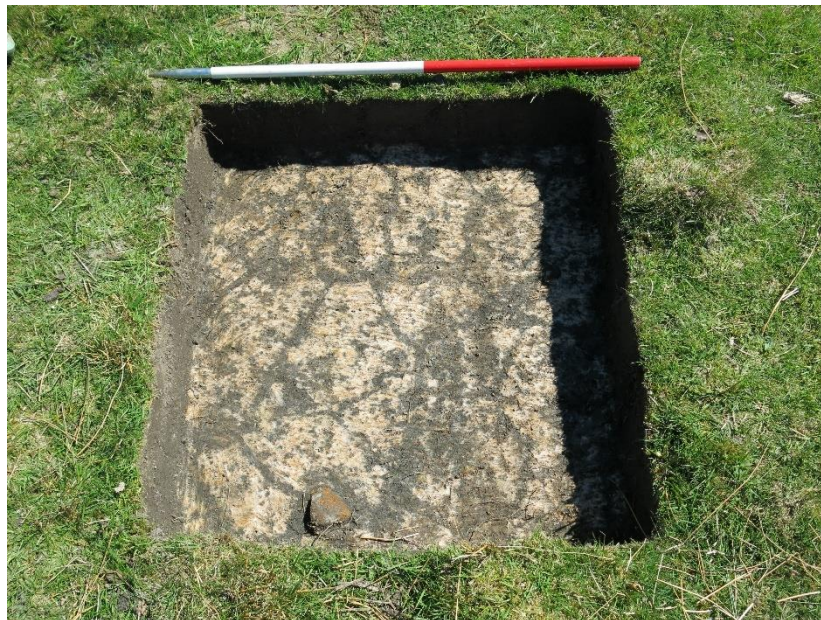
TP3 looking south

Geophysics had shown several anomalies beyond the western gable wall of the grange. TP3 was located 2 metres west of the wall to examine the archaeological potential of these anomalies. Natural yellow clay was found at a shallow depth so there was clearly no archaeological activity at this place. The turf level was 223.50 m aOD and the top of the clay at 223.31 m aOD. It was noted that in undergrowth near the test pit were pieces of concrete and scrap metal that probably account for the geophysical survey anomalies, so this area appears to have been used for dumping material in the 20th century.

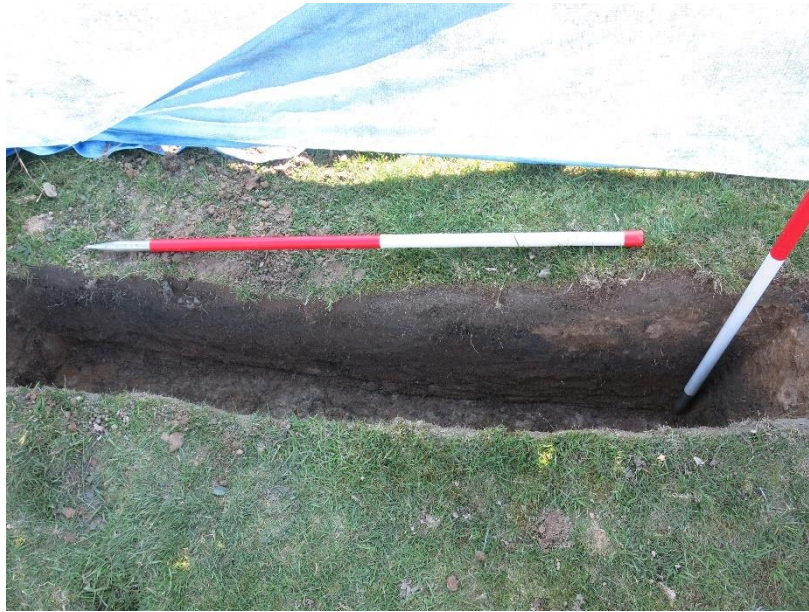
TP4 looking south west

This was a narrow slot 1.5 metres long by 0.5 metres wide positioned across a small mound around 5 metres north of the western range near its north west corner. At its deepest point the mound was found to be 0.55 metres deep and lying above natural white clay with some charcoal flecks. Material making up the mound comprised mid- grey silty clay loam mixed with small patches of light-yellow clay. Finds included

19th century black glazed earthenware. It can be concluded that this is a post medieval spoil mound but the origin of the spoil is uncertain. The top of spoil mound was 223.42 m aOD and the clay natural was at 222.87 m aOD.

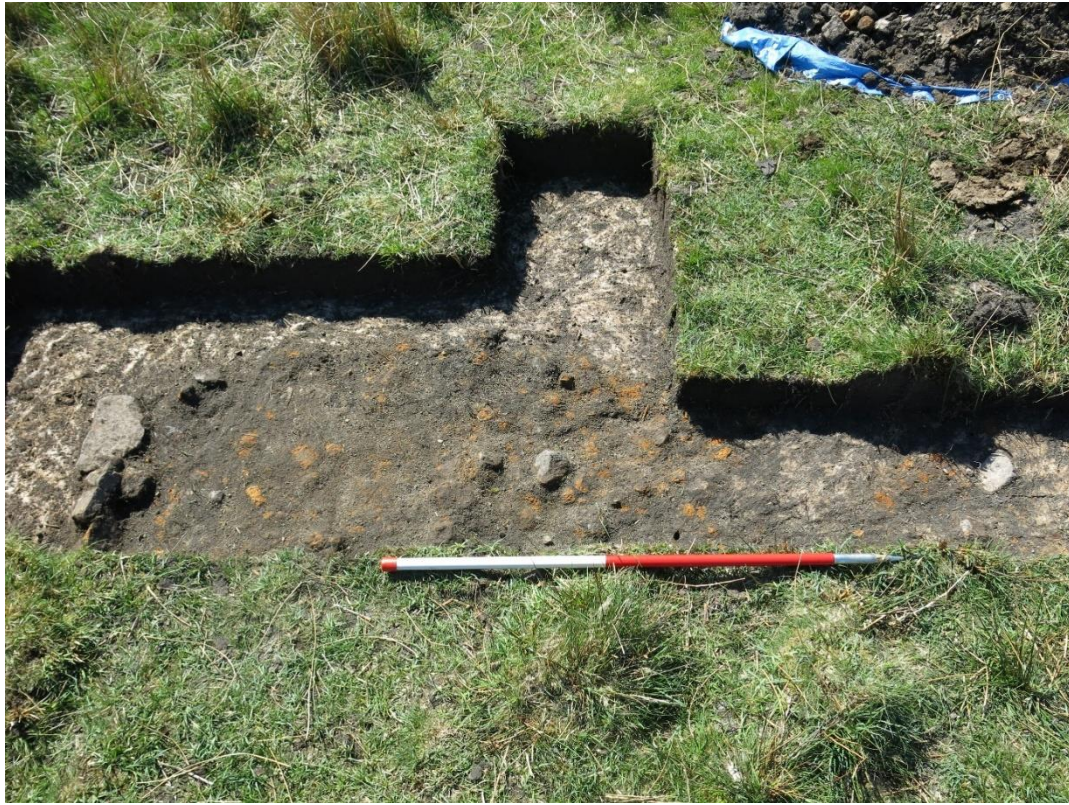
TP5 looking west across the terminus of the stone track, with remnant kerb stones on the left and the end of trackway visible against natural white clay.

Initially a one metre square test pit, which successfully located track material, TP5 was opened up to show the full width of the track. This was found to be 2.5 metres wide which was narrower than the 3.8 metres width exposed in Trench 3 in the previous year (located c 10 metres to the east). The track also differed in its composition, comprising predominantly small pieces of weathered sandstone set in a grey silty clay loam, with only occasional grit stones. This contrasts with much more stonework seen in Trench 3 in 2018. The track surface was at 223.40 m aOD. On the south side of the track were two longer grit stones which appeared to represent kerbing. Significantly, it was seen that the track material gave way to the natural white clay at a point almost perfectly in alignment with the western gable wall of the grange building. There was a gap of c 2 metres between the two. It is clear that the stone track was closely connected to the building and this supports the theory that it was laid down to enable carts to get close access to the walls being dismantled. Further, rare, dating evidence came from the top of the track material in the form of a single body sherd of medieval dark green glazed pottery.

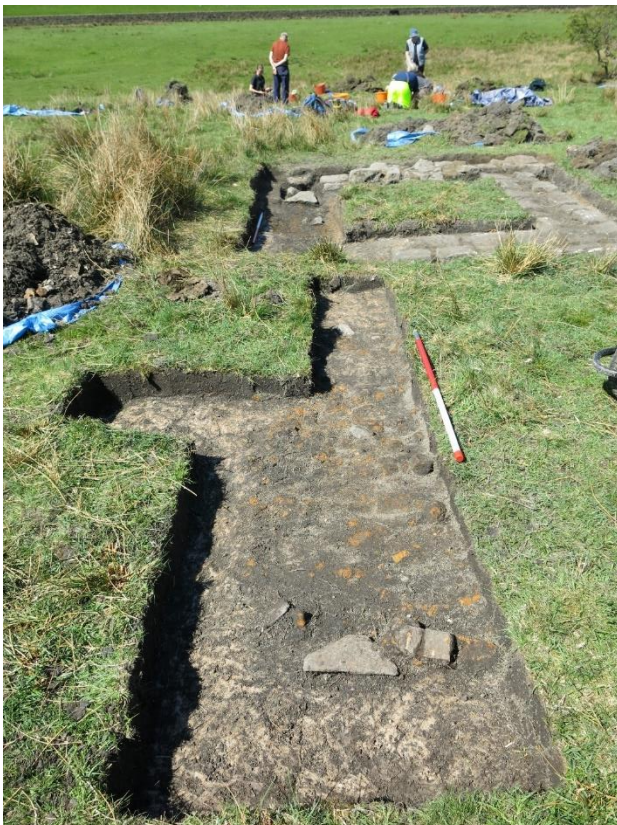
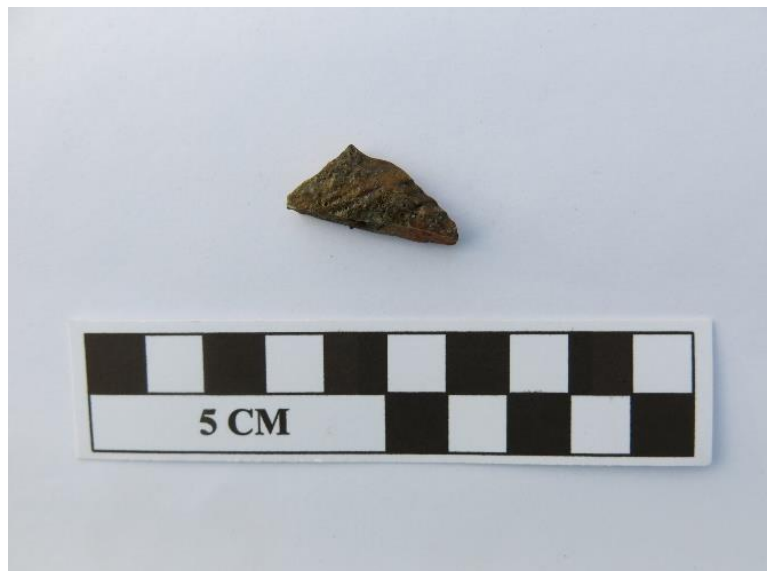
Looking north across the trackway terminus in TP5 to the projecting chamber foundations at the south west corner of the grange building (left) and the sherd of medieval dark green glazed pottery (right)

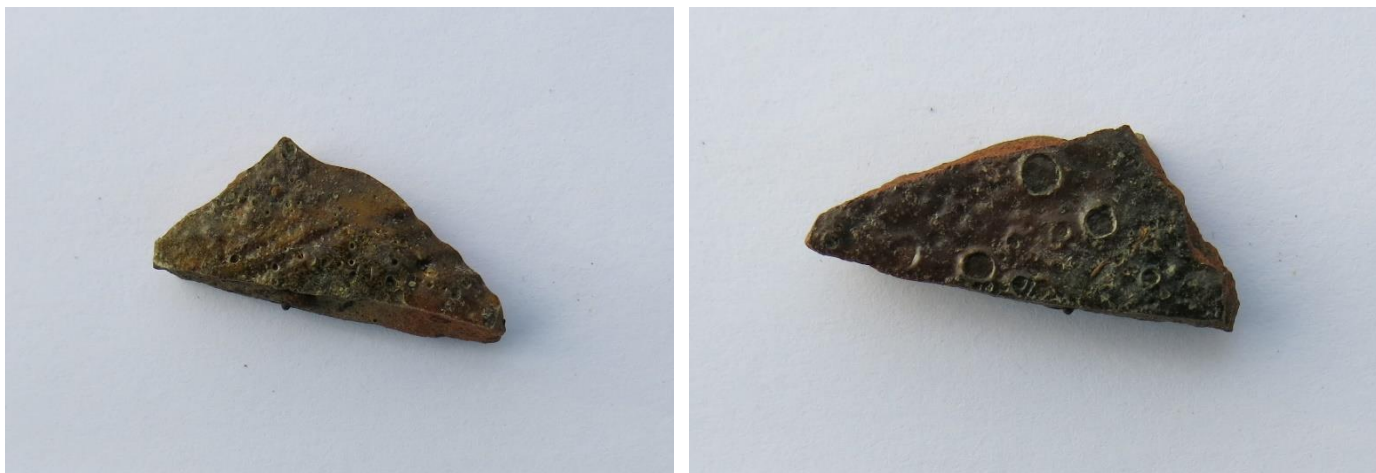
Detailed photographs of both sides of the dark green/olive glazed medieval pottery sherd

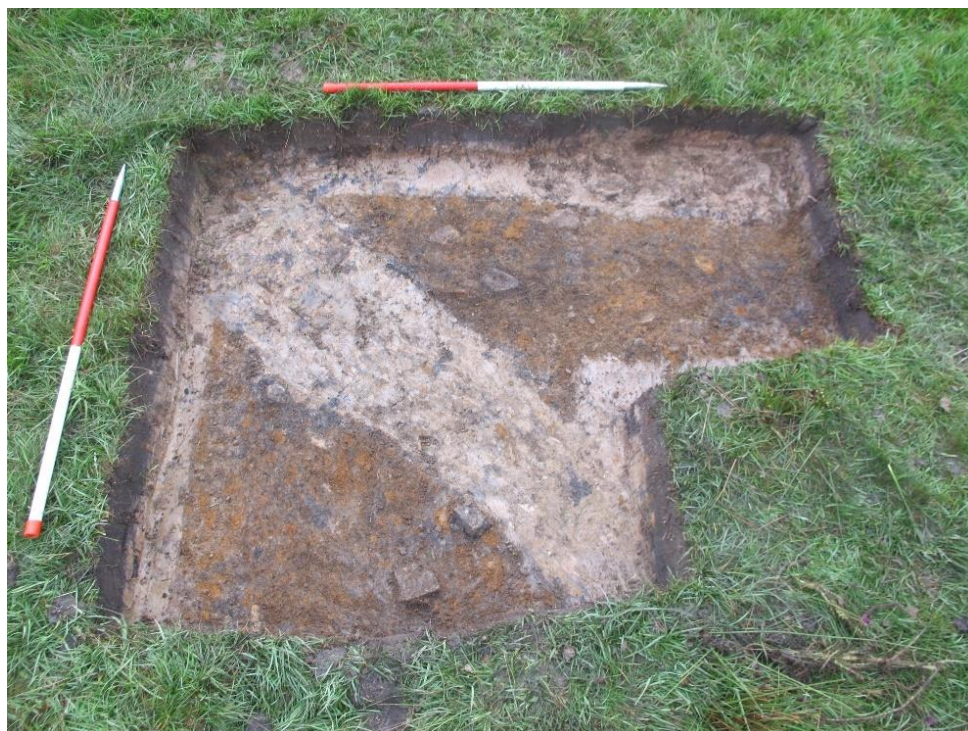
TP26 showing the junction of the two wall lines, with natural white clay on either side, and with the diagonal pipe trench backfilled with white clay cutting through the corner

This was positioned to confirm that the room arrangement within the western range mirrored that of the east range. TP26 was located at the south-eastern corner of a set of three rooms in order to expose the corner and confirm that a wall did not carry on eastwards to the central range. In 2018 TP19 had found that the southern wall of the eastern range terminated to leave a gap of c 4 metres between it and the central range wall. It is not clear why this gap exists, but it could relate to an entrance into the complex. Did the western range have a similar arrangement? Excavation of TP26 found former wall foundation slots and was opened up to fully reveal the junction of two former walls lines. These were filled with the usual grey silty clay loam and orange mortar, with occasional small gritstones and no in situ stone blocks. The foundation trenches were cut into natural white clay. Unfortunately, a modern pipe trench, similar to the one exposed in TP1, ran right through the wall's junction. However, enough was exposed to demonstrate that there was the south east corner of a room here and that there was no evidence for a wall continuing eastwards to the central range. This is exactly the same arrangement as for the eastern range. The surface level of the south wall was at 224.40 m aOD to the east at the corner and 224. 31 m aOD at the west end of the test pit.

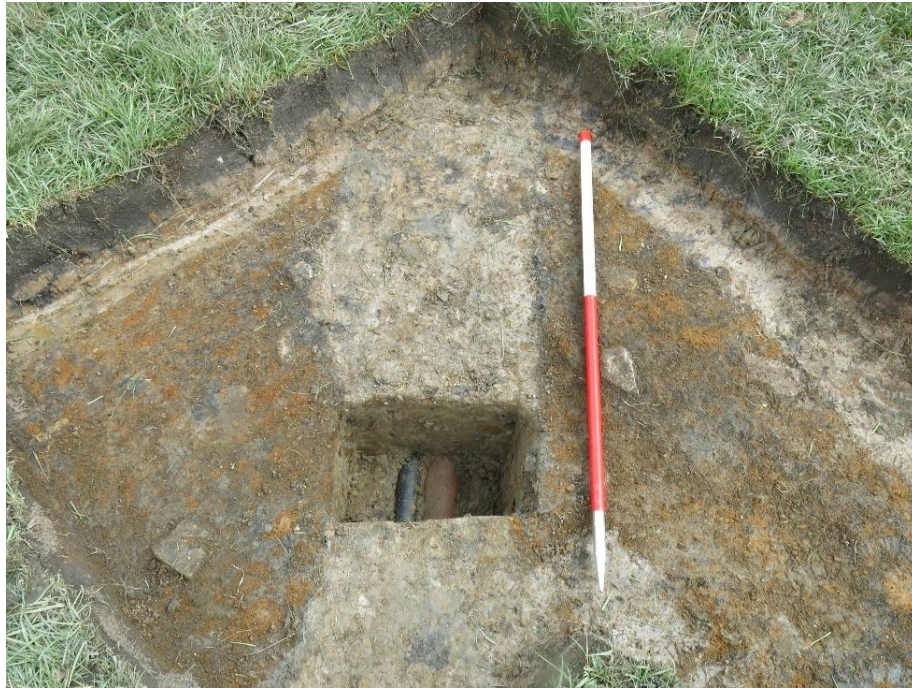
TP26: the pipes are showing in this section excavated through the backfilled trench

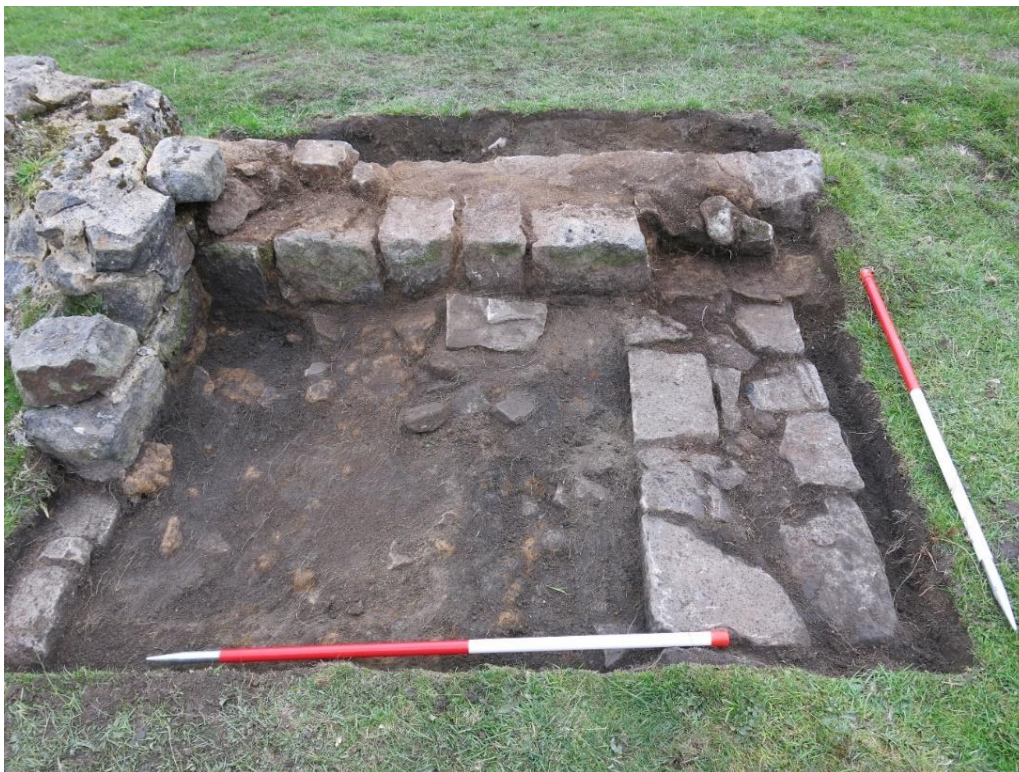
TP7 looking north, showing the rubble deposit pre excavation at the end of the corridor

From previous work we know that there is middle corridor in the central range, 1.2 metres wide. It runs up to what appears to be an entrance, however there is a low stone wall blocking this 'entrance' so we wanted to discover what was happening here. TP7 was excavated as a 2 metre square area to fully reveal the three walls framing the 'entrance' and to investigate the internal corridor as it approached the north wall of the central range.

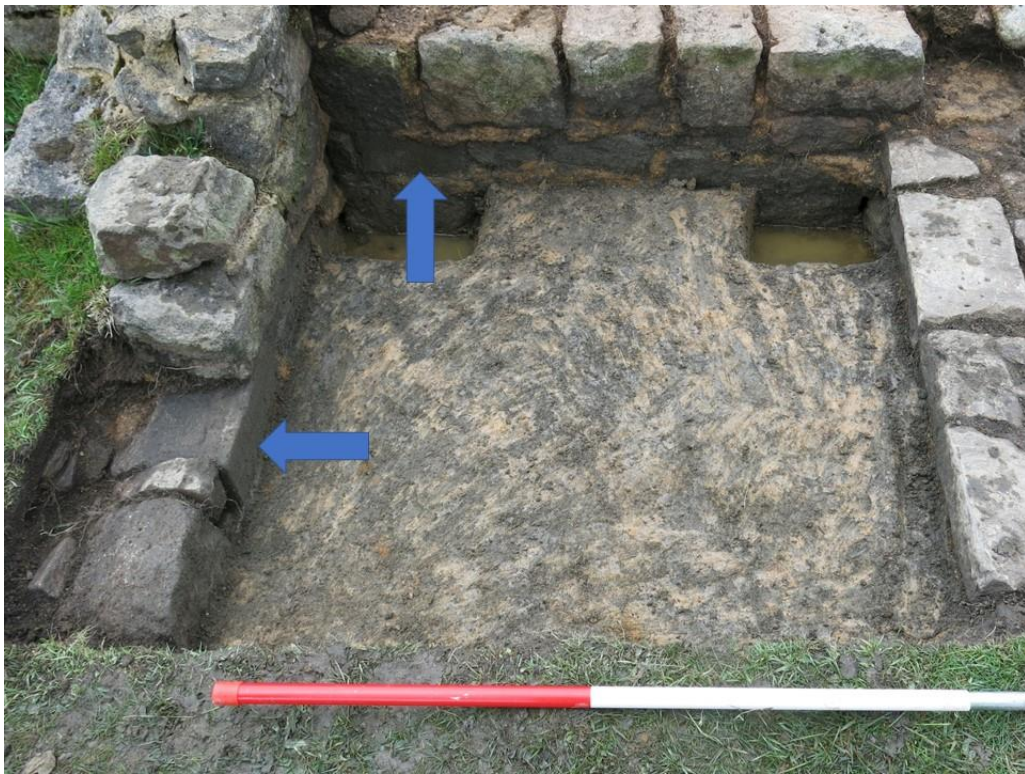
TP7 looking north after excavation of the rubble deposit and corner sondages – the two rectangular dressed stones are indicated by blue arrows

The north wall was seen to be continuous across the corridor terminus indicating that there was not a doorway here. Interestingly, there was a butt joint where the western wall of the corridor connected to the north wall of the central range, whereas the east wall was keyed in and integral. There was a lot of orange mortar covering the north wall and the area where it joined with the corridor west wall. Of particular interest were two well-dressed rectangular stone blocks occurring in the base of the corridor west wall and the north wall. These had vertical chisel lines which were very regular. These look to be post-medieval and re-used which suggests that this part of the central range was re-built for later use, perhaps as an animal shelter, store or even human habitation. This would also explain why the only visible walls, surviving above ground, are in this part of the complex. Disappointingly, no dateable artifacts were recovered from the rubble deposit.
