Archaeological Excavation of the possible monastic grange building at Water's Clough, Castleshaw, Saddleworth

2019

Report written by Norman Redhead
for the Friends of Castleshaw Roman Forts

June 2020

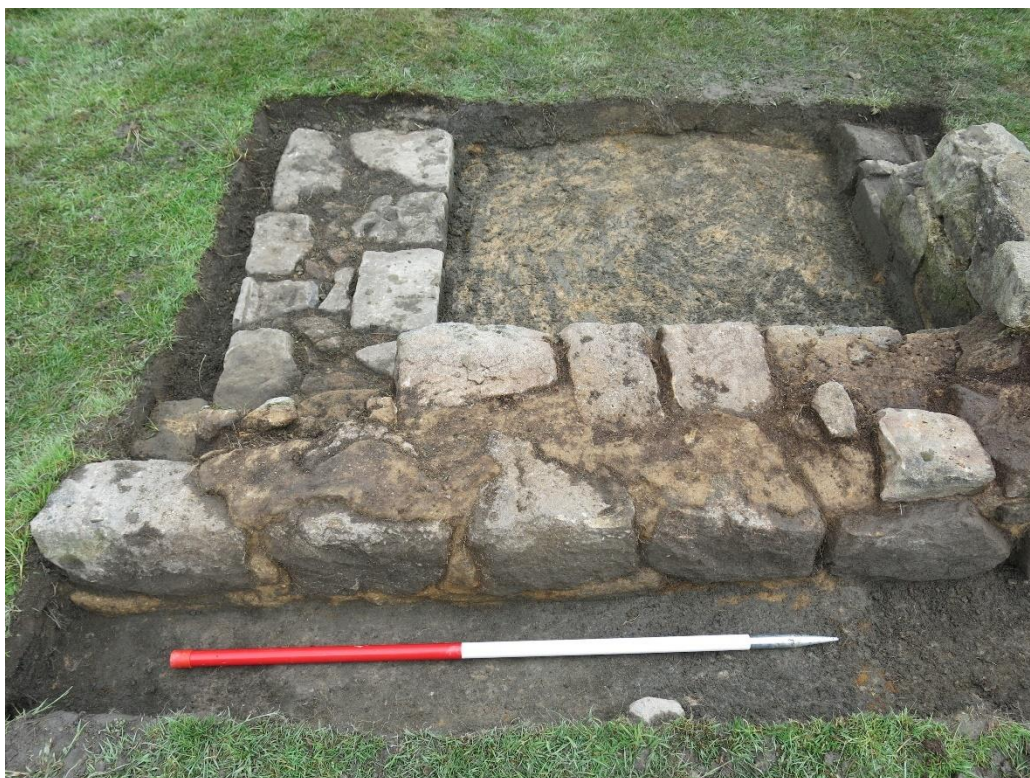
TP7 looking south

dismantling or post demolition weathering. The rubble deposit was only 10-15 cm deep and came off on to natural light-yellow white clay. There was no evidence for a floor. The cut for the foundation trench was very tight to the wall, which is not surprising given the stiff nature of the natural clay which is ideal foundation material. Two small sondages were dug through the clay against the north west and north east corners of the corridor to examine the foundation stones. They were excavated to 17cm depth and proved that the white clay was natural and revealed the foundation base layer of stones. In the north west corner five courses of surviving masonry were visible. The white clay surface was at 225.00 m aOD with the top of the wall at 225.58 m aOD.

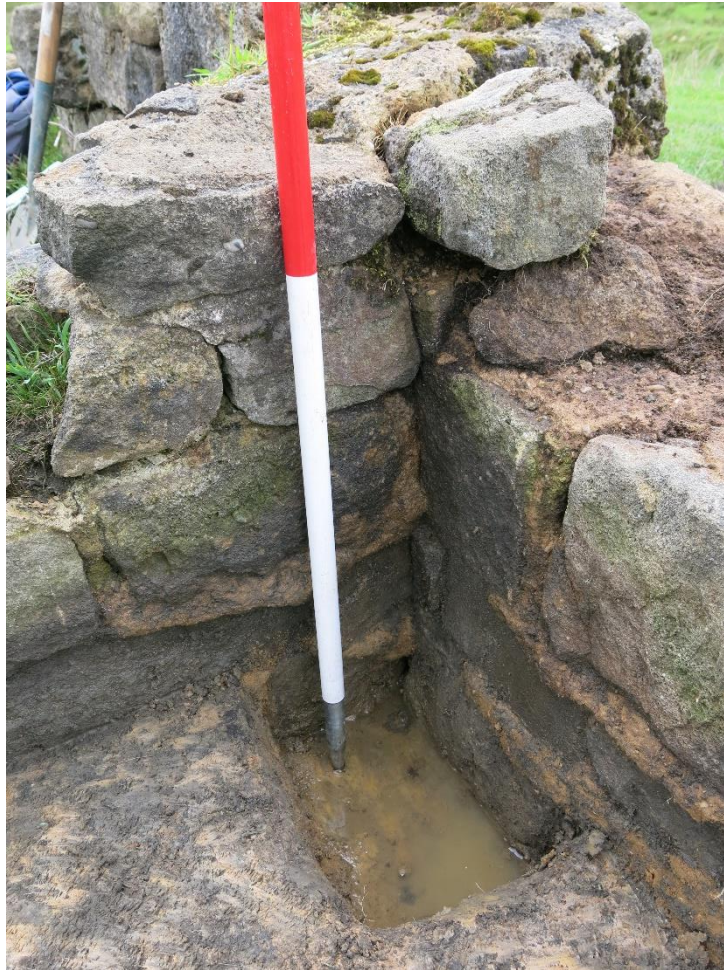
Detailed view of north west corner of corridor in TP7 showing butt joint and five courses of stonework

The north wall was seen to be continuous across the corridor terminus indicating that there was not a doorway here. Interestingly, there was a butt joint where the western wall of the corridor connected to the north wall of the central range, whereas the east wall was keyed in and integral. There was a lot of orange mortar covering the north wall and the area where it joined with the corridor west wall. Of particular interest were two well-dressed rectangular stone blocks occurring in the base of the corridor west wall and the north wall. These had vertical chisel lines which were very regular. These look to be post-medieval and re-used which suggests that this part of the central range was re-built for later use, perhaps as an animal shelter, store or even human habitation. This would also explain why the only visible walls, surviving above ground, are in this part of the complex. Disappointingly, no dateable artifacts were recovered from the rubble deposit.

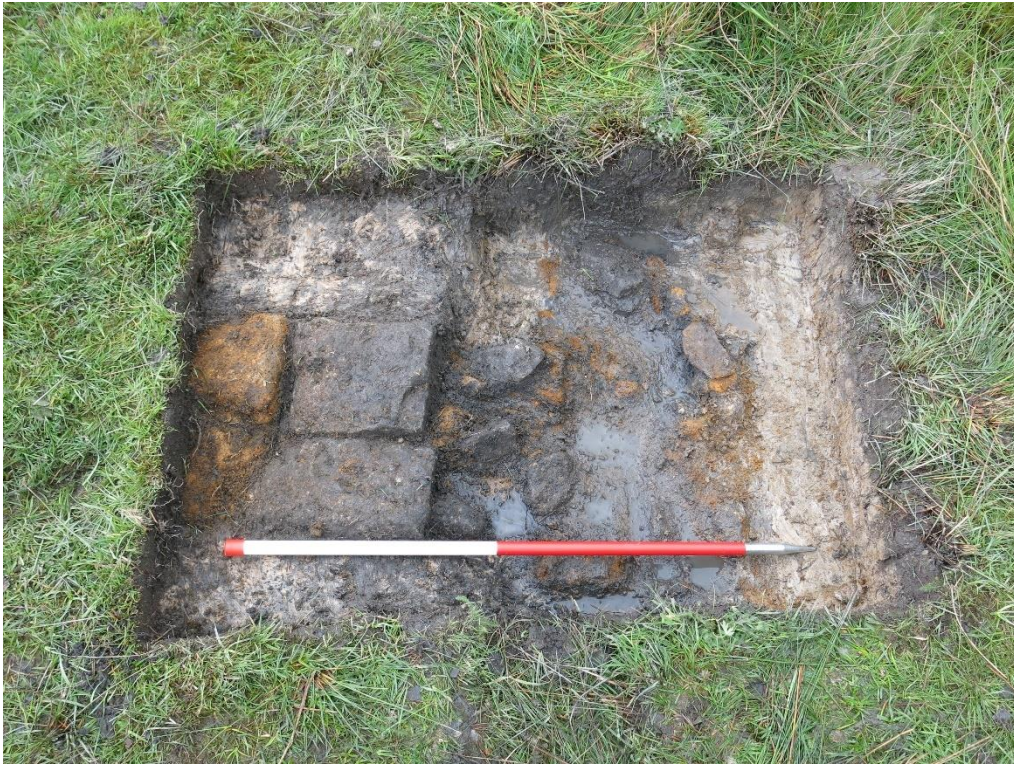
TP8 looking east showing: surviving stonework of the south to north corridor (left), the course of the robbed out west to east corridor to the right running from bottom to top of the photo, and white clay natural on the far right side demonstrating that the wall foundation does not carry across the other corridor

In terms of levels, the stone wall tops in TP8 and TP9 were 225.00 and 225.16 m aOD respectively, whilst the west to east corridor trench fill tops were 224.84 and 224.88 m aOD respectively.

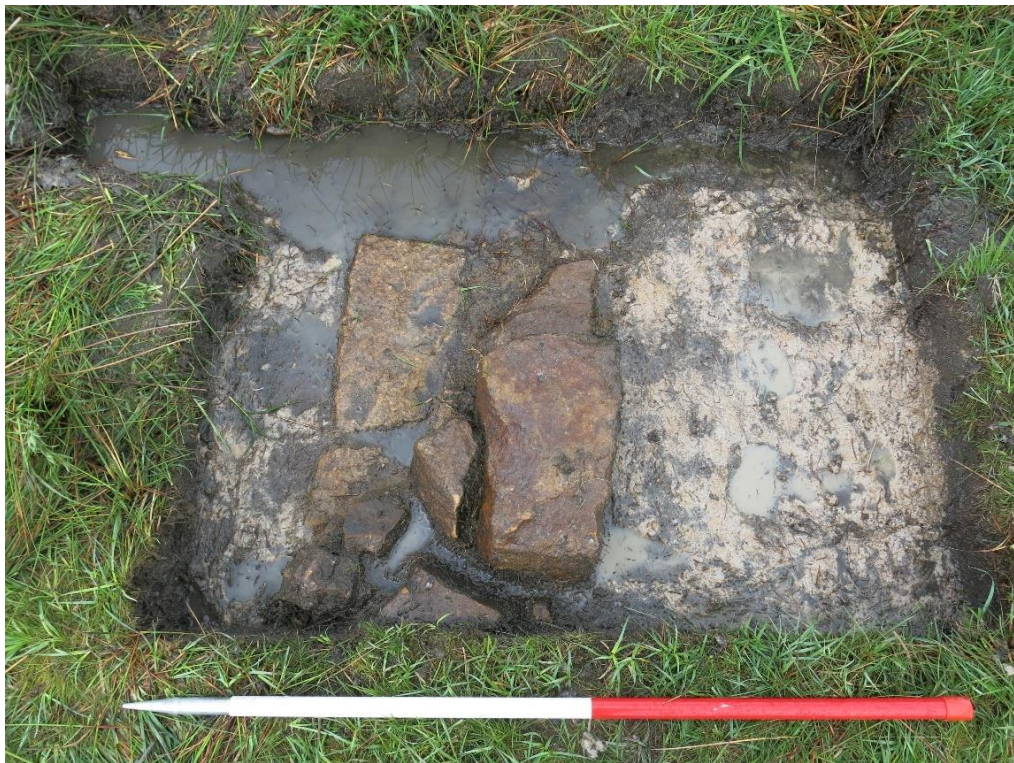
TP9 looking north showing surviving stones of the south to north corridor looking

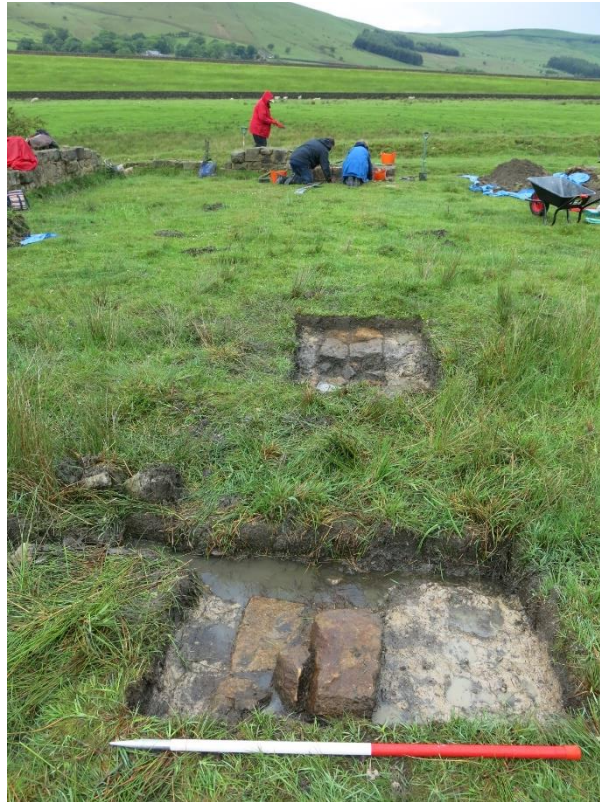
View northwards across TP8 and TP9 showing, with TP7 being excavated in the background

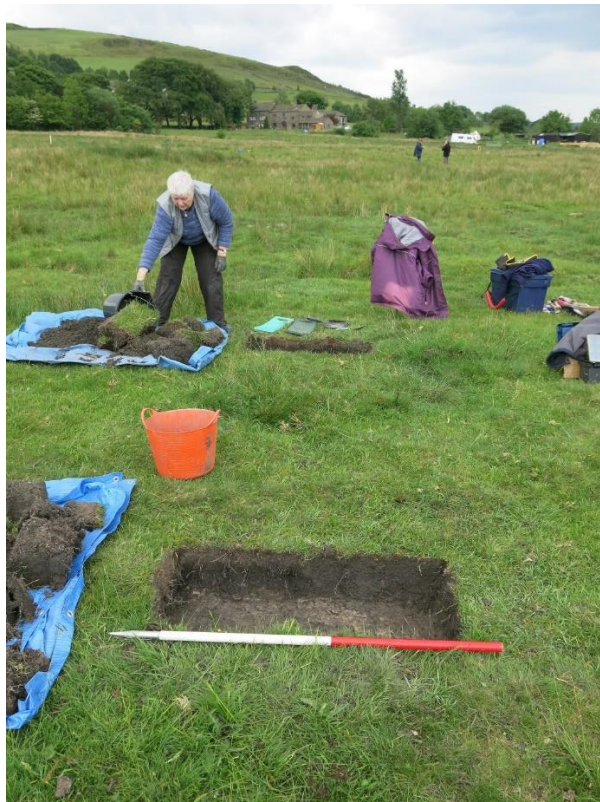
Looking south across TP10 in the foreground and TP11 beyond, being dug by Nora

These two test pits were half the normal size, 1 x 0.5 metres, to look for a potential wall line running south from the project chamber attached to the north east side of central range. TP10 was 3.5 metres south of the north wall of the central range and TP11 6.5 metres. Both test pits revealed natural yellow-white clay at a shallow depth of 20 cm beneath the turf, confirming that there were no structural remains here.

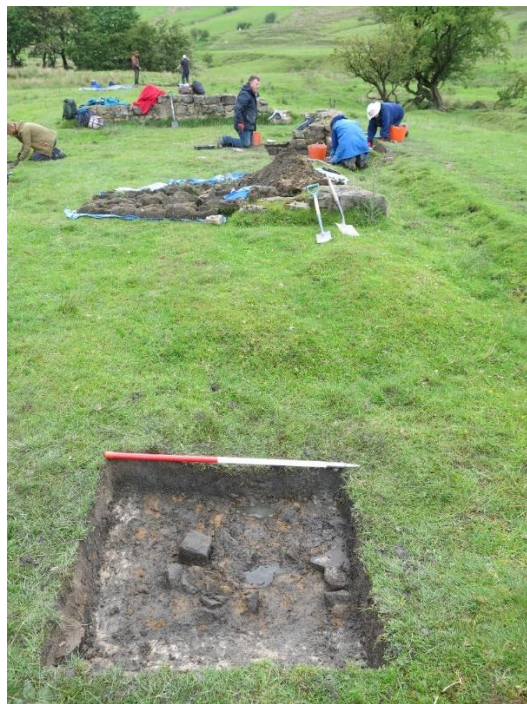
Looking across TP13 westwards to the central range (being excavated in the background)

Excavation of TP13 revealed the corresponding corner of this chamber, with the junction of two walls clearly visible against the white natural clay. No walling survived in situ but there were several small to medium gritstones amidst the dominant fill of lumps of dark orange mortar. As indicated by TP10 and TP11, there was no foundation trench running towards the north wall of the eastern range. This leaves us with a small rectangular structure measuring the same width as the corner chambers at each end of the grange building, ie. 1.70 metres internally and with a length of 4.60 metres internally. The wall construction is exactly the same as seen elsewhere in the grange. The top of the foundation fill was at 225.44 m aOD.

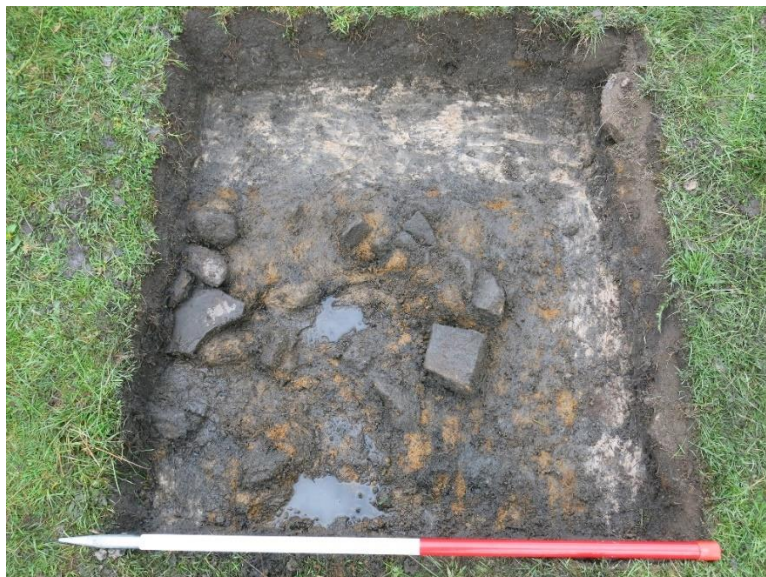
TP13 looking east showing the south east corner of the rectangular chamber jutting out from the north east side of the central range

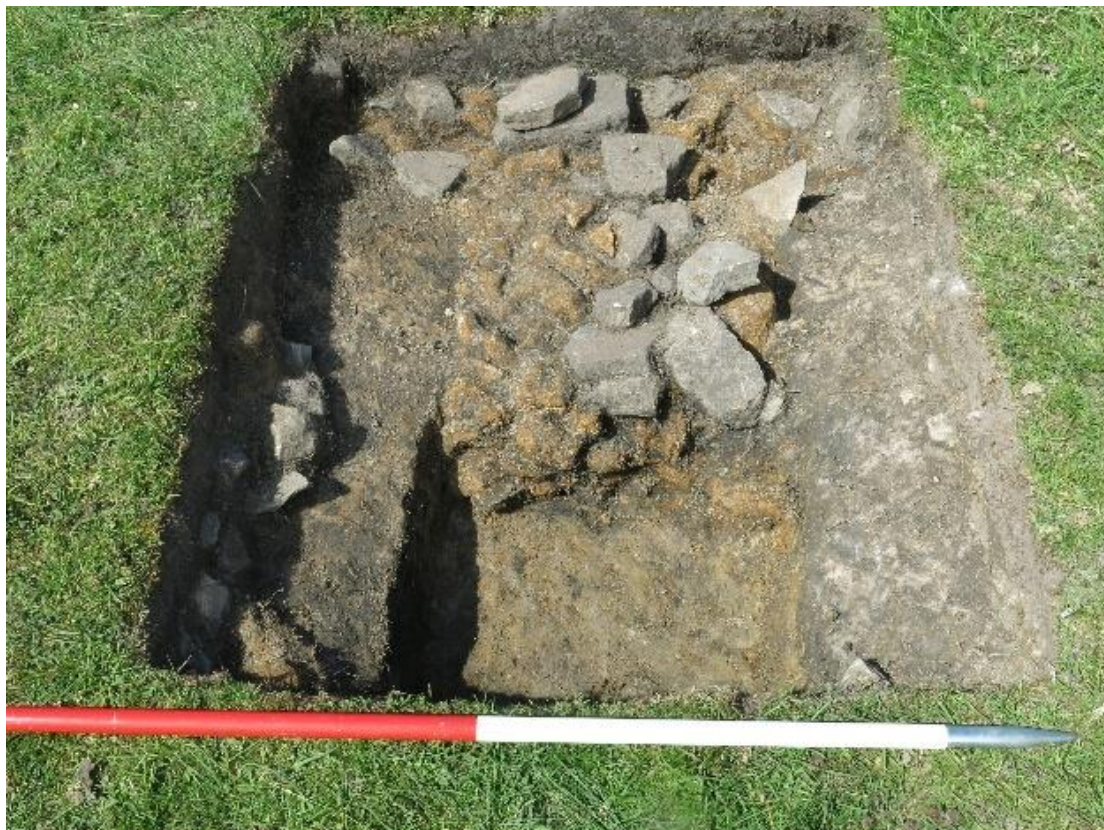
TP15 looking north, showing the packed lumps of orange mortar infilling the internal wall trench

A section was excavated which revealed the neat cut of the foundation trench and nature of its fill. The clumps of orange mortar, which were chipped off the stone blocks when they were reclaimed, were neatly laid and packed in. Medium gritstones were laid over them in a rather haphazard way but generally laid flat. The top of the mortar infill was at 225.31 m aOD. Could this represent a re-use and re-build for this structure using building debris left over from the original dismantling which was re-purposed to create a new, less robust structure? If this is the case, then it supports the evidence of re-use of the northern part of the central range as discussed under TP7.

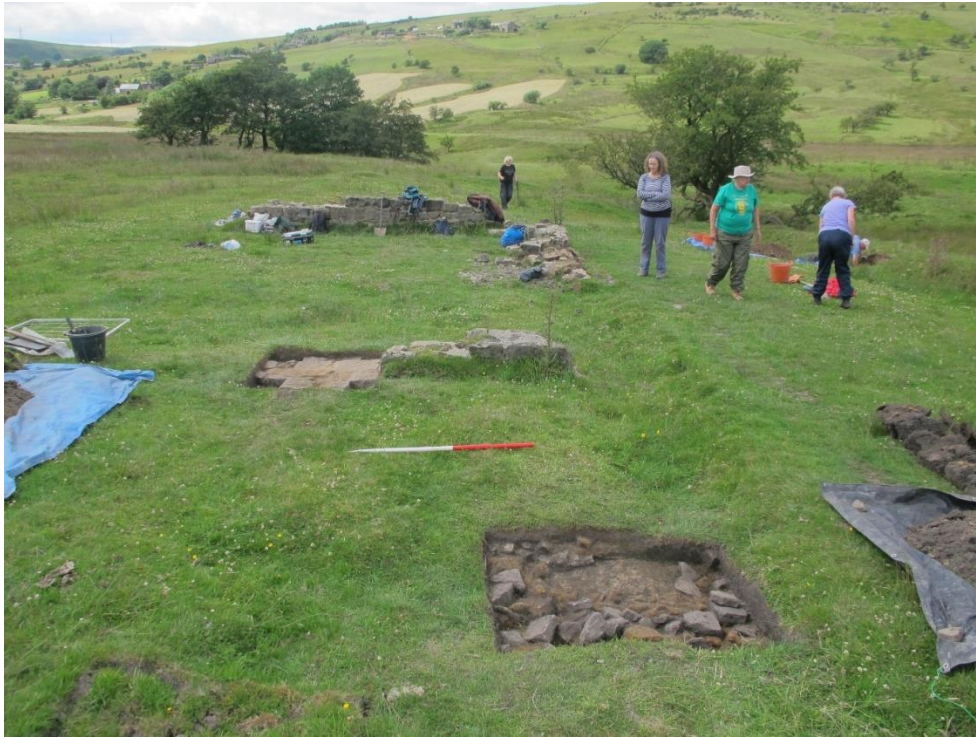
Looking west across to the central range ruins with TP15 in the foreground - the photographic scale lies in the middle of the small rectangular chamber jutting out from the central range

A linear depression visible in the turf within the footprint of the narrow chamber projecting from the north east side of the central range suggested an internal division. TP15 was located at the junction of the linear depression and the north wall line of this chamber. A dense concentration of lumps of dark orange mortar and small to medium gritstones was revealed at a shallow depth and showed a former wall foundation trench subdividing the rectangular chamber. This gives a larger room nearest the central chamber measuring 1.7 x 2.5 metres internally and a very small outer room of 1.7 x 1.6 metres internally. A deposit of stones and mortar occurred in the south west side of the test pit. This seems to relate to a shallow spoil mound.

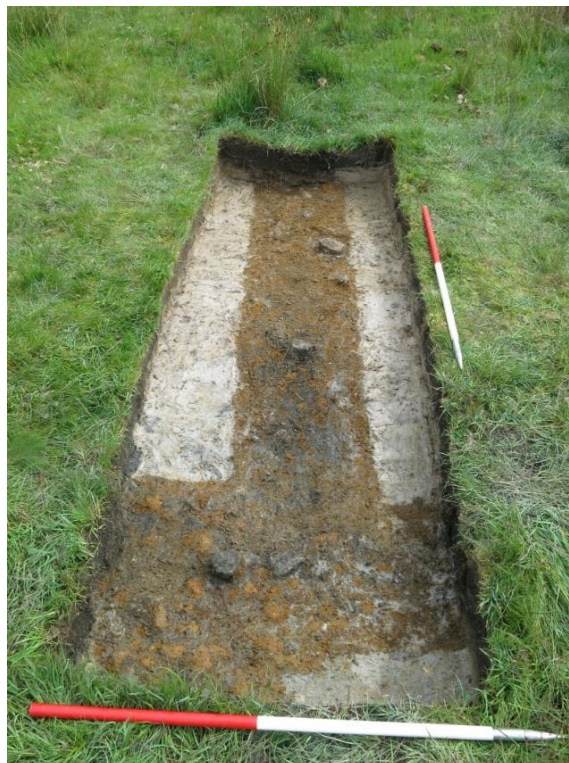
TP17 looking east, with the staggered wall junction in the foreground

The trench was excavated a little deeper than normal to reveal the foundations' very clean cut through the natural white clay. The top of the mortar infill was at 225.08 m aOD towards the eastern end of the trench, dropping to 224.98 m aOD where it met the central range east wall. A section was cut through the foundation trench at the east end of the excavated area. This showed that the foundation trench was very shallow being only 12 cm deep. The top 7 cm comprised a mixed layer of white clay, orange mortar and dark grey silty clay loam. This layer appeared to be a weathered deposit representing a time when the foundation trenches were left exposed after removal of stones, so that rain and frost had diffused the edges. Lower down, the cut of the foundation trench is much clearer and orange mortar is the prime fill – but only for the bottom 5 cm depth.

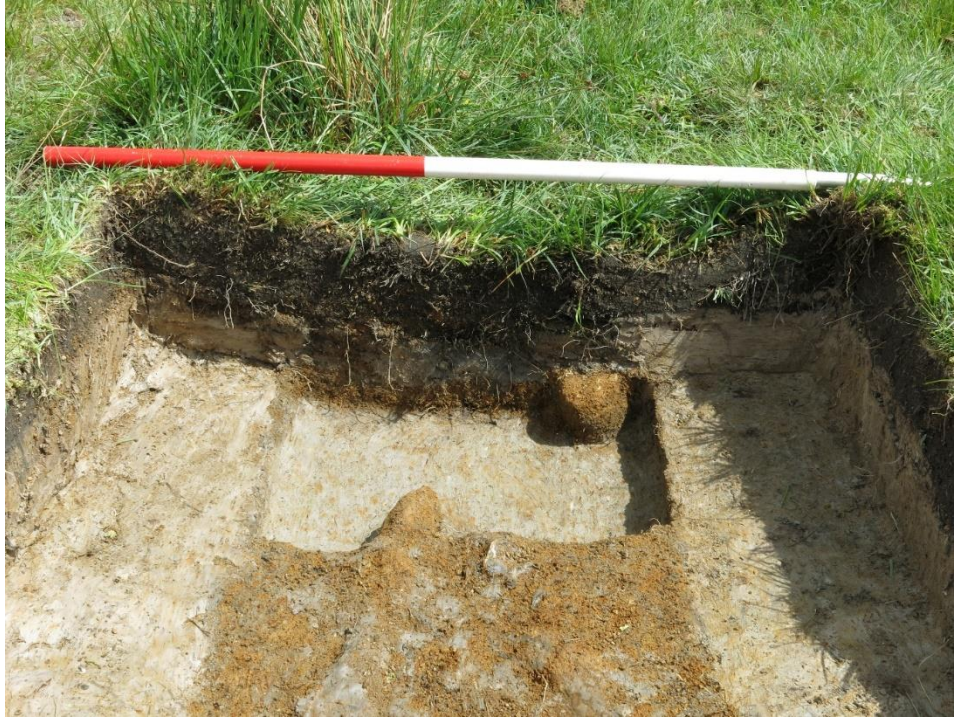
Section through the foundation trench at the east end of TP17

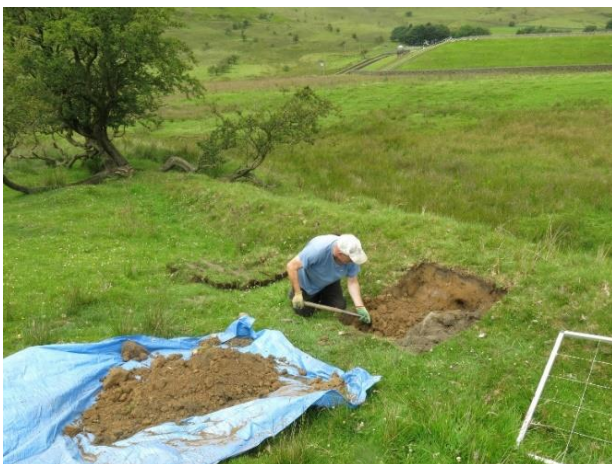
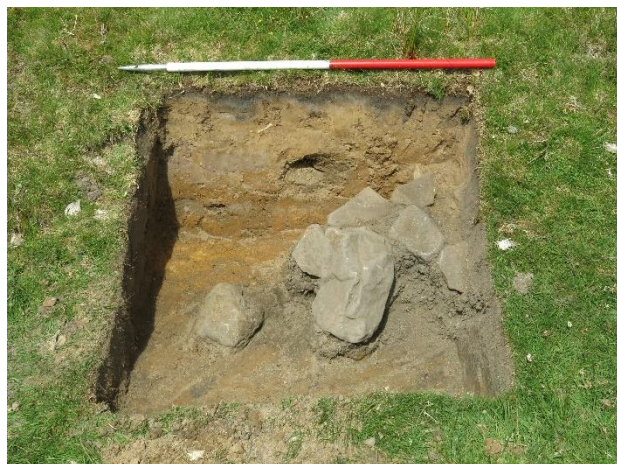
Mike excavating TP20 (left) and the stone revetment (right)

This was located against and partly over the earthwork bank just north of the central range and overlooking Waters Clough. It has been postulated that the bank is contemporary with the grange construction and formed part of a landscape management system for cattle ranching. The investigation hoped to learn more about the form of the bank and perhaps obtain some dating material. The initial 1 metre square test pit was lengthened to become a 5 x 1 metre trench running from the bank southwards to within 3 metres of the north west corner of the central range. A 0.5 metre wide section was cut through the southern side of the bank which was found to be made of sods of clay and turf, revetted with stones.

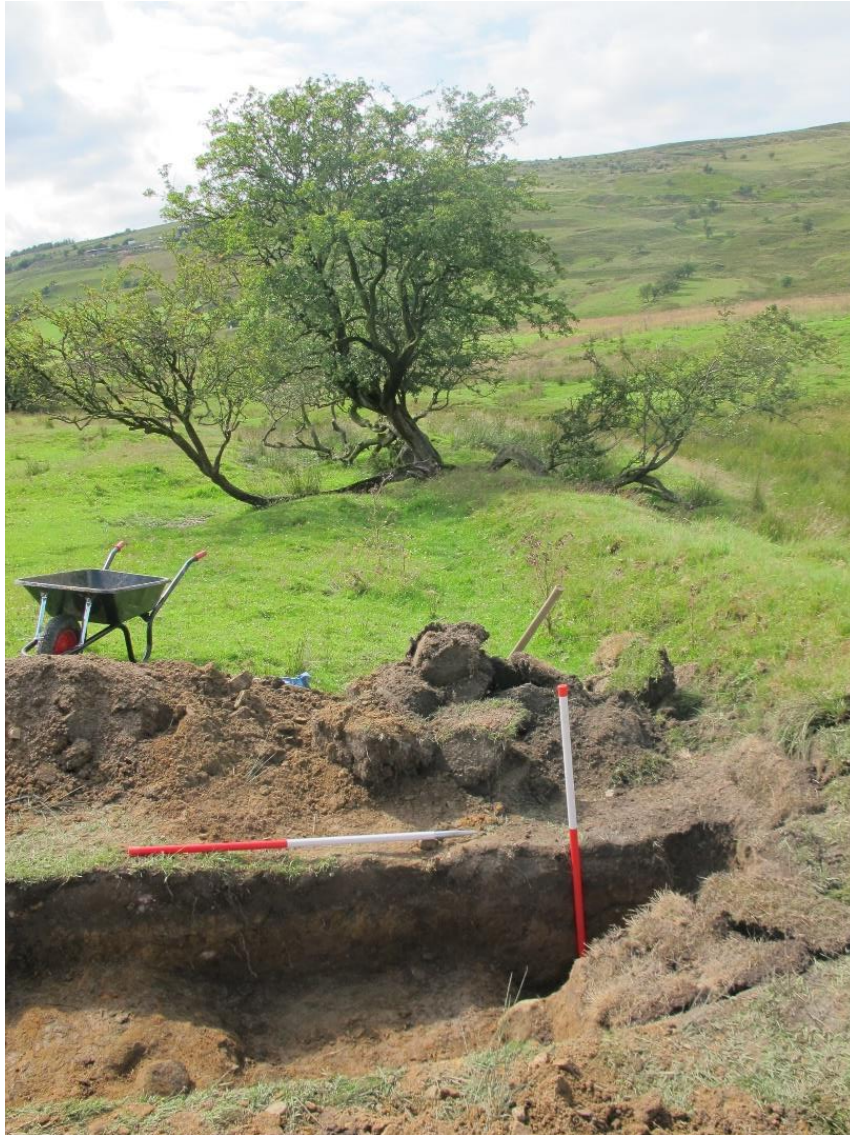
View west across TP20 showing its relationship to the earth bank on the right

When the test pit was extended a deep, cut feature filled with grey sandy silt was found on the inside of the bank. This correlates with the linear depression visible beside the bank. The turf layer above the ditch was at 224.81 m aOD and the base of the ditch 223.93 m aOD. The full profile of the ditch was not revealed due to time constraints. Under the turf and topsoil was a deposit of mixed material comprising mid-yellow clay loam and mid-grey silty clay loam varying from 10 to 15 cm in depth. This sealed the ditch fill but also overlay in the middle of the trench, c 2 metres south from the bank, a layer of weathered smooth stones, crushed orange sandstone and mid- to light grey sandy silt. The surface of this layer, which was not excavated, was very firm and smooth suggesting it is either the top of weathered natural or that it is a road or track. The surface was at 224.40 m aOD. No wheel ruts were visible and the feature was only partially exposed but this is an area that would repay further investigation. There were no finds in the ditch or bank make-up.

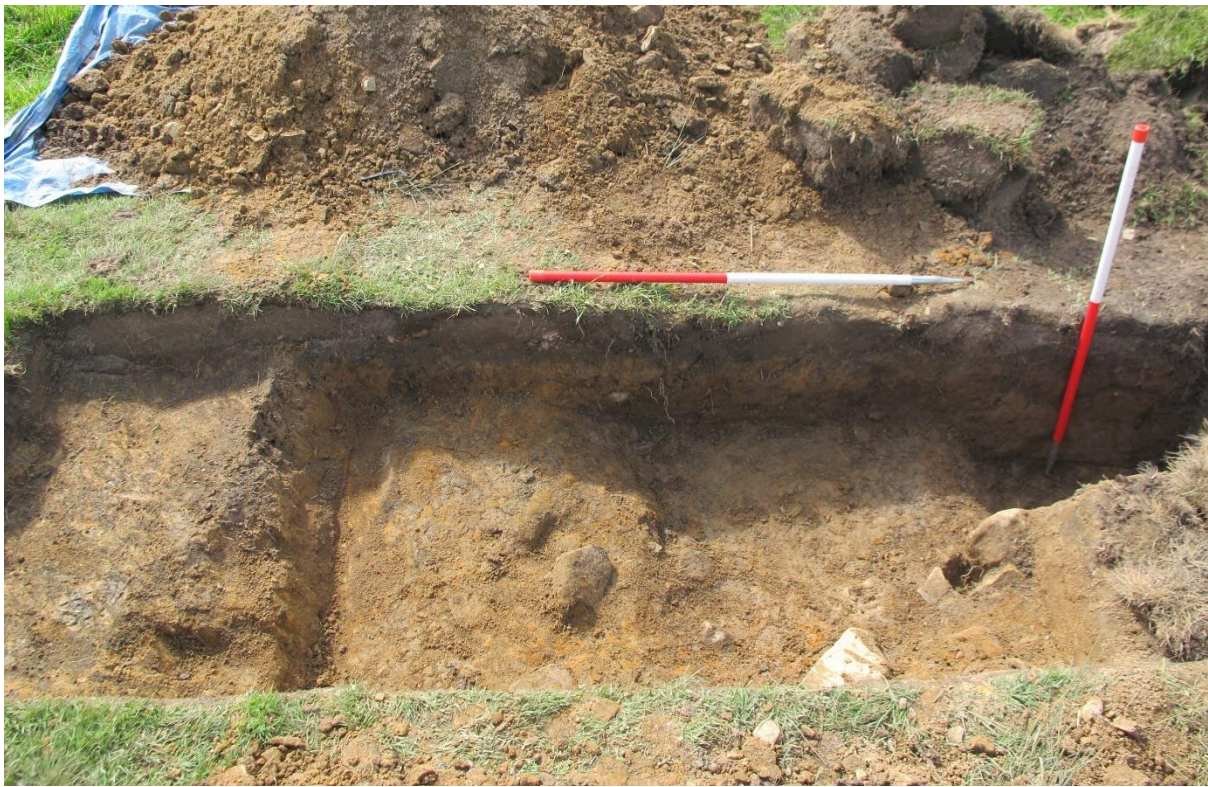
Looking at the extended trench for TP20 with the ditch on the right and the smooth, compact, weathered layer in the middle of the trench which was not fully exposed/excavated

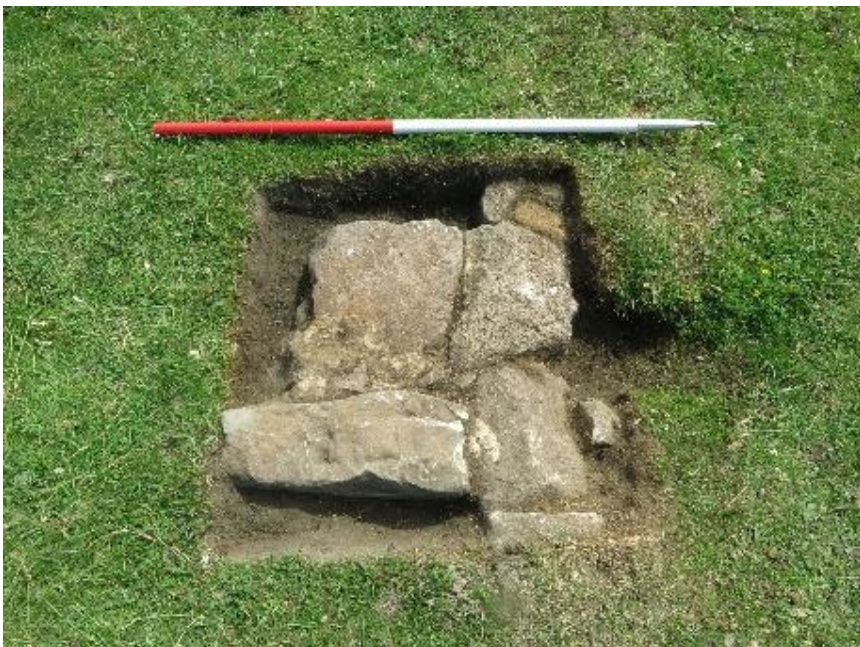
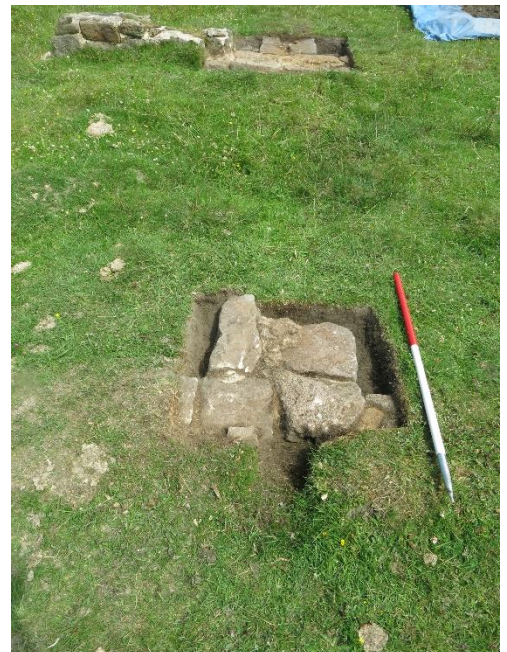
TP21 looking east (left) showing the two stones at the top belonging to the internal room wall and the lower stones forming part of the central corridor wall and, right, its relationship with TP14, seen in the background

This was excavated to examine the anticipated junction of the newly discovered internal wall in TP14 with the corridor wall in the north eastern wall of the central range. The top of the surviving wall foundation was just under the turf level at 225.25 m aOD.

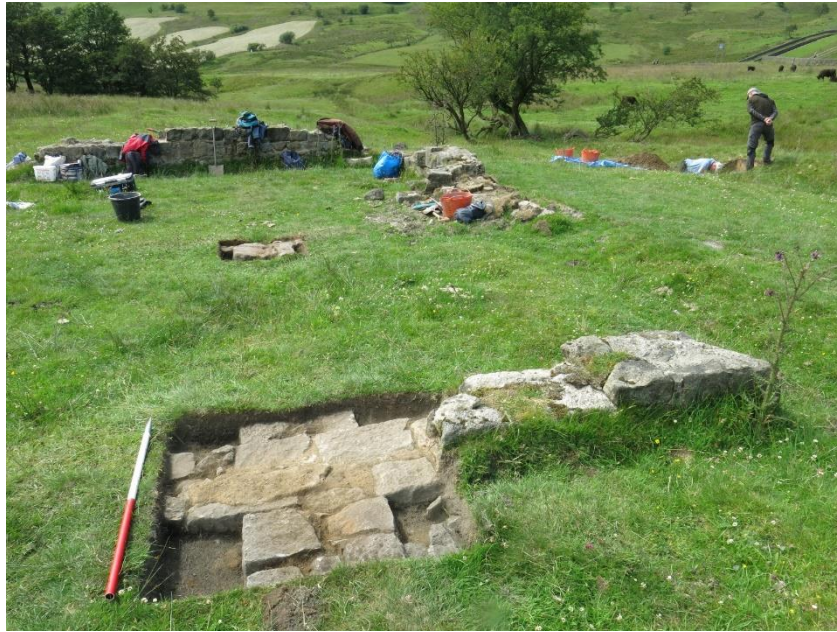
Looking west across TP14 in the foreground to TP21 in the middle left of the photo

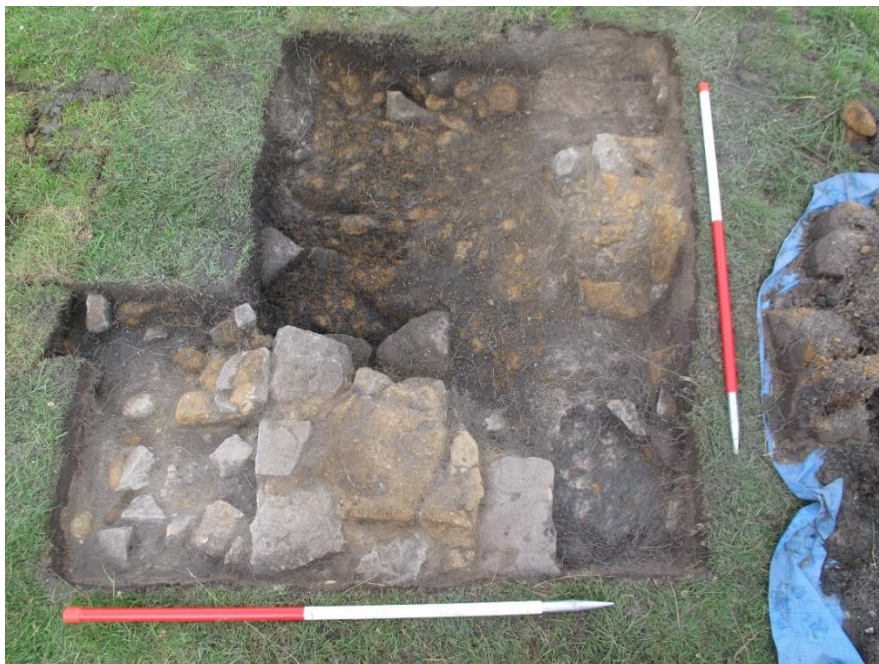
TP22 looking east showing spoil rubble deposit on far left, the well-preserved south wall in the foreground and the robbed-out junction area above

This was excavated to examine the junction of the internal dividing wall encountered in TP15 with the southern wall of the small rectangular chamber projecting from the north east corner of the central range. The wall at the junction was badly robbed out leaving predominantly orange mortar in the foundation trench, with some small gritstones. However, the southern wall of the structure to the east of the test pit was much better preserved. This may be due to the low mound of rubble spoil being next to it to the north. There was a deposit of mortar and stones opposite the junction, suggesting another wall running further south, but on closer investigation this turned out to be just rubble from the dismantling process as it overlay the natural white clay rather than being within a foundation trench. The top of the extant wall was at 225.46 m aOD and the top of the orange mortar within the robbed-out part of the foundation trench at 225.30 m aOD.

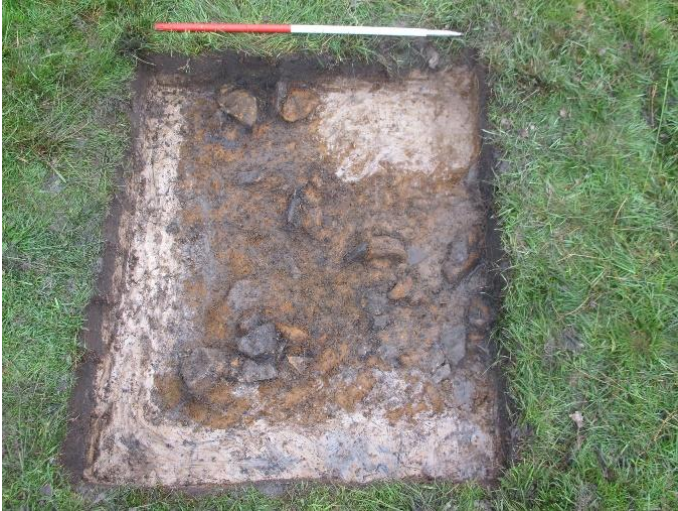
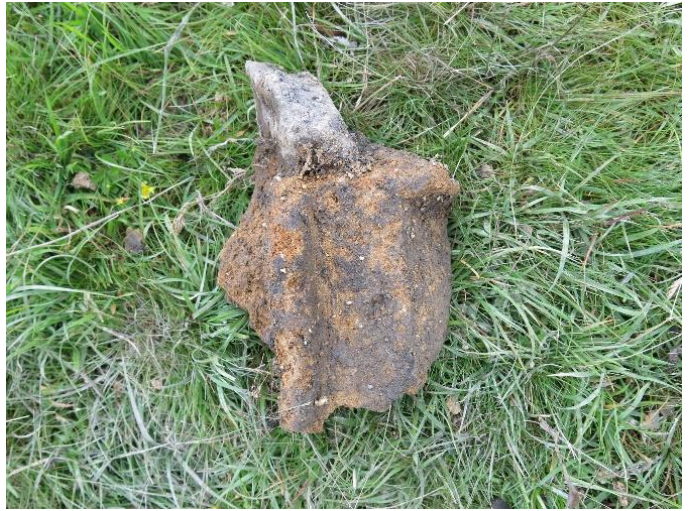
TP23 looking east (left) and the piece of stone-impressed mortar (right)

This test pit looked for the north west corner of the bank of three rooms partly revealed by investigations in 2018. The corner was clearly revealed in TP23, with the foundation trench cut through white clay natural. There were no stone blocks in situ but a large piece of orange mortar preserved the impression of the stone block it had adhered to, further evidence that the mortar had been knocked off when reclaiming the stonework. The foundation trenches were full of orange mortar lumps mixed with smaller gritstones that had not been worthy of recycling, with the top level of this material being 225.33 m aOD. There was no evidence for a wall line going north towards the projecting chamber at the north east corner of the central range, confirming the evidence seen in TPs 10,11 and 13.

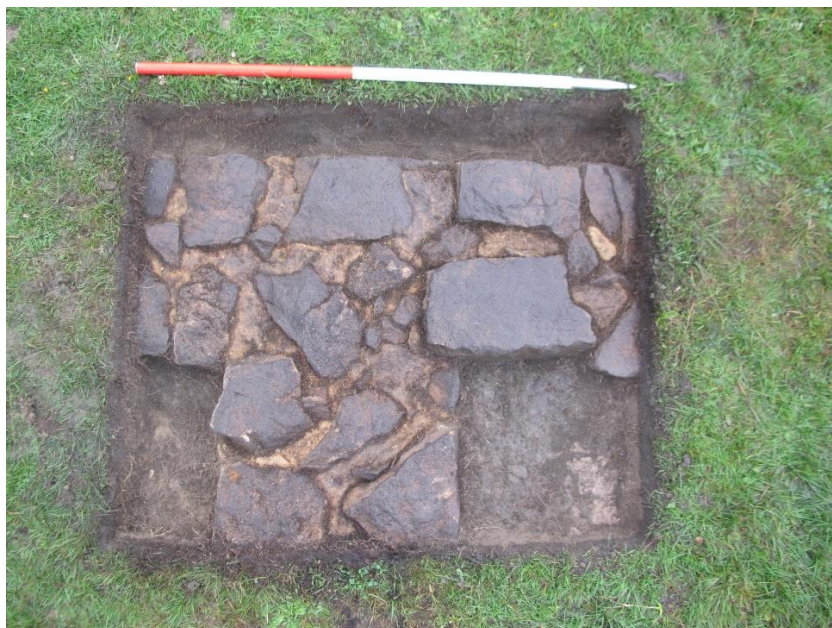
TP24 looking east (left) showing the the room dividing wall keyed in with the corridor wall (top half of test pit)

This was located to see if the newly discovered room found through TPs 14 and 21 on the east side of the corridor was replicated on the west side. Again, the wall foundation surface was immediately below the turf. It was soon apparent that there was indeed a similar sized room on this side of the corridor. A wall foundation was keyed in with the west wall of the corridor and could be seen heading west towards the highest wall of the ruin. At the point of connection with the ruined wall, which forms the west side of the central range, stonework projected slightly where this internal wall had been keyed in. The dividing wall top surface was at 225.06 m aOD.

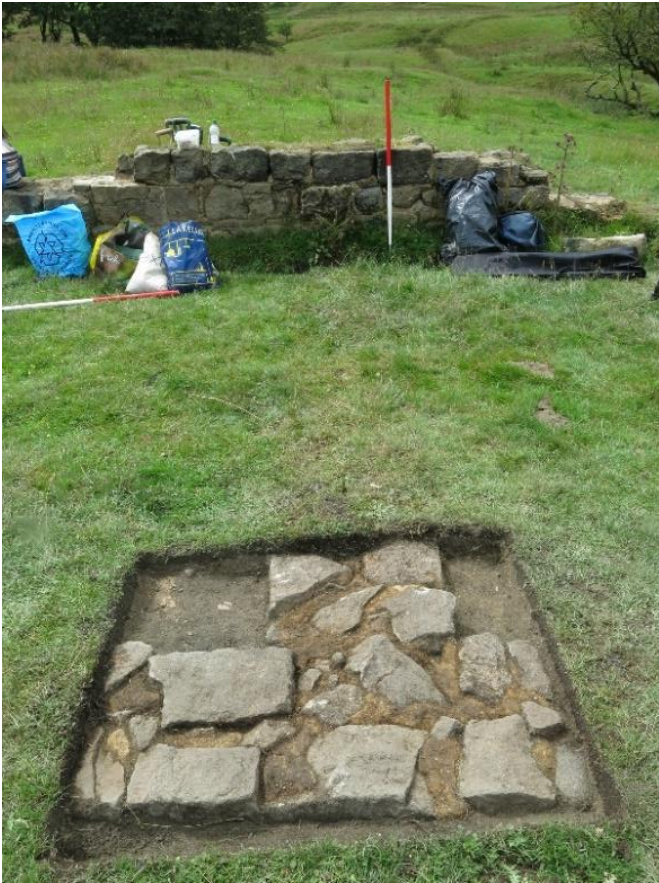
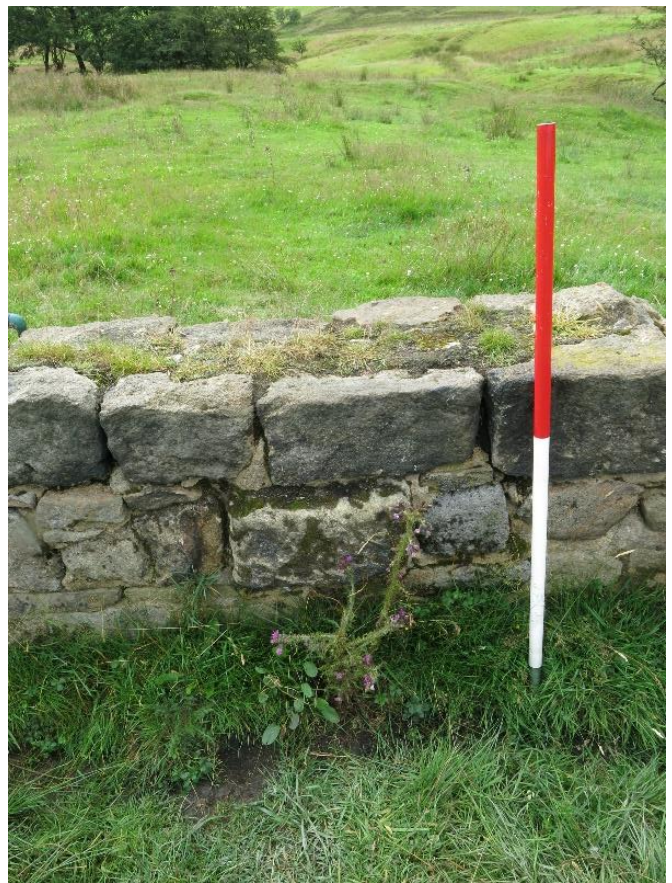
Looking west across TP24 to the upstanding ruined wall of the west side of the central range, with the detail of the slightly projecting wall joint to the left of the photo scale (right)

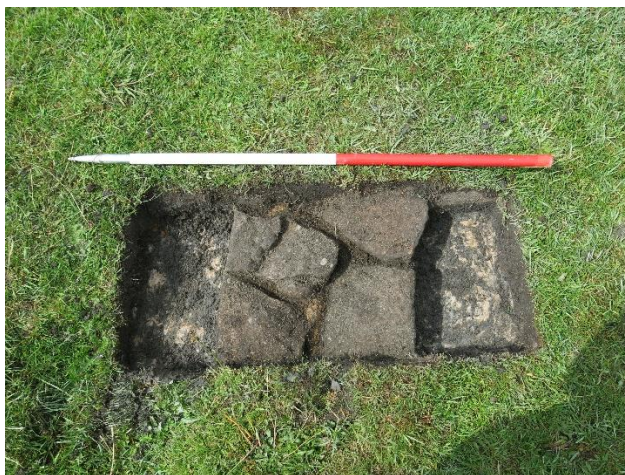
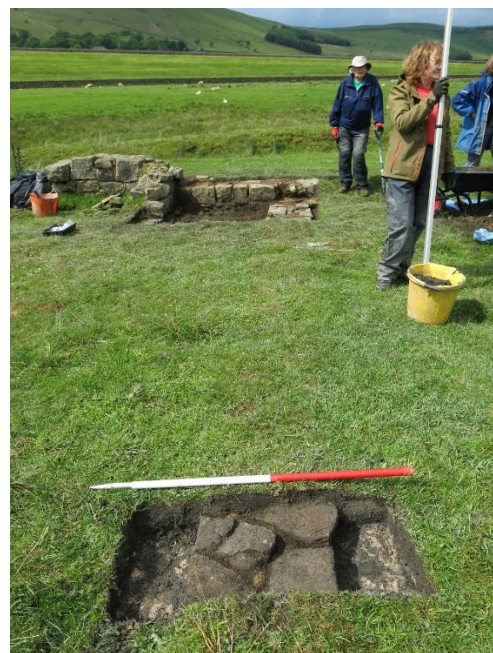
TP25 looking north (left) and seen in context (right) with the east side of the corridor visible against the north wall beside the far figure

This test pit confirmed the line of the eastern wall of the south to north internal corridor within the central range. It was located 8 metres south of the north wall of central range and had been intended to check for an internal wall junction but was slightly too far south for this. Given the shallow nature of the wall foundations that were revealed it will be simple matter of revisiting this site during the next season to confirm the presence of an internal room division, as has previously been shown on the opposite side of the corridor. The wall top was at 225.06 m aOD.

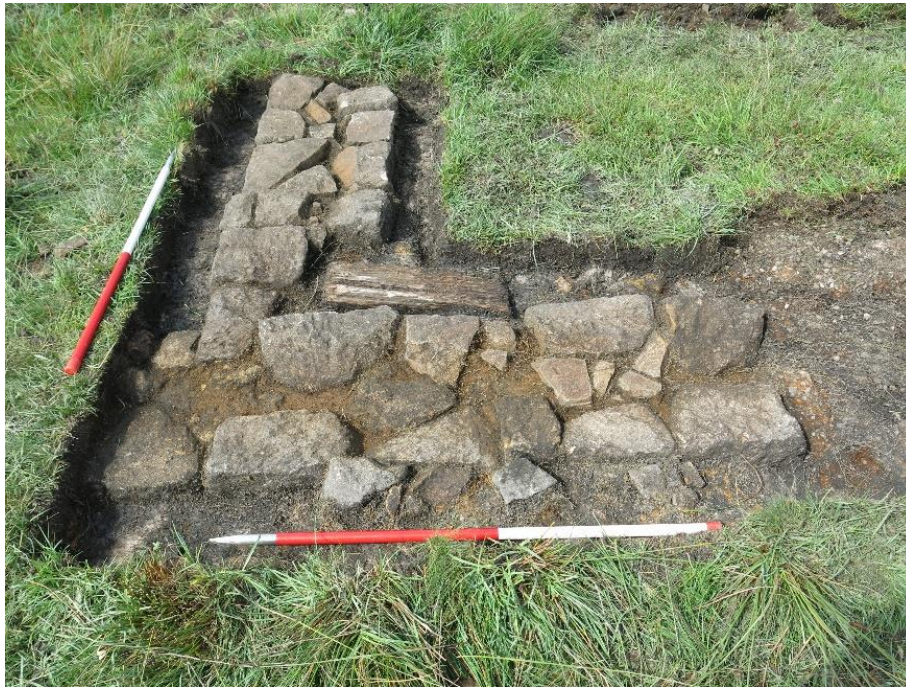
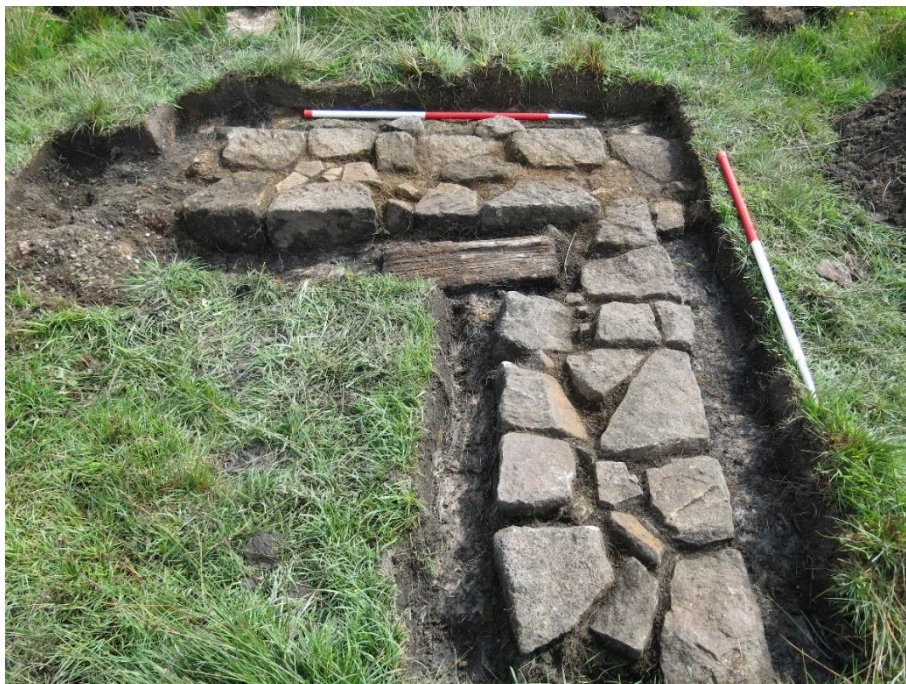
TP27 looking north, with the southern wall of the west range in the foreground and the corridor west wall above to the left, whilst the photo below is viewed from the opposite direction and shows the disturbance to the inner corner and to the wall on the left side where there is a spread of concrete

Having established in TP9 that the south to north corridor ran in to the southern part of the central range, it was decided to investigate its relationship with the southern wall of the range to see if it was similar to that in TP7 or if there was evidence for an entrance way. Well-preserved stone foundations existed immediately below the turf in TP27 which focused on the west side of the corridor as it joined with the southern wall. The test pit was extended to reveal 1.5 metre lengths of both wall foundations. The outer stone of the corridor wall was keyed in with the southern wall, but the inner corner had been disturbed by more recent activity with a wooden timber occupying the space. There was no indication of a door setting so, as with TP7, it suggests that the corridor had no entrance at this point. The top of the wall was at 225.08 m OD. The opposite side of the corridor where it meets the southern wall had been disturbed in the 20th century. The stones and foundation trench had been removed and a spread of concrete was visible

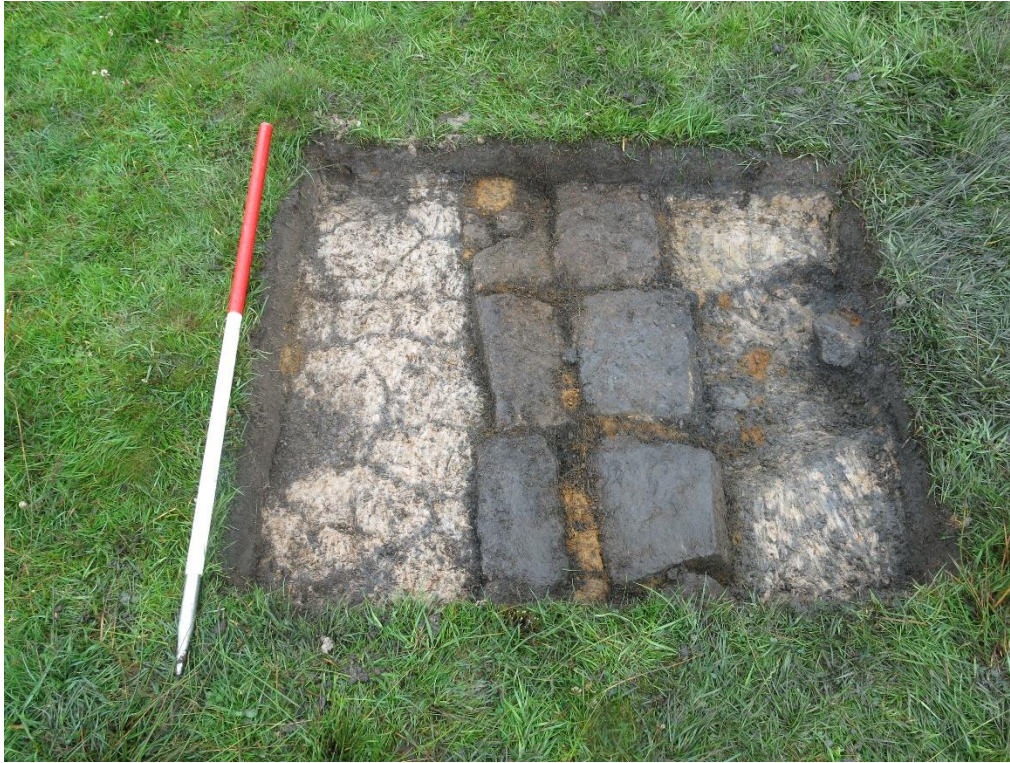
TP28 looking north with possible linear feature to right of the wall

This was excavated 2 metres south of TP9 to confirm the character and continuation of the east wall of the south to north corridor. The foundations stonework survived well and was consistent with that seen in TP9. This wall appears to be less well constructed and slightly narrower than other walls, being 40 cm wide rather than the usual 50 cm. A possible foundation trench offshoot was identified on the east side but was found on excavation to be very shallow and not convincing as a wall foundation but might relate to a slot for a wooden room division.

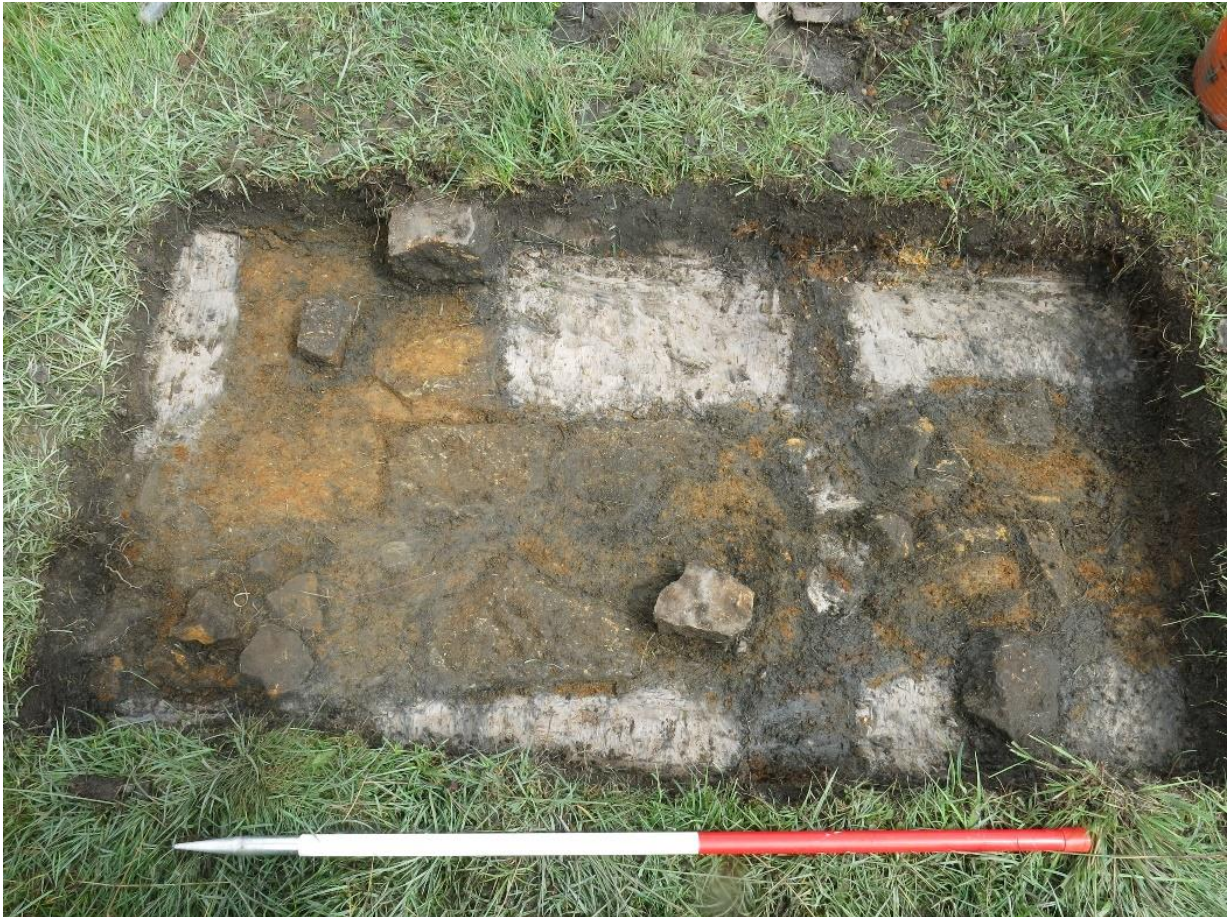
TP29 looking east, with corridor wall running left to right and with the room division wall top left and possible internal slots for wooden partitions either side of the corridor wall

This was located over the line of the eastern side of the south to north corridor in the southern part of the central range. Excavation confirmed the line of the corridor wall with the base level of foundation stones partly surviving under the orange mortar and with some small gritstones also seen in the upper fill of the foundation trench. These were of the usual standard of build and better quality than further north in TP28. Of particular interest was the discovery of the internal room division wall foundation running east from the corridor wall which means that the south east part of the central range was divided into the two unequal sized rooms with dimensions as follows: south rooms = 2.2 x 3.4 metres, north rooms = 3.4 x 3.4 metres. The wall foundation trenches were cut into natural white clay. Interestingly, there appeared to be a narrow linear cut running east from the corridor wall, about 40 cm south of the room division. This was not excavated but could represent a slot for a wooden partition. Another grey silt linear feature occurred on the opposite side of the wall, within the corridor. These require further investigation to fully expose their extent and sample excavate. The wall surface was at 225.02 m aOD.
