Archaeological Excavation of the possible monastic grange building at Water's Clough, Castleshaw, Saddleworth

2019

Report written by Norman Redhead
for the Friends of Castleshaw Roman Forts

June 2020

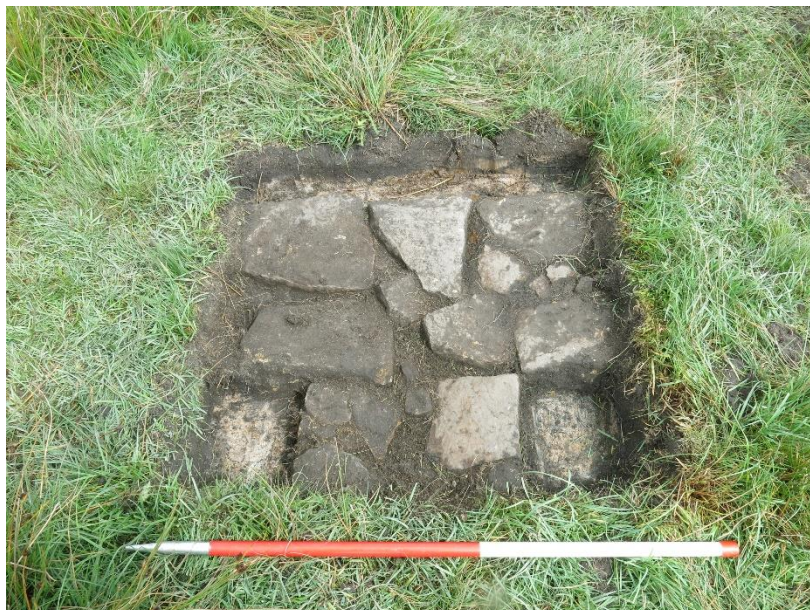
TP30 looking east showing the internal room wall in the foreground, with the western corridor wall running left to right behind

This was positioned across the wall line of the west side of the corridor opposite TP29. It was only 1 metre square but was wide enough to show there was an internal room division on this side of the corridor as well, reflecting the arrangement on the east side. The top of the wall was at 225.03 m aOD.

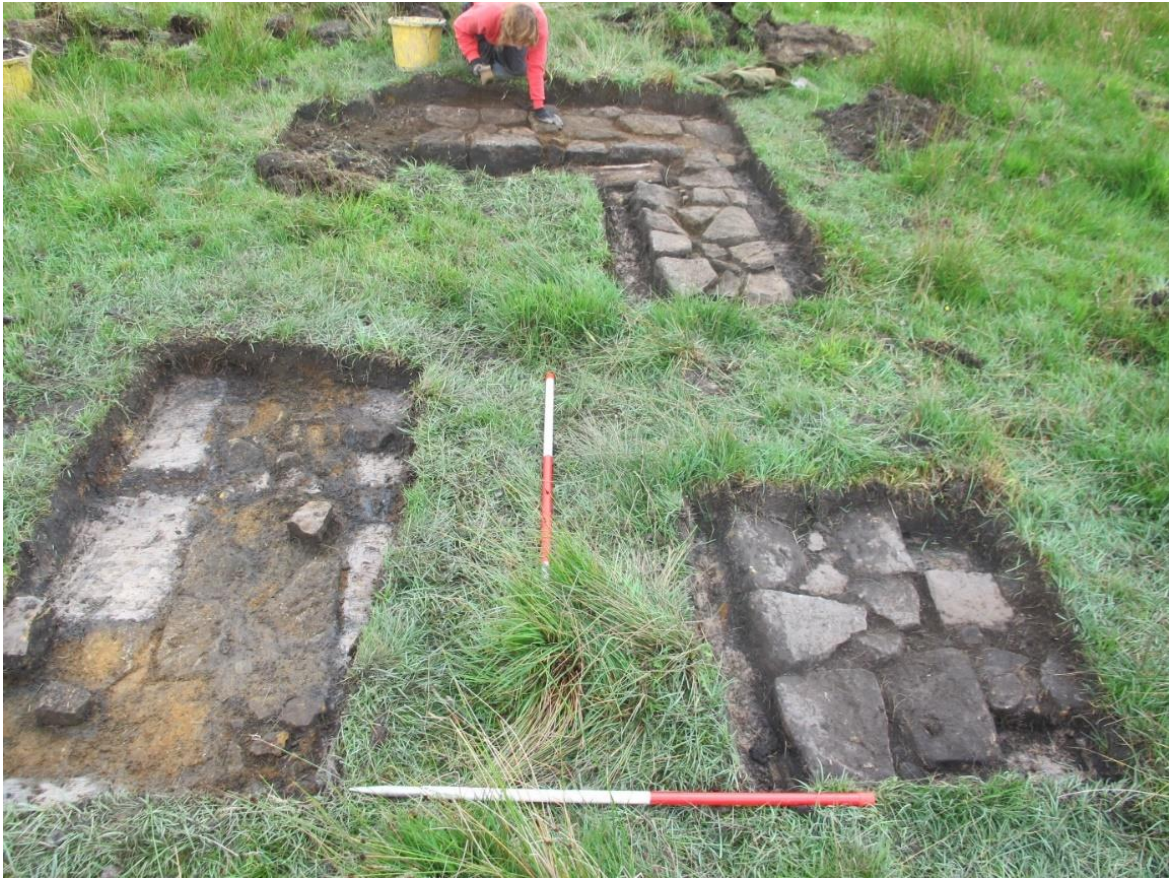
Looking south along the corridor towards its junction with the central range south wall, with TP29 left, TP30 right and TP27 at the top of the photo

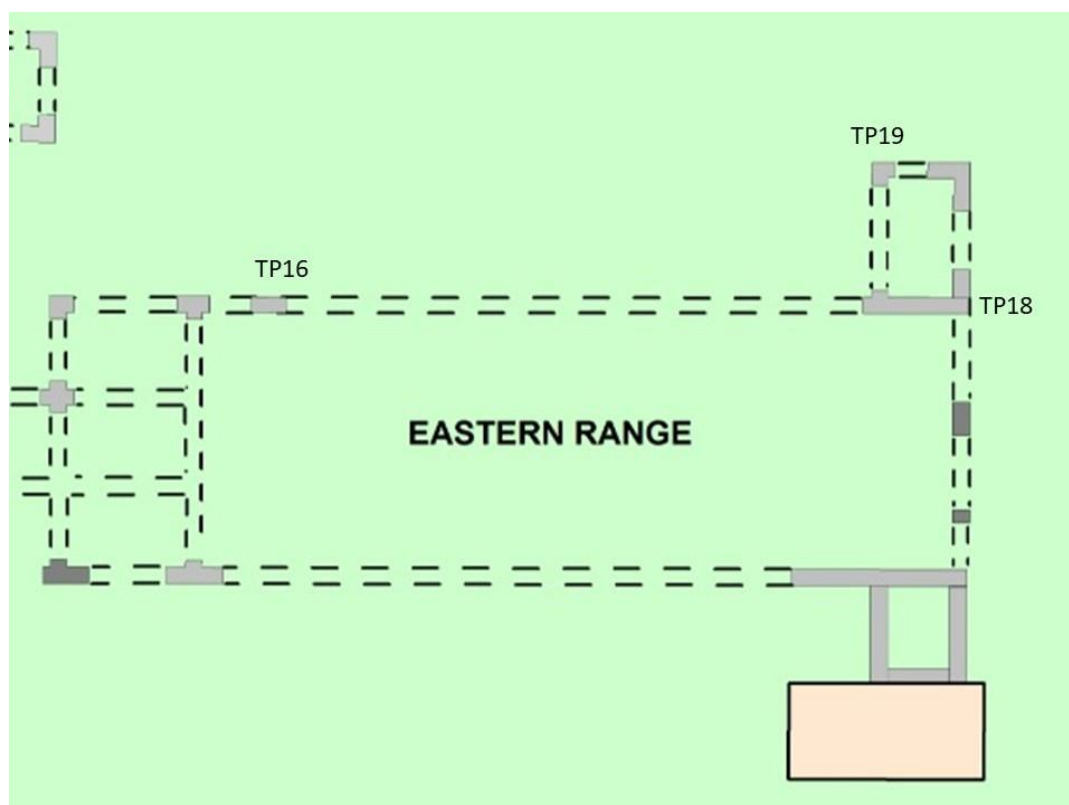
Plan of east range showing location of excavated test pits in 2019 (unlabelled trenches are previous year's investigations)

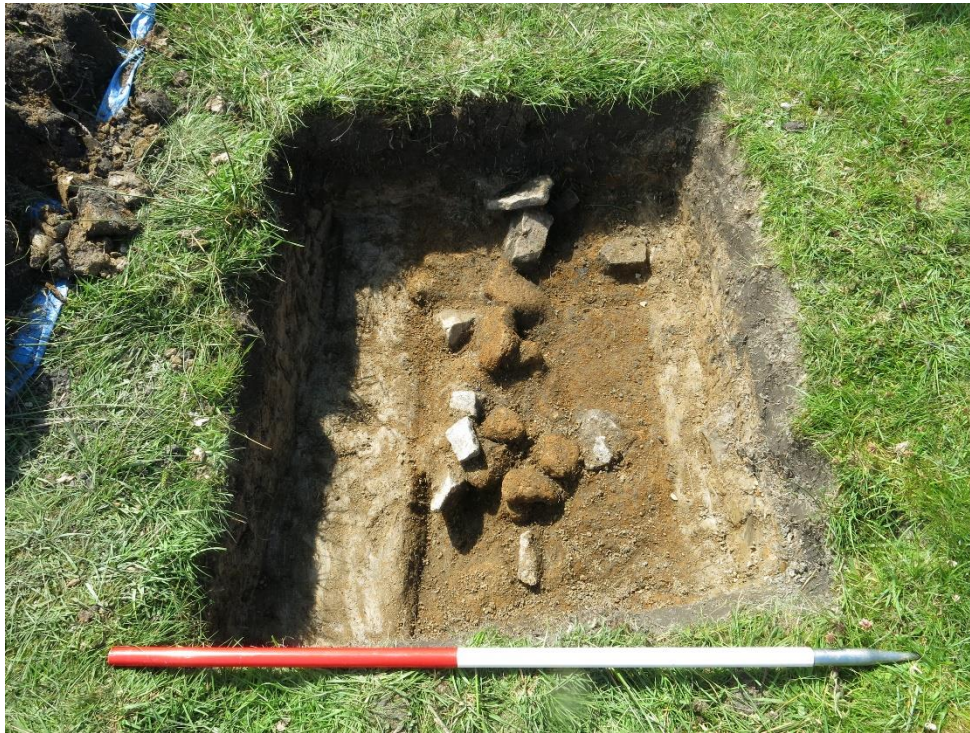
TP16 looking east

This exposed a 1 metre length of the northern wall of the eastern range towards its west end. The wall foundation was shown to be cut into natural white clay and its fill comprised dark orange mortar with some lumps of the mortar on the surface interspersed with small gritstones. No stone blocks survived in situ. The top of the trench fill was at 225.55 m aOD.

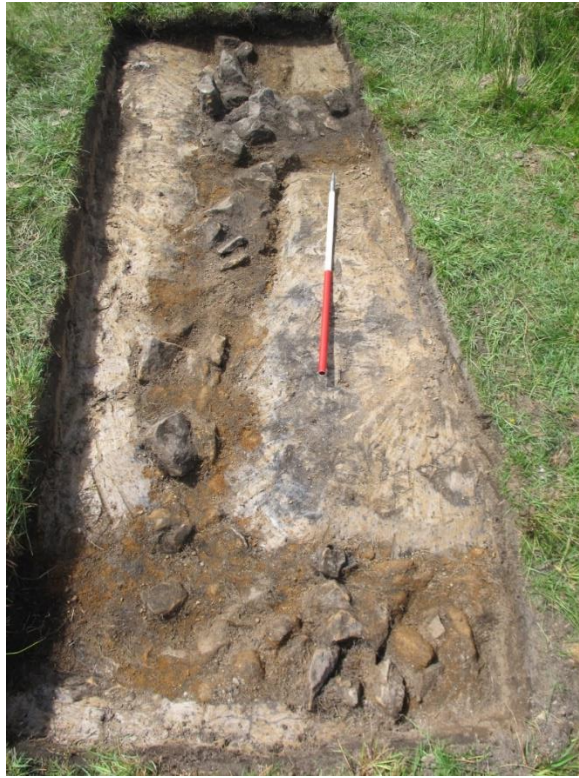
TP18 looking west, with the photo scale within the projecting chamber and the north wall of the eastern grange to the right of the scale and the eastern wall in the foreground

This test pit initially re-exposed the south west corner of the projecting chamber, where it was known to join the north wall of the eastern range based on TP15 excavated in 2018. The wall foundations were at a shallow depth, cut into the natural light yellow-white clay. Stone blocks had been totally removed with discarded small to medium gritstones left in the top of the fill along with the ubiquitous orange mortar. The test pit was then extended to follow the north wall to the opposite corner of the projecting chamber, where the wall joined with eastern gable wall of the grange structure. The fill and character of the remains continued right along this length of the wall and for the short c 1 metre length of east wall foundation trench that was exposed. It was possible to calculate the width of the projecting chamber as 1.8 metres. The top of the fill at the south west corner was at 226.28 m aOD and the south east corner at 226.53 m aOD.

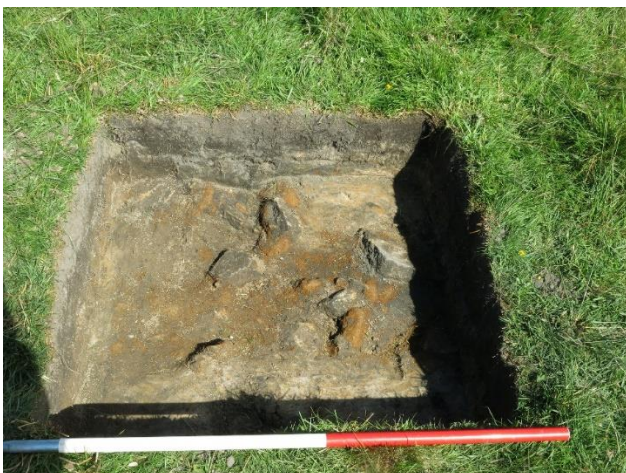
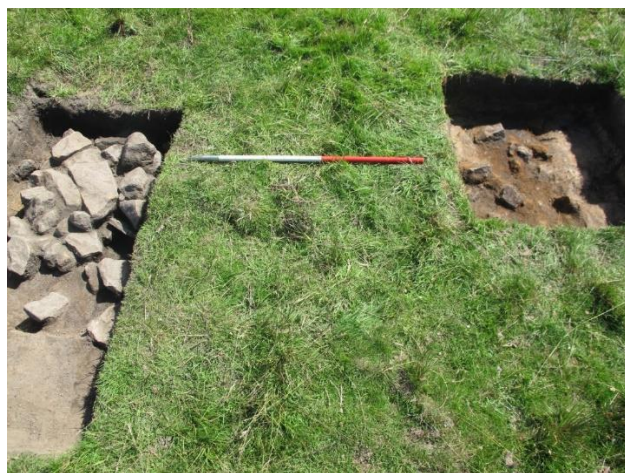
TP19 looking east showing the corner of the projecting chamber (left) whilst the right photo shows the north east corner under the dump of stones (on the left) in relation to TP19 (on the right)

This was one metre square test pit located over the north west corner of the projecting chamber. Its character and fill were the same as for TP18. The top of the fill had a level of 226.56 m aOD. The north east corner was also re-exposed – it had been first explored in 2017 (test pit M) and was characterised by the wall foundation being overlain by a dump of stones which appears to have been collected for carting away and then abandoned. We now had all 4 corners of the north east projecting chamber exposed and were able to calculate that the internal dimensions are 2.9 x 1.8 metres. This gives the same length as the opposite chamber in the north west corner, but being slightly wider; however, the stone wall had been removed and the foundation trench was not well defined so some caution must be exercised over the precise dimensions and it is quite likely that the widths were identical. Nonetheless it is curious that the 2 northern projecting chambers are 0.5 metres longer than their southern counterparts. The north east projecting chamber was the most poorly preserved of the 4.

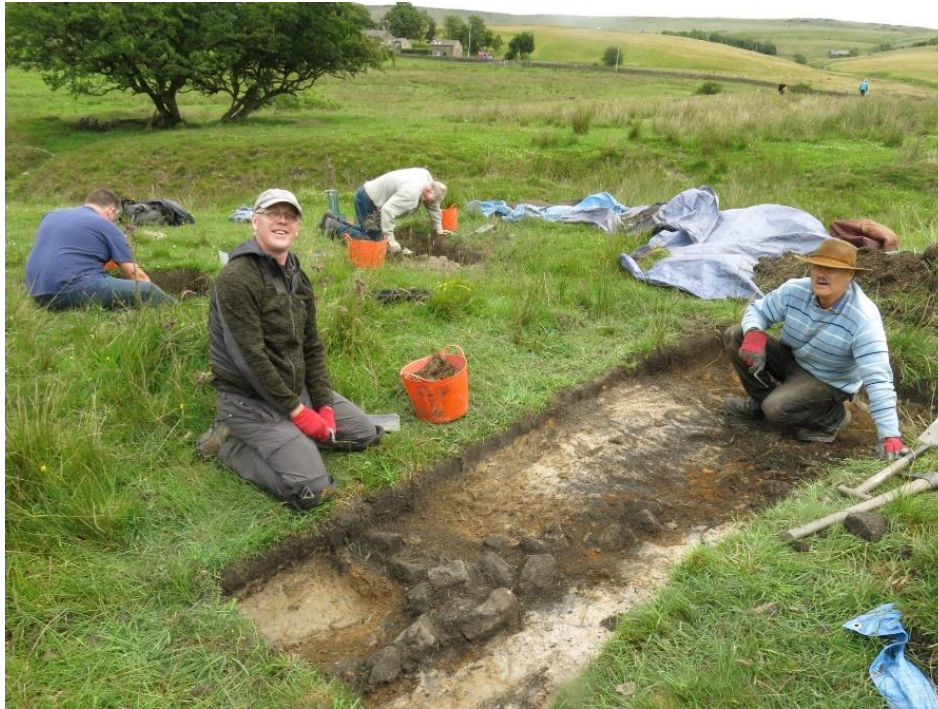
All four corners of the north east projecting chamber are visible here: Mark is by the south west corner (near left), Steve is on the south east corner to the right, Cliff works on the north west corner behind Mark (background left side), and Alan cleans the rubble dump in the north east corner to the rear

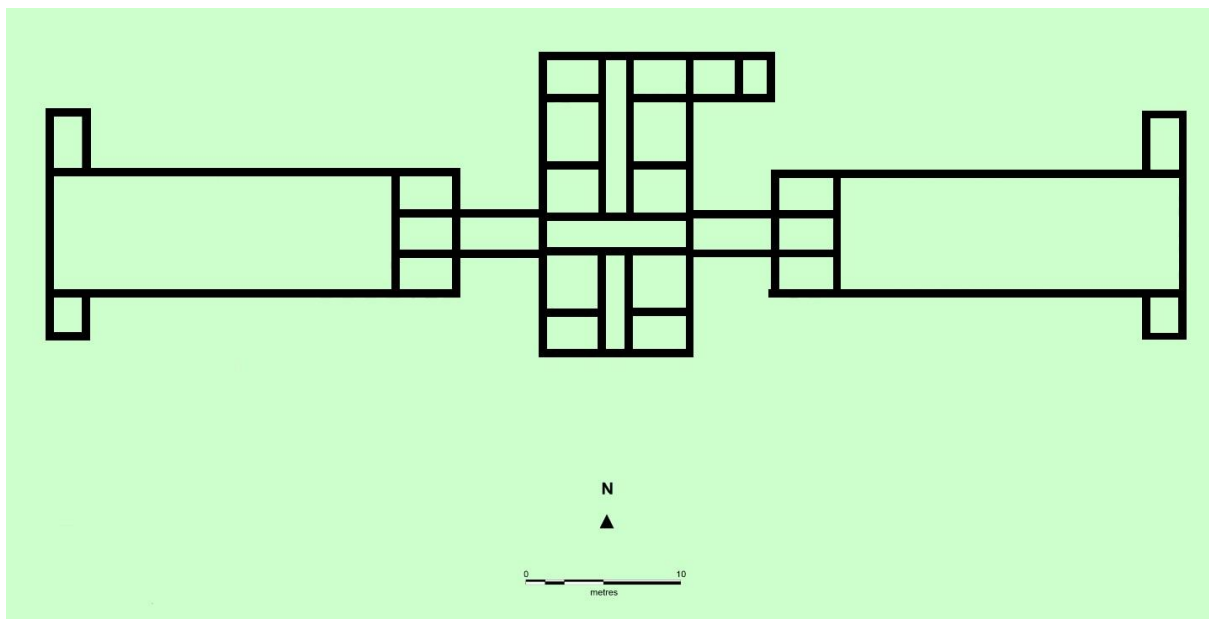
Interpretive plan of the grange building, based on test pits and trenches 2016-19

A remarkable aspect of the remains is the consistency of build for the stone foundations, and this includes the projecting rooms. The whole structure appears to have been laid out and constructed in one phase.

Whether it was ever finished is another matter; the absence of roof and floor tiles, dressed door surrounds or window tracery, along with domestic debris, strongly suggests it was abandoned before completion. Extensive reclamation of the building materials for use elsewhere means that it is very difficult to interpret the intended height of the building or the range of materials used in its construction. Was it designed to be half timbered with a thatch roof or was it a single storey stone walled structure? Could the wall foundations have supported a two-storey building? Comparative research is at an early stage but may shed light on the intended height and character of construction based on other Cistercian grange complexes but, as pointed out in last year's report, the Castleshaw grange structure appears to be unique in its scale and plan form.
