Archaeological Evaluation of the possible monastic grange site at Waters Clough, Castleshaw, Saddleworth

2022

Report written by Norman Redhead
for the Friends of Castleshaw Roman Forts

March 2023

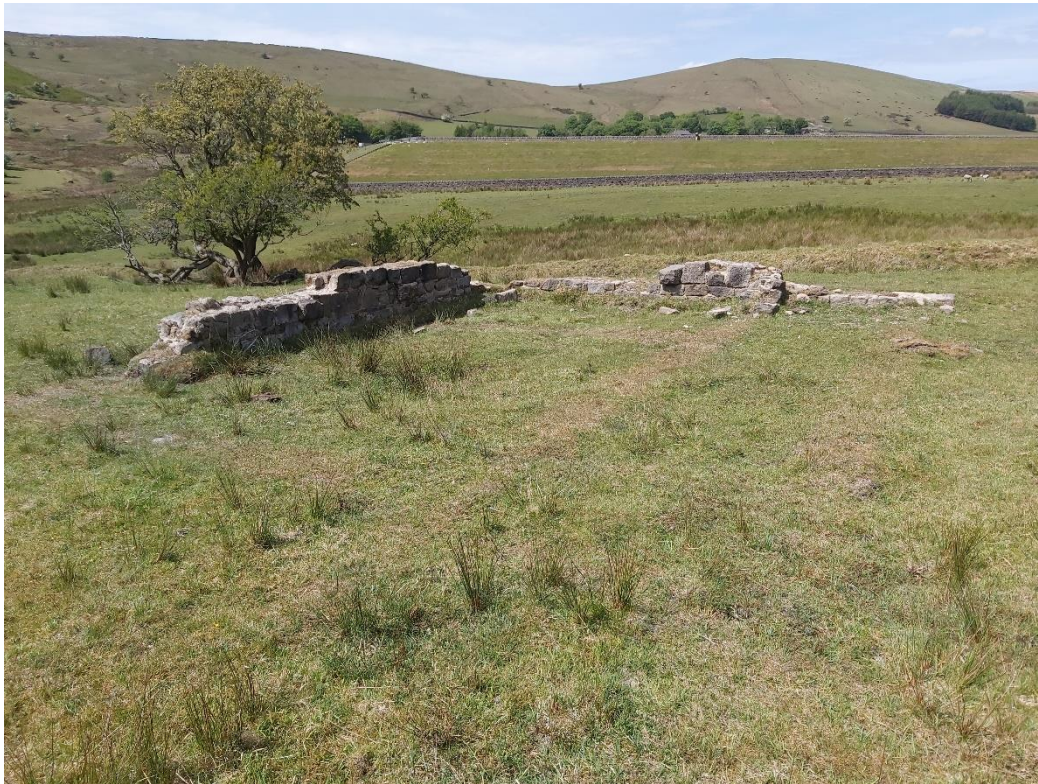
The ruin beside Waters Clough – parch marks during a dry spell indicate wall lines within the central range

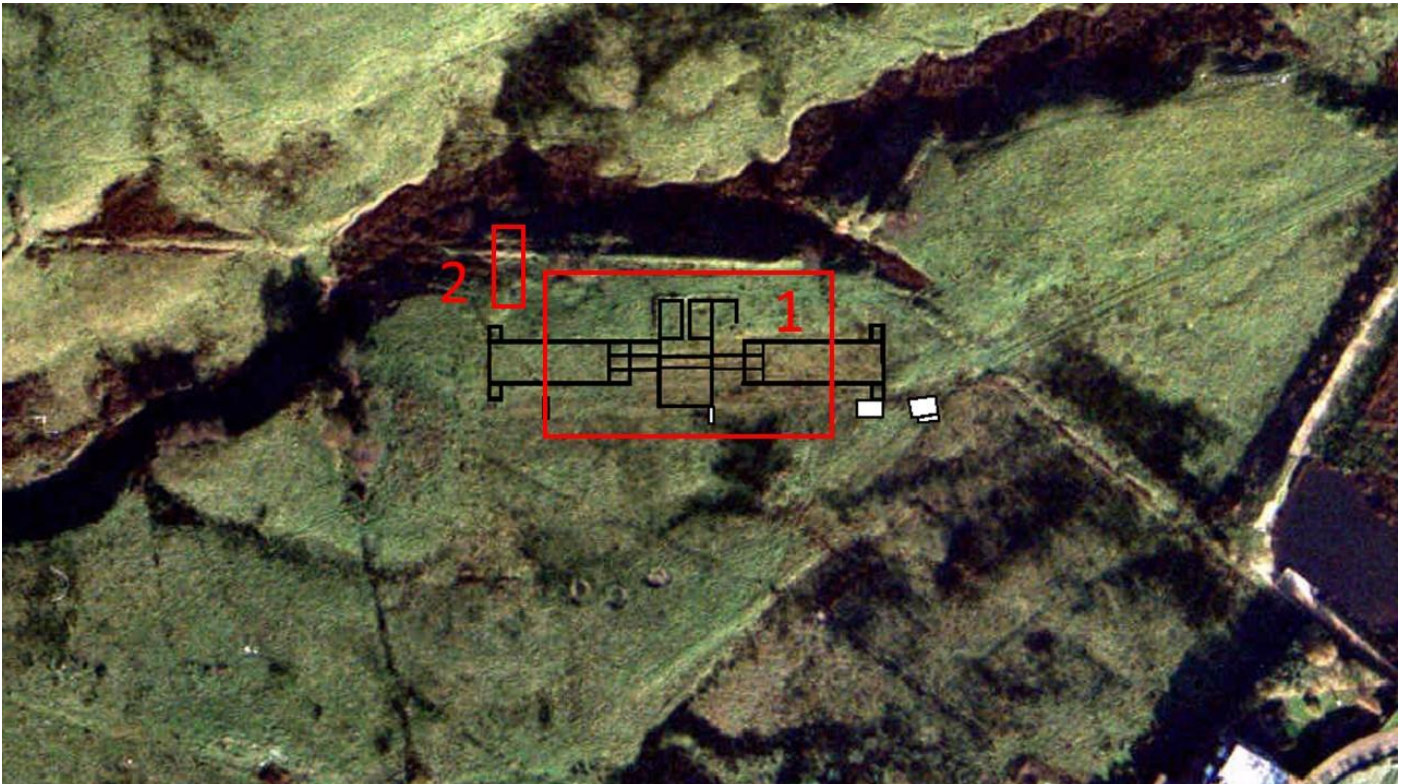
This aerial photo shows the wall lines of the grange in black, with area 1 edged in red being the focus of the 2022 investigations along with a section of bank in area 2.

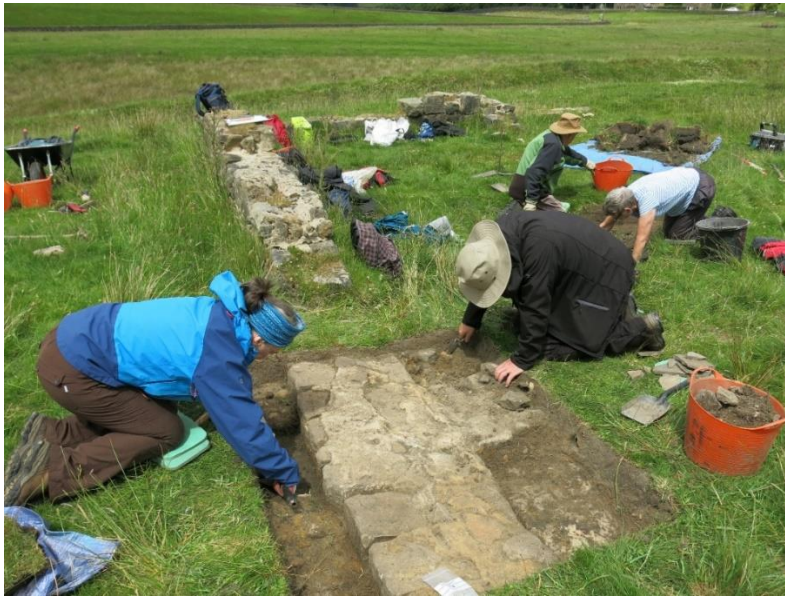
Excavating Test Pit 1 on western wall of the central range.

This was excavated to confirm the south wall line of an internal room within the north western part of the central range. The test pit measured 1 x 1.25 metres and straddled the central range's western wall. It was able to confirm the junction of the room's south wall with the west wall of the range, and showed that there was no wall on the exterior of the building at this point. The west wall of the grange continued southwards from a visible section of upstanding wall and it could be seen, prior to excavation, that the stonework lay just under the turf. The wall foundation was well-preserved and its surface was largely bound with yellow-orange, gritty mortar the same as used across all the grange walls. It had a width of 50 cm and comprised medium sandstones which were dressed to give a relatively straight, neat external face, with a thin rubble core. Again, this was consistent with that encountered across all the grange walls. The return wall for the internal room was of similar construction but appeared to be slightly narrower at 45 cm. The wall foundation was cut in to natural white/cream coloured clay as found elsewhere. Against the exterior of the west wall were deposits of the yellow-orange mortar – almost certainly derived from the construction or demolition of the wall. The top of the wall was at 225.06 m AOD (Above Ordnance Datum) and the clay at 225.00 m AOD.

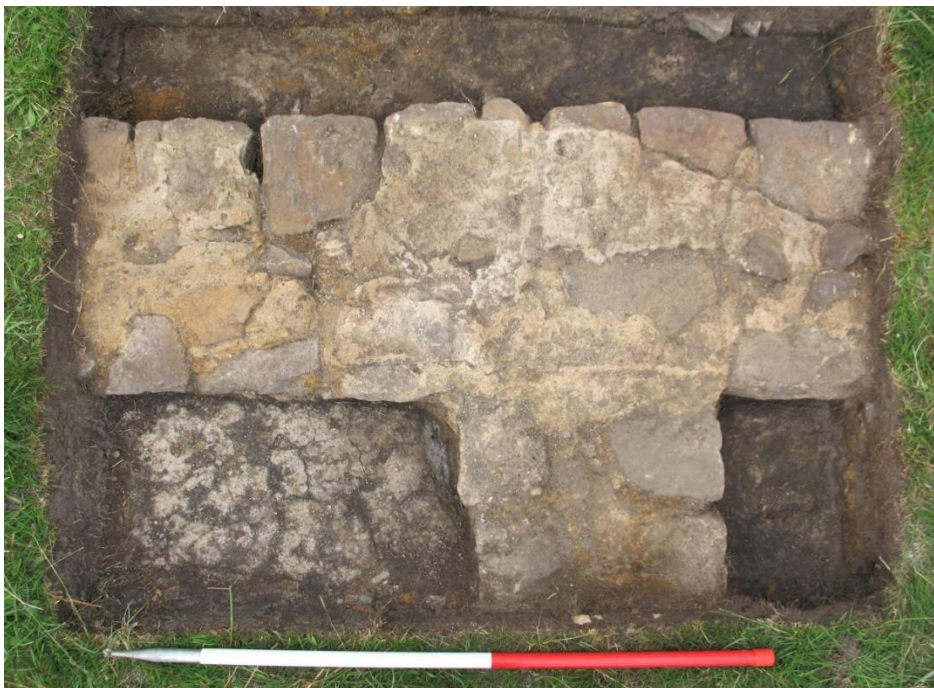
Overhead view of the west wall in Test Pit 1, running left to right, with the internal wall running eastwards from it (below).

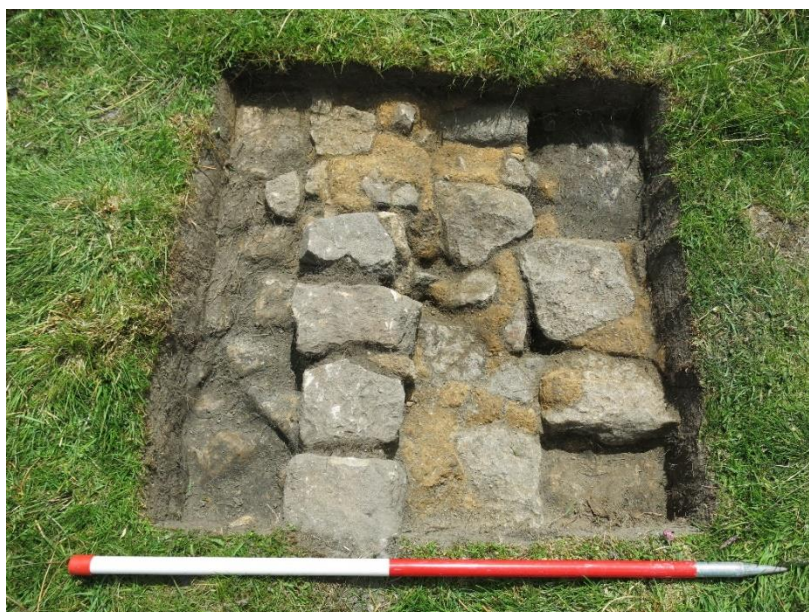
Test Pit 2 looking south, with the western side of the corridor wall on the left and the south wall of an interior room on the right.

This test pit was 1 metre square and aimed at confirming the junction of the western wall of the north to south corridor in the central range with the south wall of the room as identified in TP 1. The corridor wall foundation was quite well-preserved, made up the usual medium-sized flat grit stones bound in the yellow-orange mortar and. It was 45 cm wide and the top height was 225.27 m AOD. Running westwards and butting against it was a wall of similar character, but a little narrower at 40 cm wide. The top of the wall height was a little lower at 223.11 m AOD.

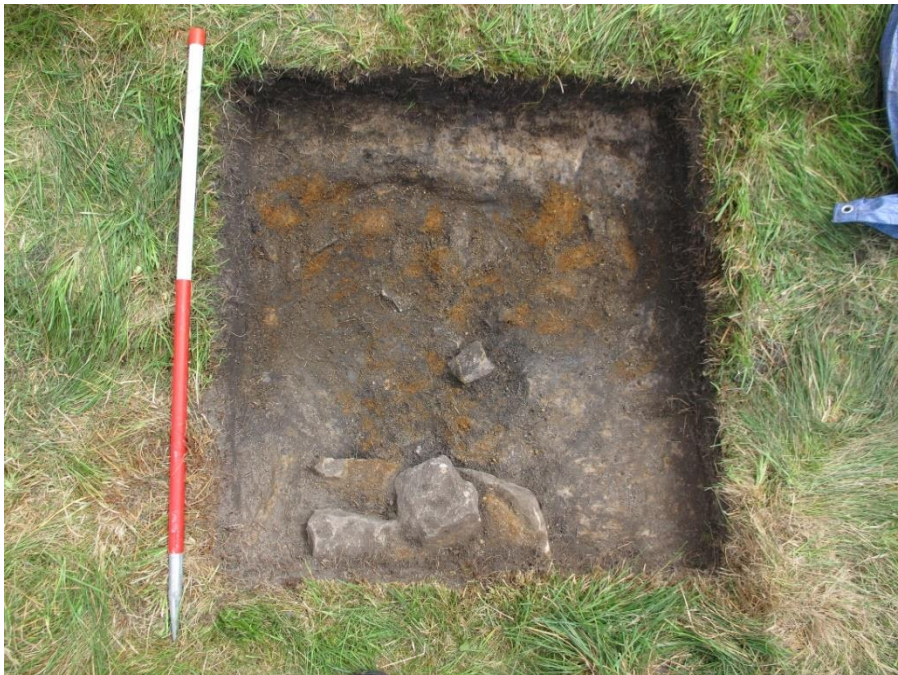
Test Pit 3 looking south showing the remnants of the north to south corridor wall at bottom of the photo and the junction with the east to west corridor wall running right to left in the upper half of the photo.

This was located to confirm the assumed continuation of the west wall of the north to south corridor of the central range to meet with the east to west corridor wall. Excavation of the 1 metre square test pit showed that this was indeed the case. The walls' survival was patchy. The north to south corridor wall survived as a stone foundation for about 30 cm length running into the northern half of the test pit but then died away to leave just the foundation slot with its dark yellow-orange bedding mortar and dark grey silt fill. This continued to the junction with the east to west corridor wall foundation trench which had also suffered the 'robbing' out (removal) of its stones. It was interesting to note that the north to south corridor wall was 'subservient' to the east to west corridor wall, the former butting up to the latter and white clay beyond showing that the north to south wall did not continue on the other side. There must have been a doorway giving on to the east to west corridor, but the archaeology is too truncated to leave any trace of this. The top of the surviving section of wall was at 225.11 m AOD, the top of the mortar in the foundation trench at the junction of the former walls was at 224.90 m AOD, and the white clay in the south side of the test pit was at 224.99 m AOD.

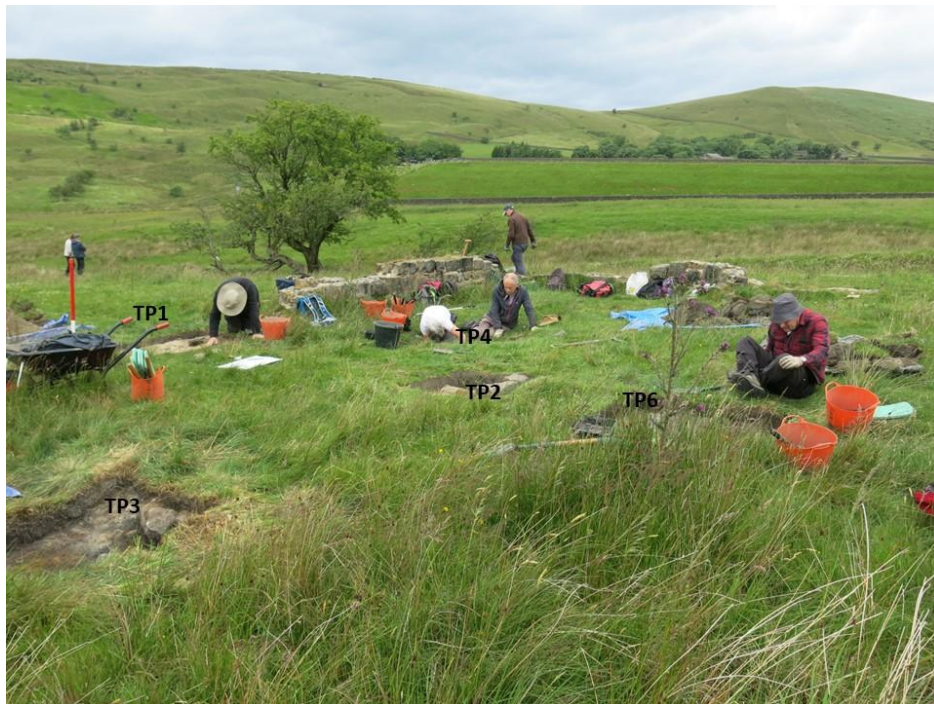
Test Pit 4 can be seen in the middle of the photo.

A circular depression in the north west part of the central range was investigated by excavating a 1.5 x 0.8 m test pit/small trench. It turned out to be a c 30 cm deep pit backfilled with stones and mortar taken presumably from adjacent walls. It does not appear to be structural, that is there is no evidence for a post setting, and it appears to post date the medieval building being full of material derived from that building. There were some post medieval finds but the reason for the pit is unclear. The turf level over the pit was at 224.95 m AOD and the bottom was at 224.63 m AOD.

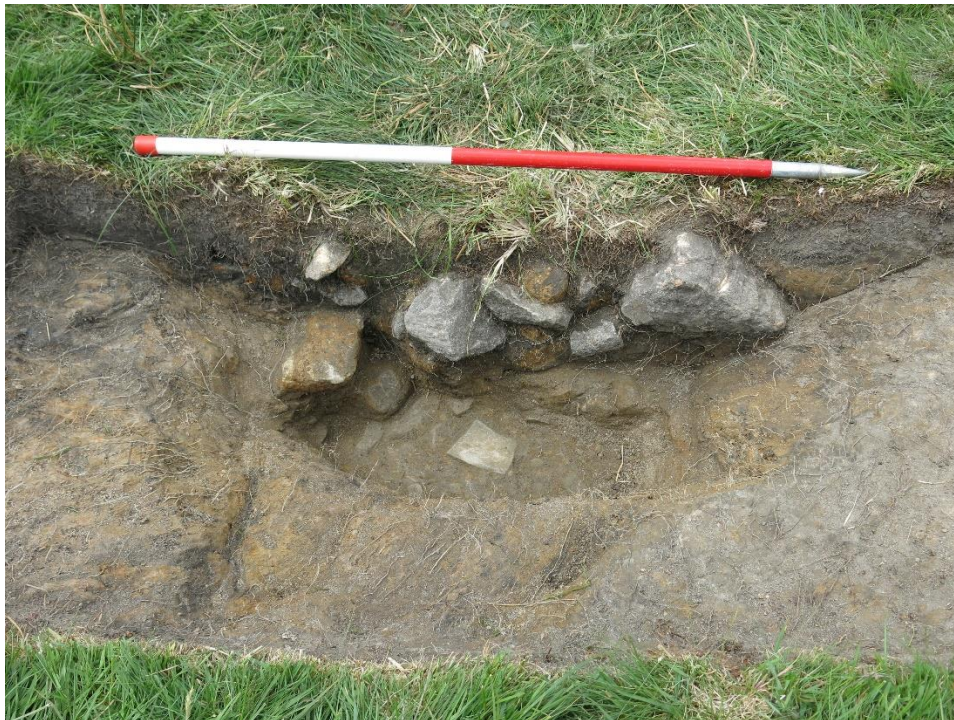
The section across the depression shows the rubble and mortar fill within a roughly circular pit.

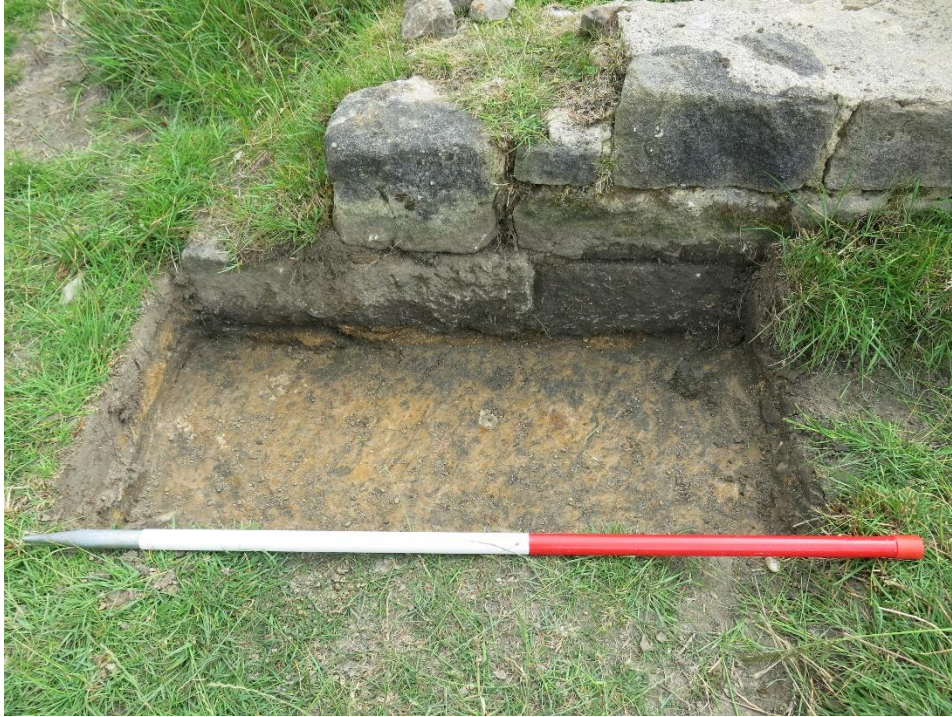
The photo shows the well-dressed base stones sitting on a bed of dark yellow mortar.

This was located against the exterior wall face in the north west corner of the central range. Test Pit 5 examined the potential for small rooms to project from this part of the building, as has been found on the north east side of the central range. The test pit was 90 cm long by 50 cm wide. It found that there was a thin layer of turf and mortar/soil that came down to natural yellow clay. It was clear that there is no wall extending off the corner of the building. So, the arrangement seen on the opposite north-east side, where two small rooms project out from the corner, is not mirrored here. This is the only example of non-symmetry in the whole building. The test pit did allow a closer examination of the exterior wall face. The dark yellow-orange bedding mortar could be seen under three courses of dressed stone blocks. The clay base was at 224.81 m AOD, and the wall surface on top of the stones was at 225.35 m AOD.

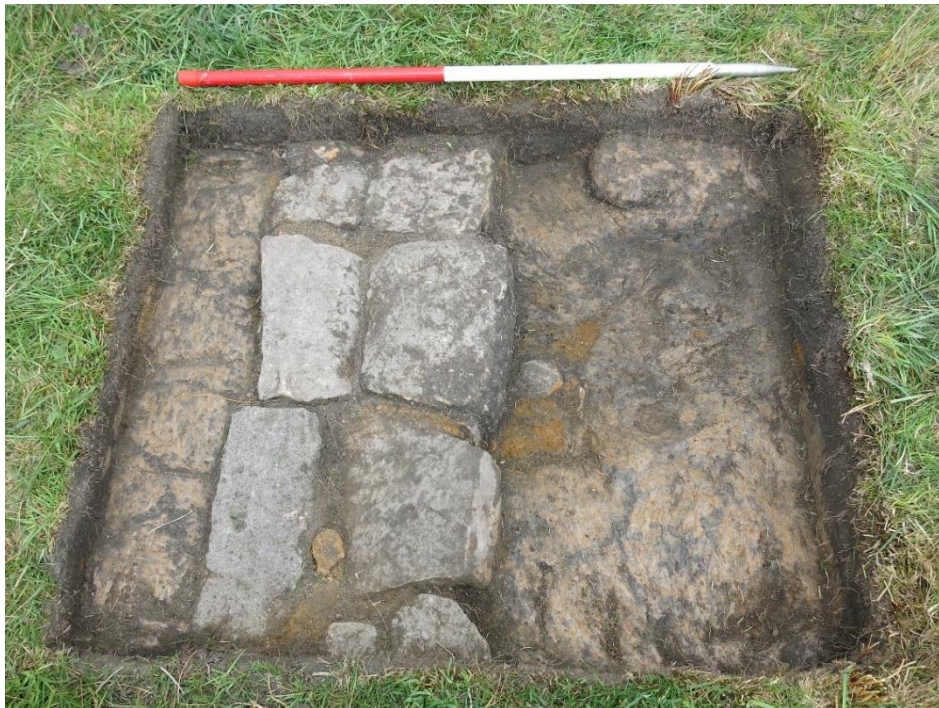
Test Pit 6 looking north with the vestiges of the internal wall showing on the right, running up to the much better preserved corridor wall.

This was located to find an interior dividing wall on the opposite side of the north to south corridor to match that revealed on the west side of the corridor in Test Pits 1 and 2. The one metre square test pit exposed a one metre long section of surviving wall foundation for the eastern side of the north to south corridor. The interior wall was evident only as a patch of dark yellow-orange foundation mortar and a dark silty stain to indicate the shallow wall trench. So only slight vestiges of the wall survive but it is there. The corridor wall top was at 225.19 m AOD, the internal wall site at 225.04 m AOD and the natural cream coloured clay at 225.17 m AOD.

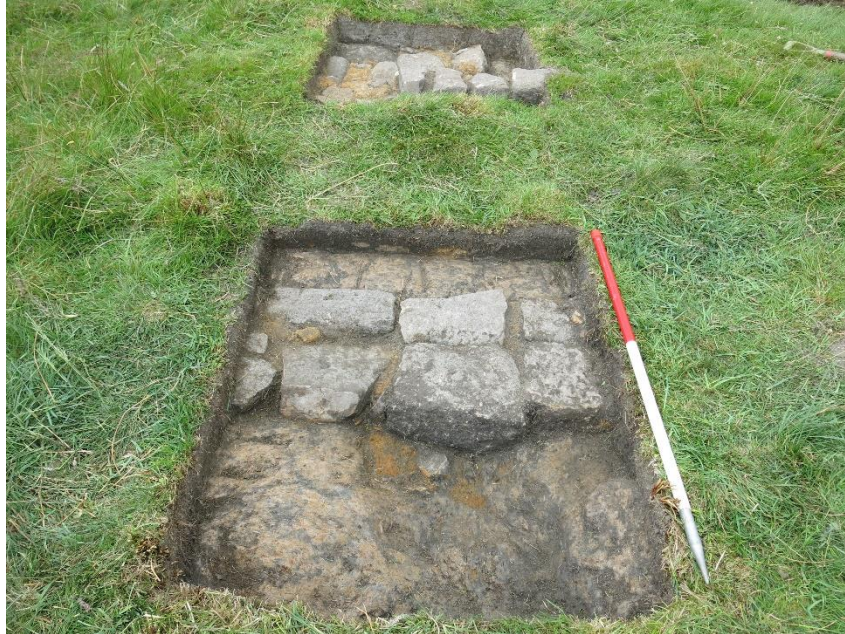
The photo shows Test Pit 6 in the foreground, with the other side of the north to south corridor evident in Test Pit 2 at the top of the photo. Looking west.

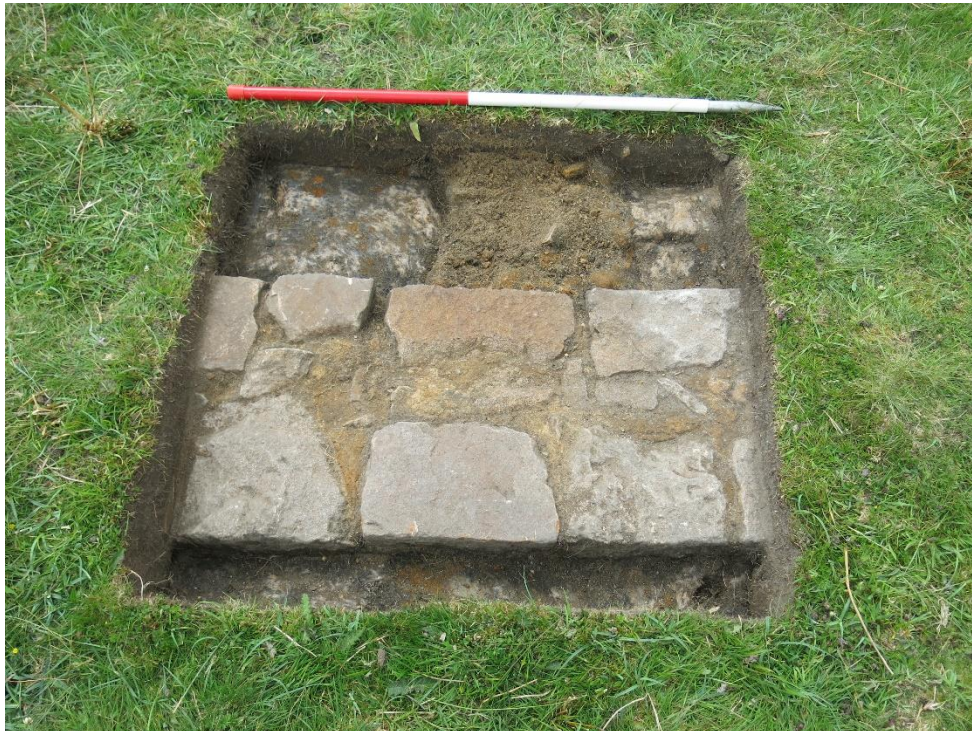
Test Pit 7 looking west. The eastern external wall of the grange's central range is in the foreground and the loose mortar of the interior wall can be seen beyond.

The line of the interior wall revealed in TP 6 was confirmed where it joined with the eastern external wall of the central range. Again, the interior wall was much more fragmentary than the main wall it abutted. In this case, the interior wall was evident as crushed gritstone and yellow-orange mortar, whilst the east external wall survived as a level well-constructed wall foundation with dressed wall edges and the medium sized stones bound with yellow-orange gritty mortar - as seen elsewhere. The wall surface was flat and at 225.44 m AOD, the interior wall top at 225.34 m AOD and the natural cream coloured clay at 225.30 m AOD.

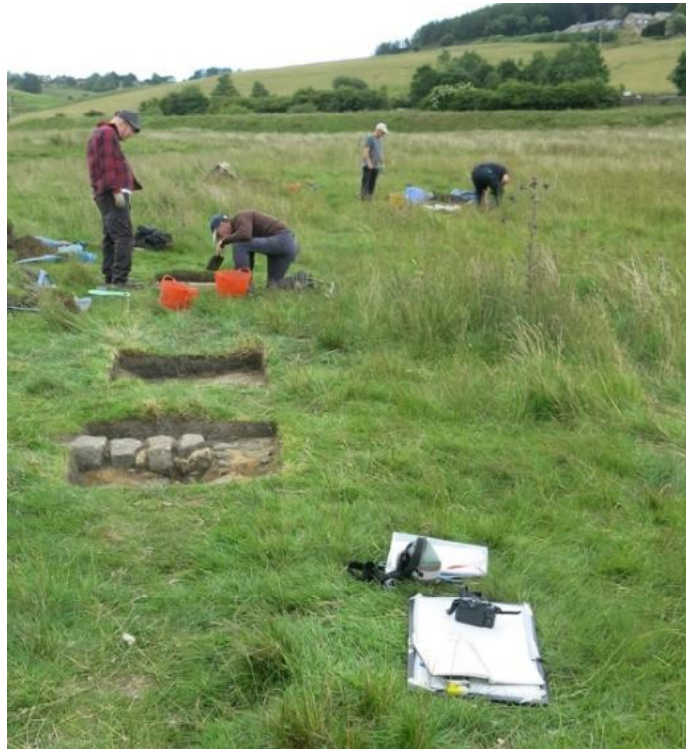
Test Pits 2, 6 and 7 in the central range can be seen in the foreground with Test Pit 8 being dug in the background.

A test pit was dug across the northern external wall of the east range to examine a depression to see if there was an internal wall at this point. The base mortar layer of the main wall was evident but there was no sign of an internal wall. A sondage against the wall foundation material confirmed this, with just natural clay being encountered. The shallow, small depression was created by the low level of the 'robbed out' foundation. Not levelled.

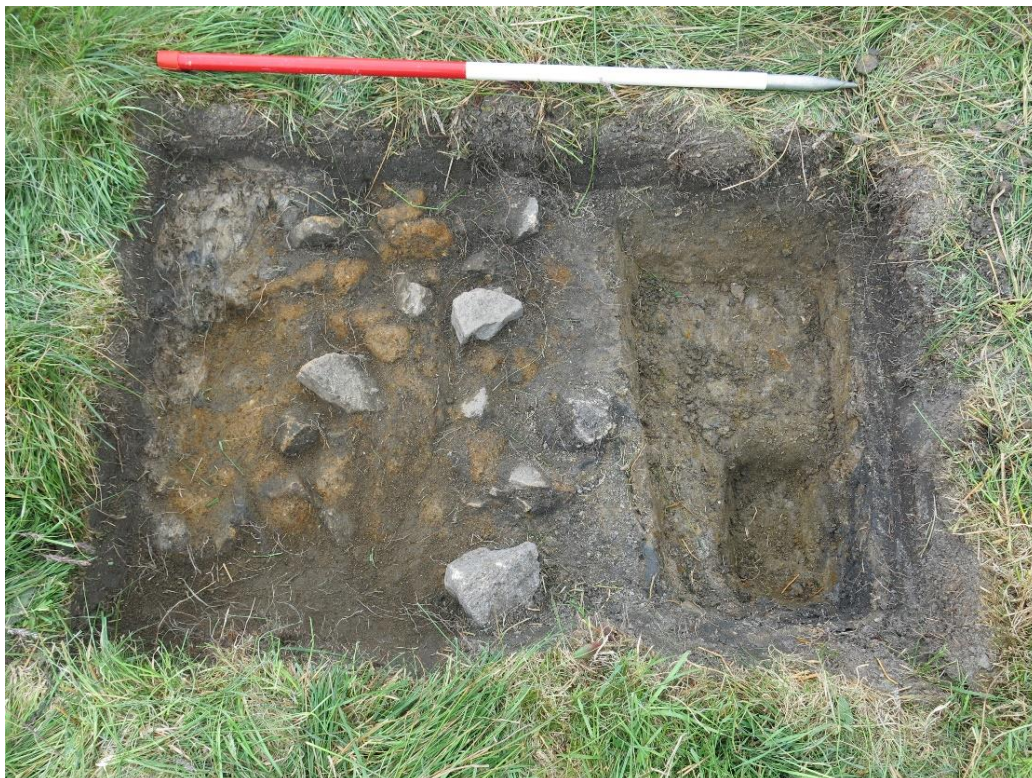
Test Pit 8 looking east. The northern external wall of the grange's east range is on the left, represented by clumps of mortar and a few stones. The sondage into natural on the right demonstrates that there is no internal wall here.

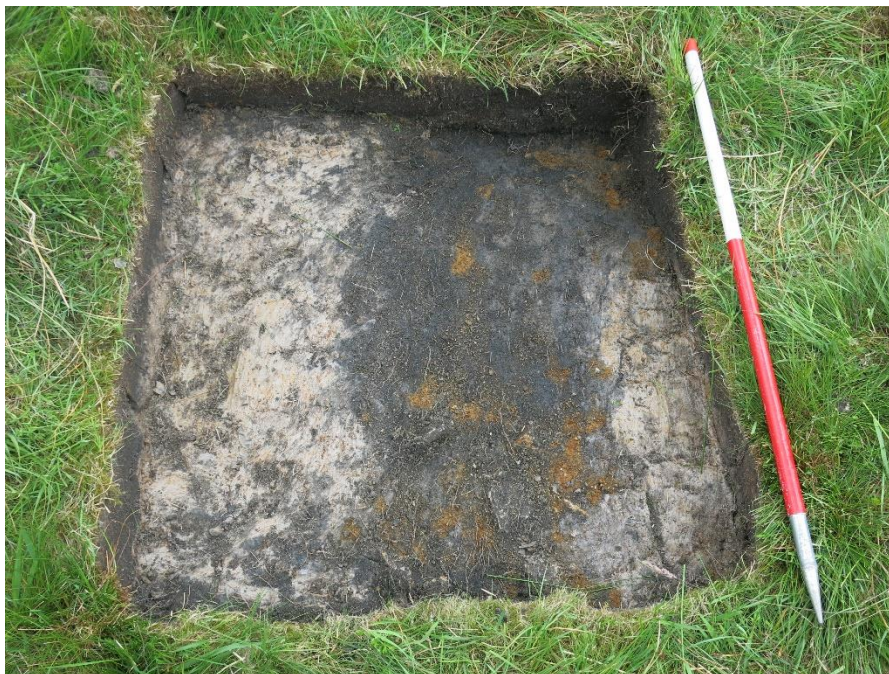
Photo of Test Pit 9 showing extensive robbing of the walls for their stones, with just some mortar and dark grey silt indicating the wall trenches – but in the top right corner the junction of the two walls is clearly visible. Looking south.

This was dug to confirm a junction for two walls defining the south-east corner of the middle chamber within the east range, which was accessed by the east west corridor. The junction was revealed in the corner of the test pit against the natural cream-coloured clay, with the wall foundation lines represented by dark grey silt and patches of dark orange mortar and occasional small gritstones. At the wall junction the top of the dark grey silt fill was at 225.57 m AOD and the turf level near the south-east corner was 225.71 m AOD.

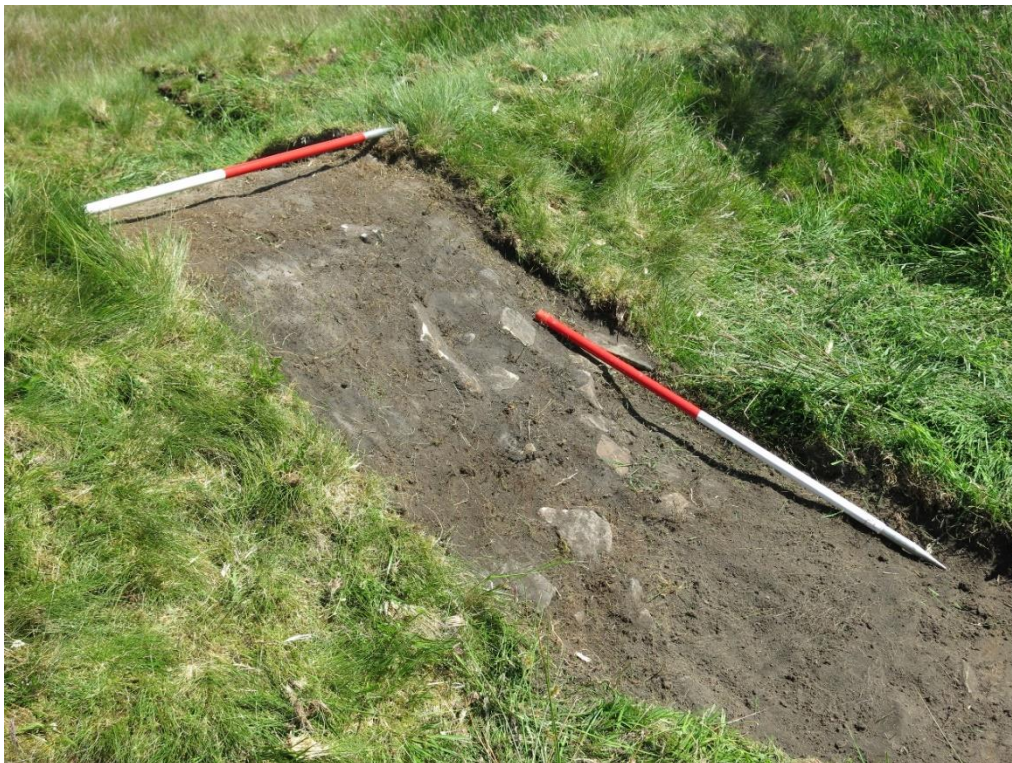
The deposit of stones on the south facing slope of the bank.

Immediately under the turf and a shall topsoil layer was exposed a deposit of flat stones laid on the south facing slope of the bank. They were very shallow, only one stone deep, and set within a loose dark grey-brown humic soil. The reason for the presence of these stones is unclear. They may have been laid to stabilise or protect the bank or could even have been discarded stones from the grange site.

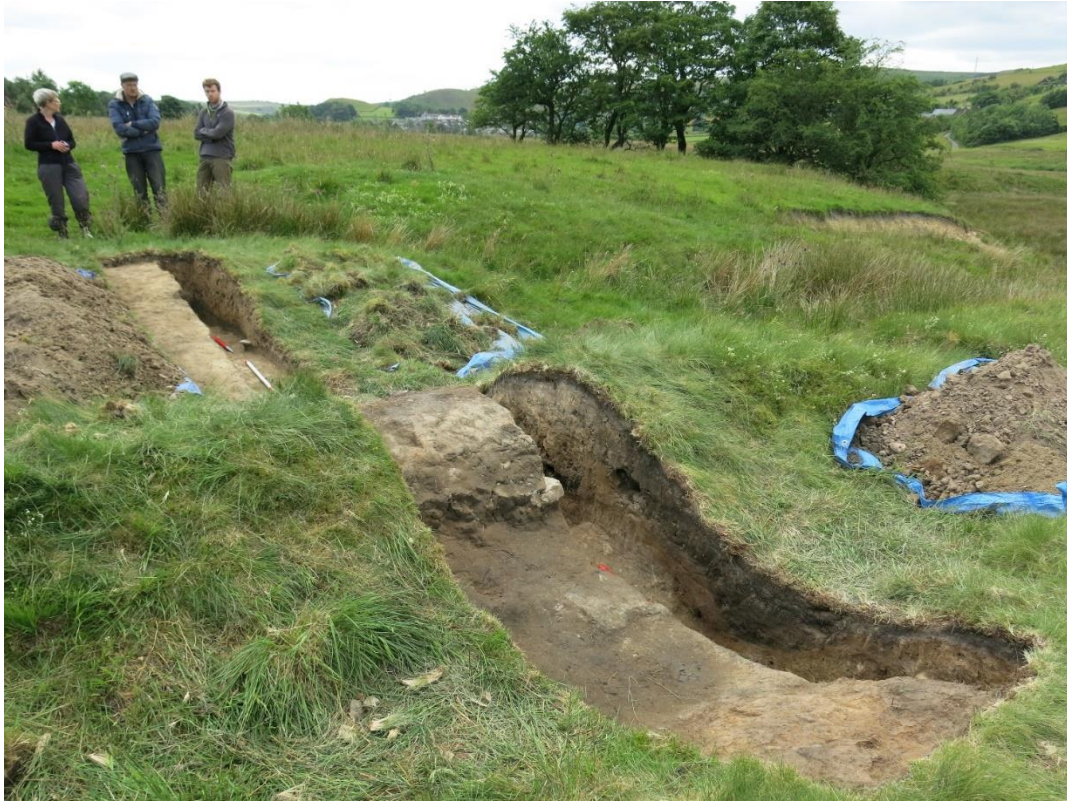
Looking south-west across Trench 1 after completion of the excavation.

Completion of the excavation showed that the bank was flanked by a ditch on either side and that the hollow-way did not exist.

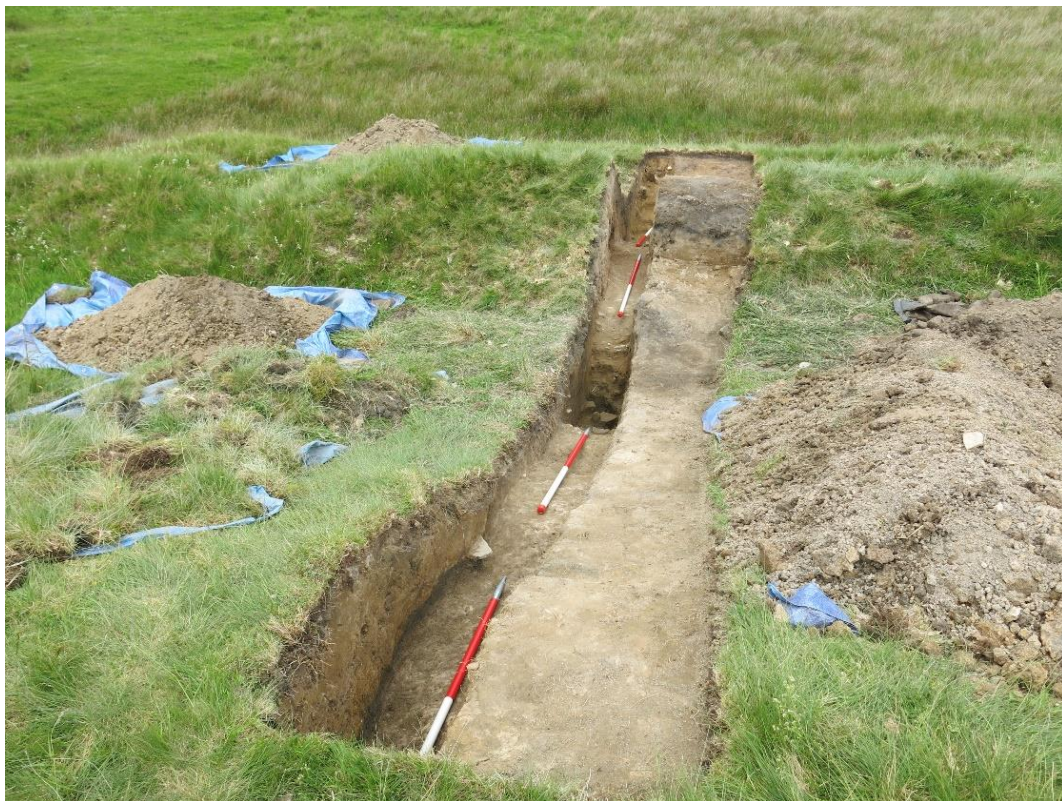
Looking north across Trench 1.

The following describes the east facing section from south to north. At the south end of the trench was a raised area which formed the south side of the potential hollow-way. The section revealed that this landscape feature was artificial and of relatively modern origin. The raised ground was created by a 60 cm

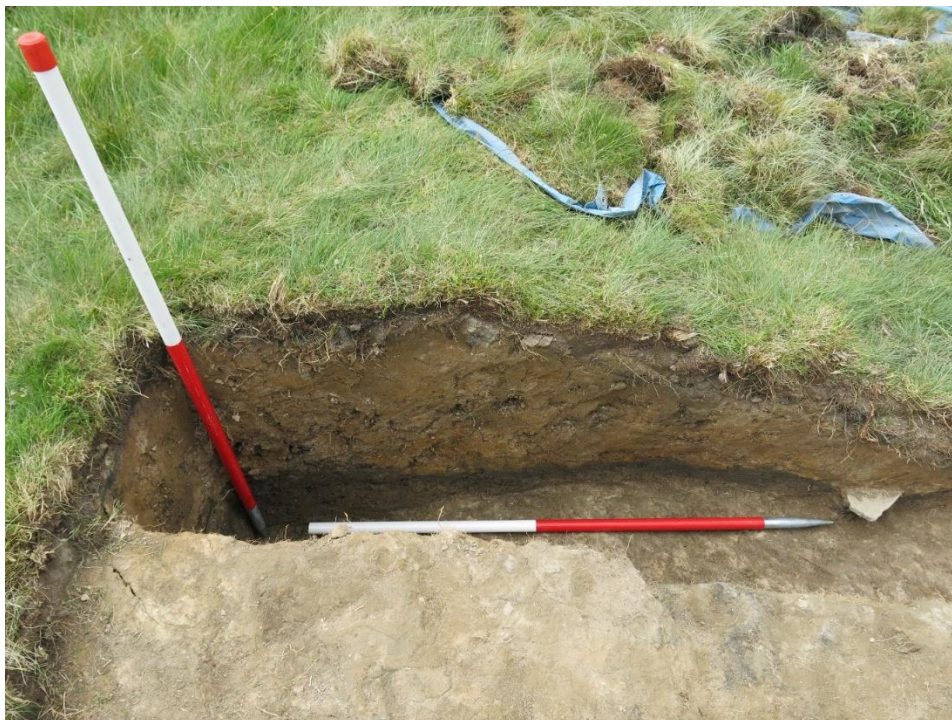
South end of Trench 1 showing the spoil mound.

deep mound of spoil comprising mid-yellow-brown clay loam over a deposit of very dark grey silty clay loam which in turn covered natural. The spoil appears to derive from one of the 20th century drains that cut through this area.

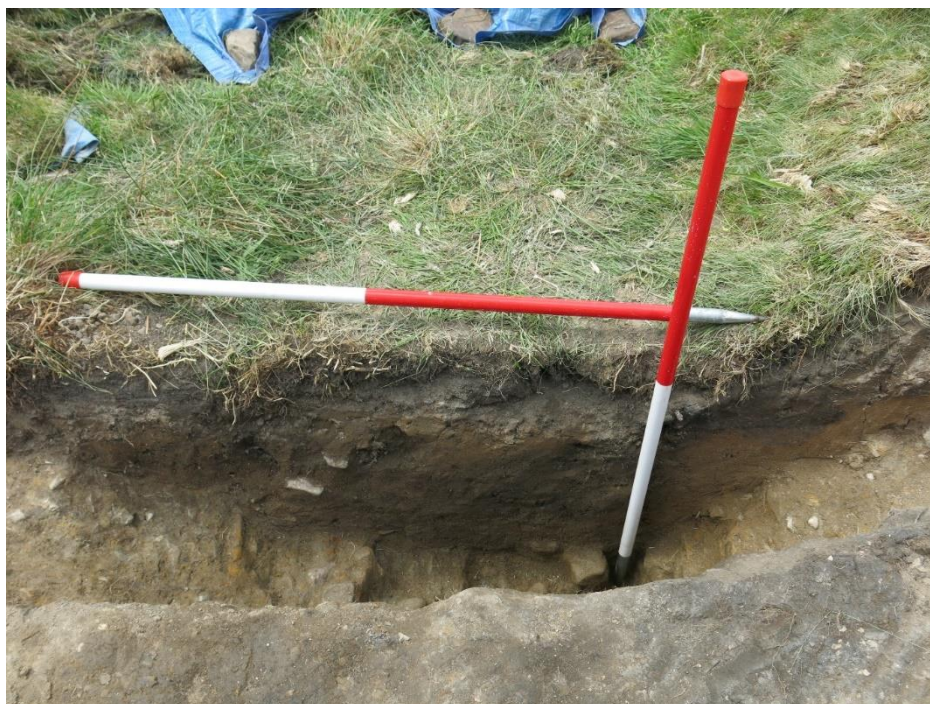
The ditch against the south side of the bank, with the irregular natural base shown below.

Moving northwards along the section revealed a ditch against the south side of the field boundary bank. Under a layer of loose dark grey silty clay loam (which held the flat stones) was a 50 cm deep layer of very dark grey brown clay loam which forming the ditch's fill. The ditch was cut into natural clay which contained frequent gritstones, so that the ditch edge was quite irregular. The ditch was about 1.7 m wide, forming a gently sided 'V' shape in profile, and was 65 cm deep from the top of the turf to the natural base. There were no finds from the ditch fill.

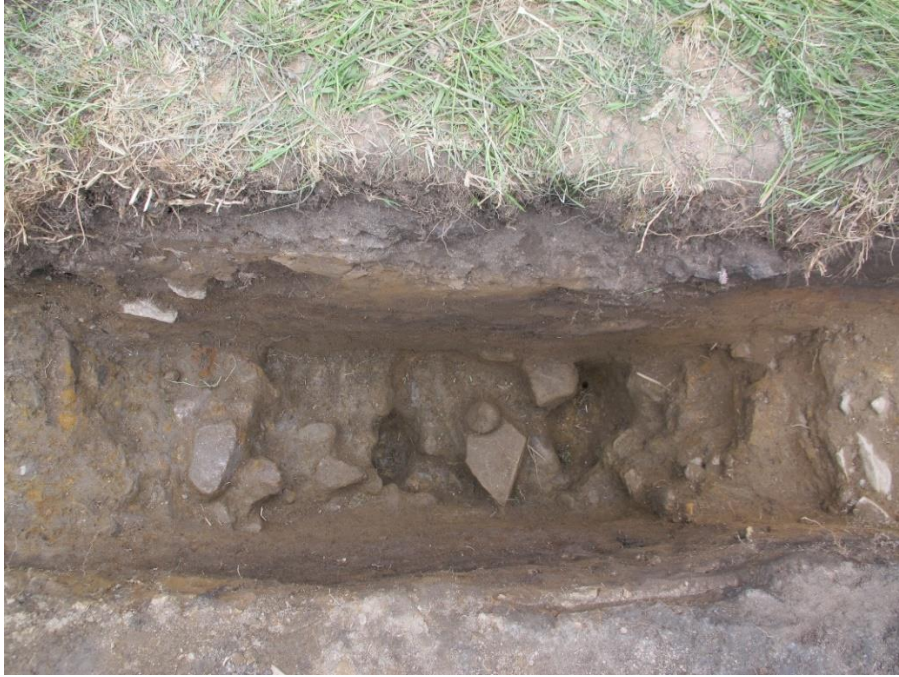
Vertical view of base of the ditch, showing the stones set in natural clay.

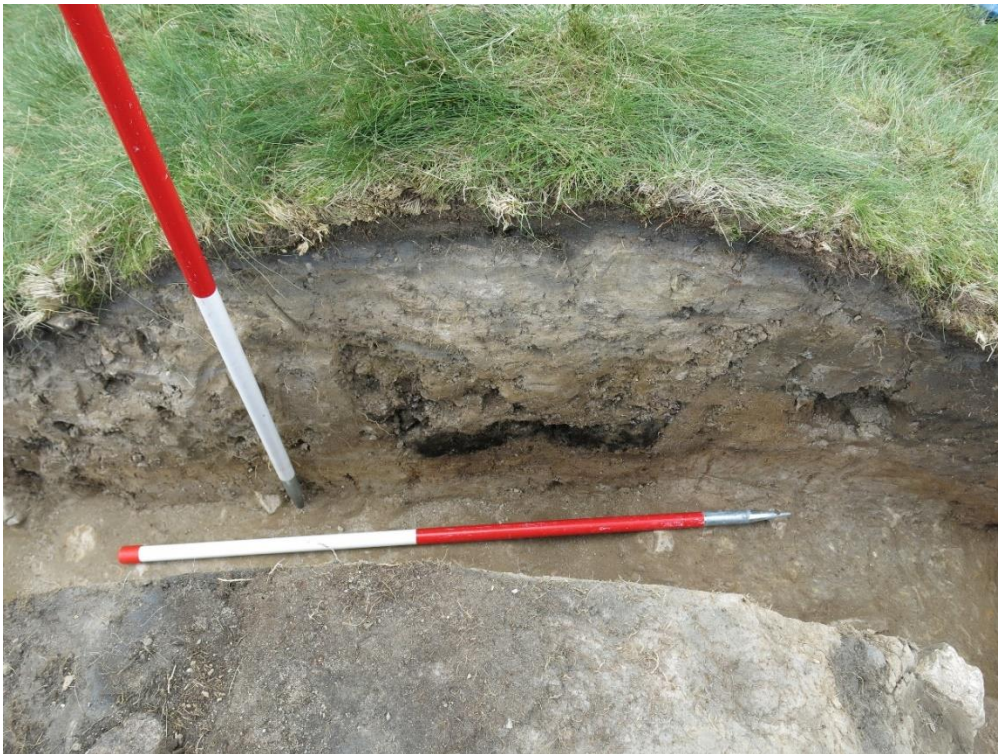
The field boundary bank in section, showing the 'U' shape cut in its middle (marked in its base by the thick layer of black humus).

The field boundary bank itself was c 1.5 m wide and 70 cm high. A 'U' shaped feature was cut into the middle of the bank. This feature had a flat base and steep sides, measuring 50 cm wide at the base and 85 cm at the top, and was 55 cm deep. It was filled with a layer of mixed light grey and light yellow clay loam at the top, very loose mid-grey-yellow clay loam in the middle and a black humic layer at the base. This humic layer was formed of decayed vegetation, probably turf. The bank was made up of a layer of mid- orange-brown sandy silt loam overlying a grey silt layer with some iron stain bands in it. Above these was a very dark grey silty clay loam on the north side and a light grey clay loam on the south. All these deposits were cut through by the 'U' shaped feature except for the base layer of light grey clay. There were no finds. Only c 50 cm length of this feature was exposed so it is impossible to say too much about its function other than to postulate that this was dug to plant a hedge or erect a palisade to help with stock control.

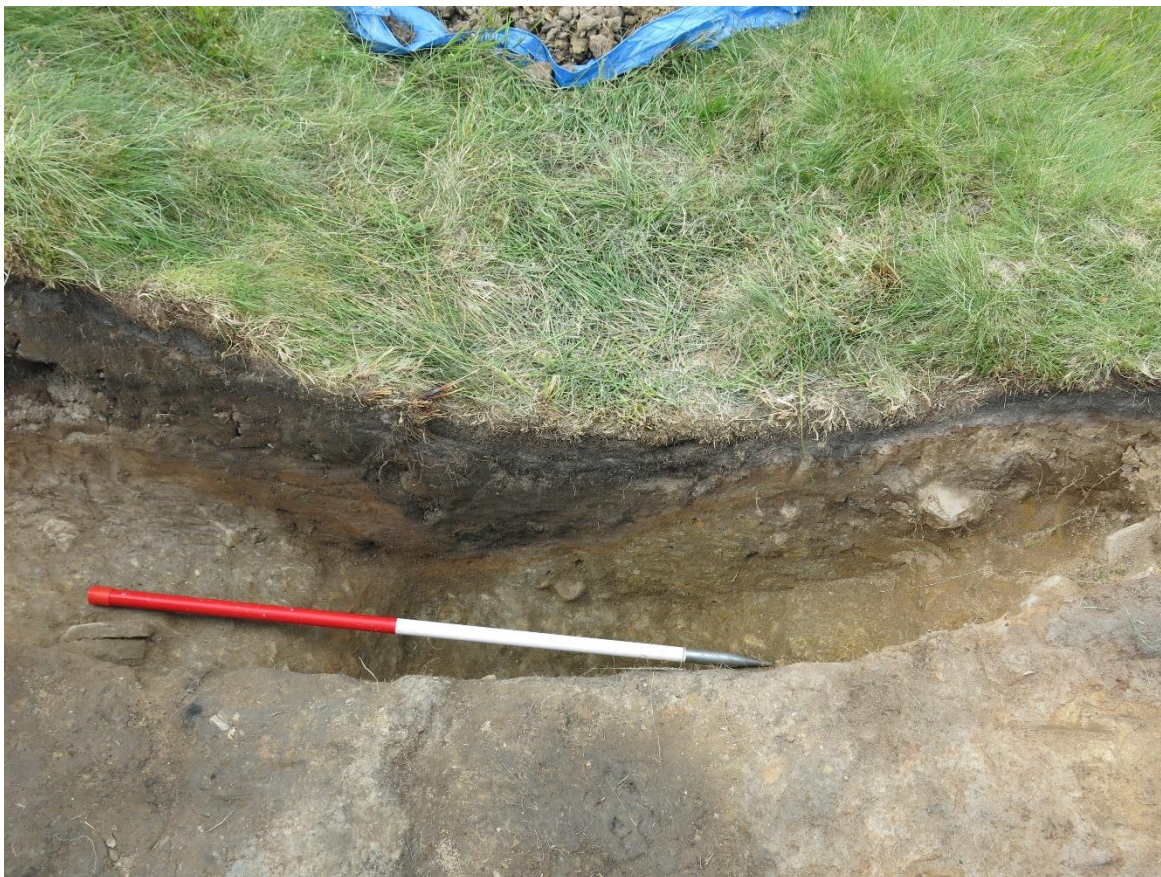
The second ditch, which flanks the north side of the bank.

On the north side of the bank and close to the edge of the steep slope down to Waters Clough was a second ditch. This was shallower than that on the south side of the bank, being 40 cm deep, and was slightly less wide, at 1.5 m. Its upper fill was of very dark grey-brown silty clay loam, lying over a mid-orange-brown sand silty loam which also forming part of the bank and continued through to the northern end of the section. A compact and contrasting layer of mid-yellow grey clay loam mixed with small soft sandstones formed the base fill on the north side of the ditch. However, this material may be sub-natural as it was not dissimilar to the ditch base material of yellow-grey compact shale. If this is the case then the ditch is narrower, at 1.1 m. Its profile forms a gentle-sided 'V' shape, as with the north ditch. A body sherd of dark glazed earthenware possibly of 17th century origin was found in the lower ditch silt.

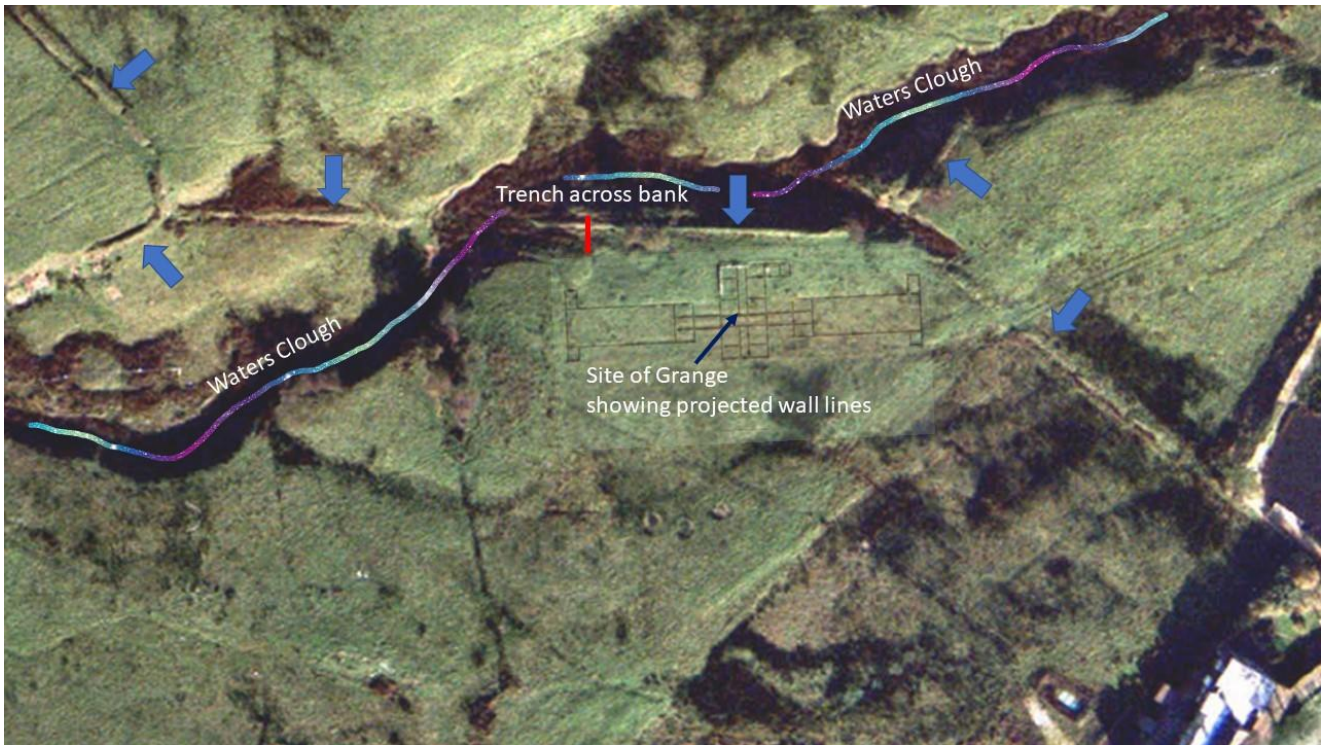
Aerial photo showing the grange site in its immediate landscape context, with the position of Trench 1 marked in red and the location of earthwork field boundaries in close proximity to the grange site.

The aerial photo below shows the earthen banks in the vicinity of, and their relationship to, the grange building (indicated by blue arrows). The trench across the bank and ditches is shown in red. The impressively straight line of the bank just north of the grange, subject of the trench excavation, is apparent. It does not deviate as it crosses Waters Clough.

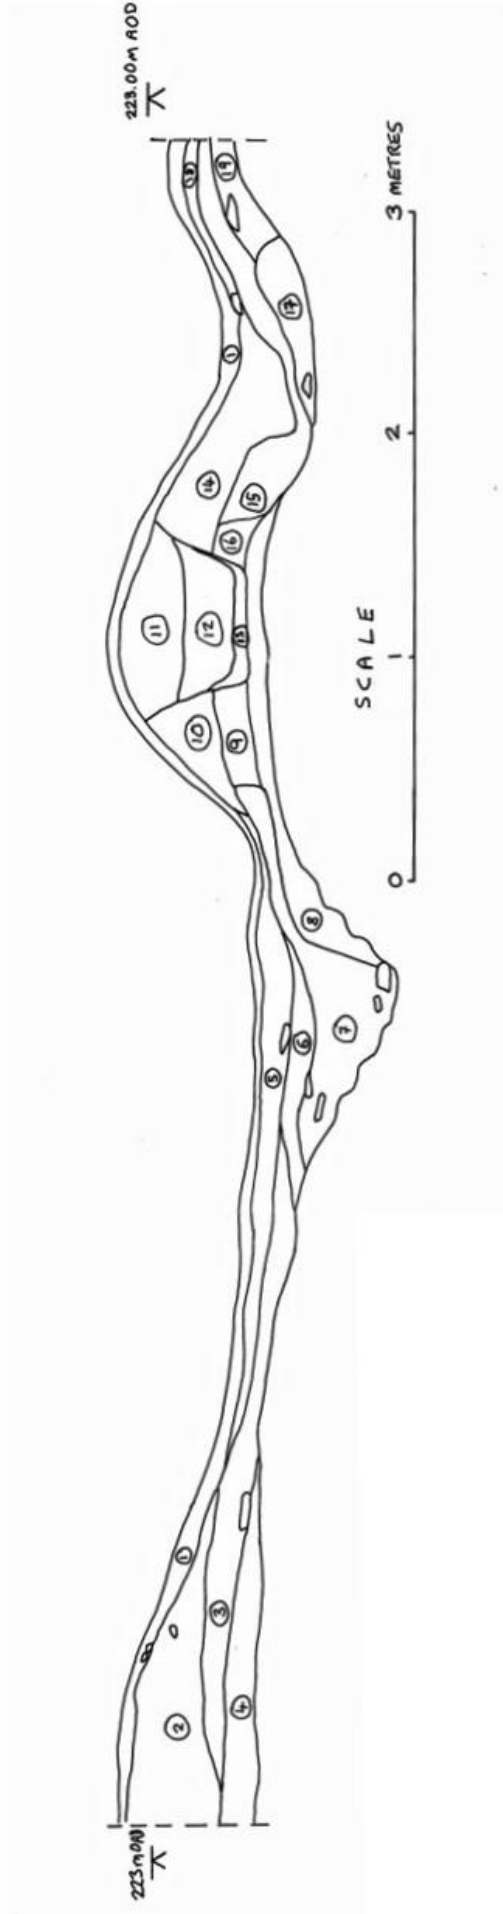
Section drawing of Trench 1

1 = topsoil and turf, 2 = mid- yellow-brown clay loam, 3 = mid- orange-brown silty clay loam, 4 = very dark grey silty clay loam, 5 = loose very dark grey silty clay loam and stones, 6 = dark brown silty clay loam, 7 = soft dark grey-brown silty clay loam, 8 = light grey silty clay with banding of dark brown, 9 = mid-brown silty clay loam, 10 = light grey clay loam, 11 = mixed light yellow and light grey clay loam, 12 = very loose mid- grey clay loam, 13 = soft black humic material, 14 = very dark grey-brown silty clay loam, 15 = mid- brown sandy silt loam, 16 = light yellow and orange sandy silt loam, 17 = compact mixed mid- yellow clay loam and small sandstones, 18 = light grey sandy silt loam, 19 = mixed mid- grey and orange patches of sandy silt loam.

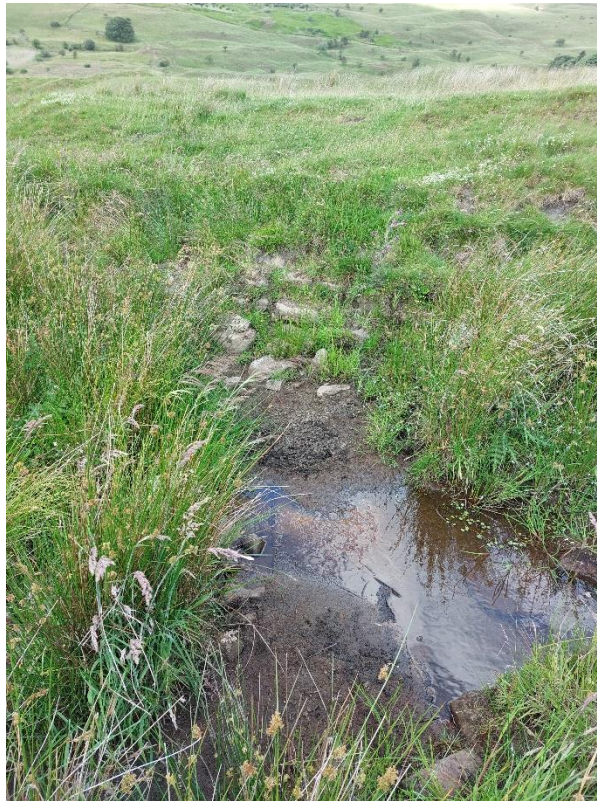
Prior to clearance work, the stepped stonework can be seen on the far side of the clough. Looking west.

As part of the investigation of the potential lane leading down to a crossing over Waters Clough, the area of the possible ford or bridge was examined. A stepped foundation of stone, evident on the west side of the brook, was thought to represent a former bridge crossing. Vegetation and silt were cleared away to reveal the character of this area. At this point the clough is quite shallow which allowed easy access to carry out this work.
