Archaeological Evaluation of the possible monastic grange site at Waters Clough, Castleshaw, Saddleworth

2022

Report written by Norman Redhead
for the Friends of Castleshaw Roman Forts

March 2023

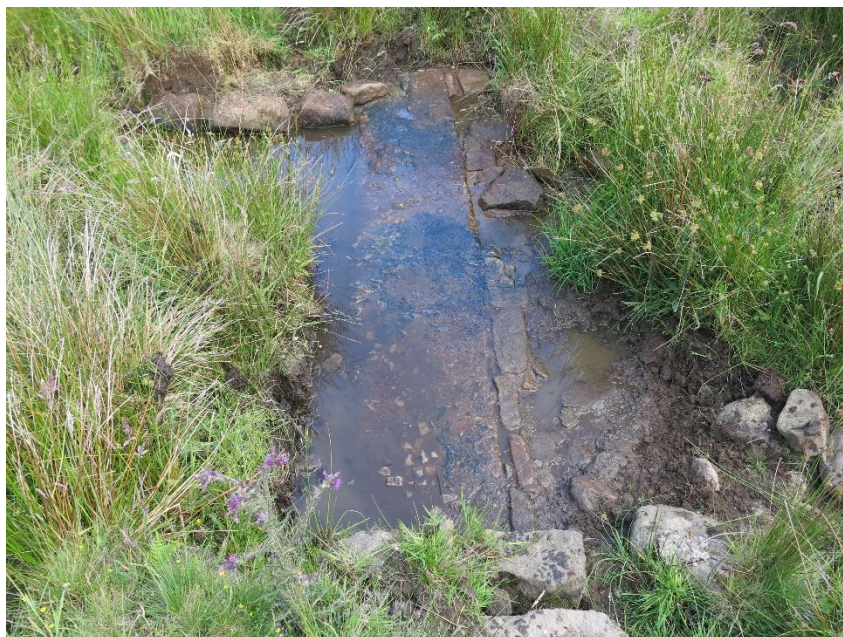
Looking east from the stepped stones across the cleaned crossing, showing the slab of iron with a line of stones marking its southern edge.

After cleaning off the silt and some vegetation it became apparent that the crossing was formed of a substantial rectangular slab of iron packed in with stones on its south side. This iron is likely to be of more recent origin and not medieval. It is not clear if there was an earlier crossing here that has been reconstructed in the 19th or 20th centuries.

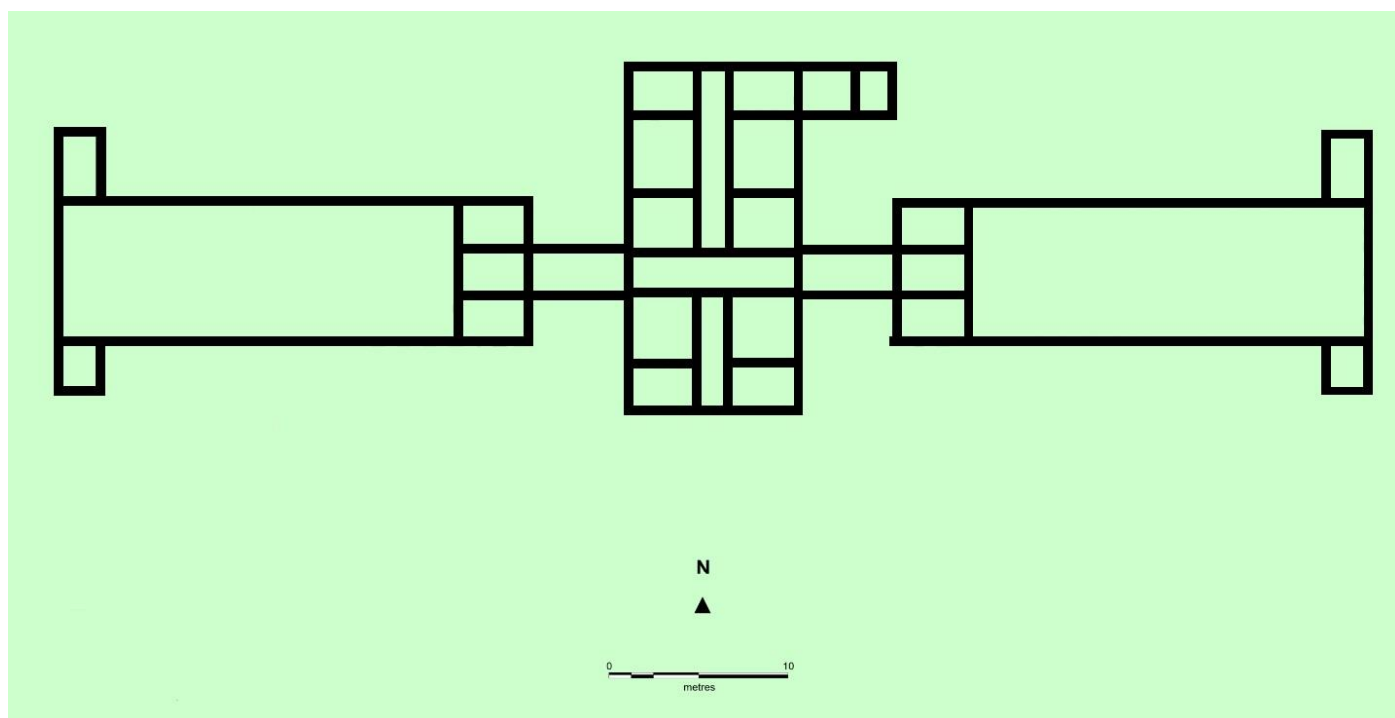
Final interpretive plan of the grange building, based on test pits and trenches.

It can be seen from the plans that the building layout is symmetrical, except for the curious pair of small rooms projecting from the north-east corner of the central range. It comprised a long narrow central range

20 metres long by 10 metres wide, flanked by a west and east range, each being 31.8 metres in length and 8.4 metres wide. The total building length is an astonishing 73.6 metres (including the central range).

The 2022 investigations have completed our picture of the central range which is divided into 10 rooms of unequal size. There are 3 chambers either side of a north to south corridor in the northern two thirds of the central range with 2 chambers either side of this corridor in the southern part of the range, separated by an east to west corridor. This corridor projects into the west and east ranges where it terminates and serves a suite of 3 chambers of equal size running on a north to south axis. Beyond these chambers most of the west and east ranges appear to be formed of a large open space with no subdivision evident. At the corners of the west and east ranges are projecting chambers, with the northern pair being longer than those to the south. All the walls are of 45-50 cm in width and built in a consistent way. A dark orange-yellow mortar has been laid in the base of the foundation trenches to support the walls which are uniformly constructed of gritstones which have been dressed on the exterior to provide an even wall face. There is a narrow core filled with small stones, all bounded in the same yellow-orange gritty mortar. The foundations have been cut into a terrace of natural cream or yellow coloured clay which provides a solid material on which to build. The exterior walls, which are load bearing, are slightly deeper than some of the internal room wall foundation slots. Some of the latter are severely truncated and survive only as smears of dark grey silt and patches of mortar.
